**THE FIFTH MEETING OF PERFORMANCE BASED NAVIGATION
IMPLEMENTATION COORDINATION GROUP (PBNICG/5)**

UPDATE OF THE GNSS SIGNAL PROTECTION ISSUE
(Presented by Secretariat)

**GPS INTERFERENCE/SIGNAL DEGRADATION IN MANILA, PHILIPPINES
AFFECTING FLIGHT AND ATM OPERATIONS**

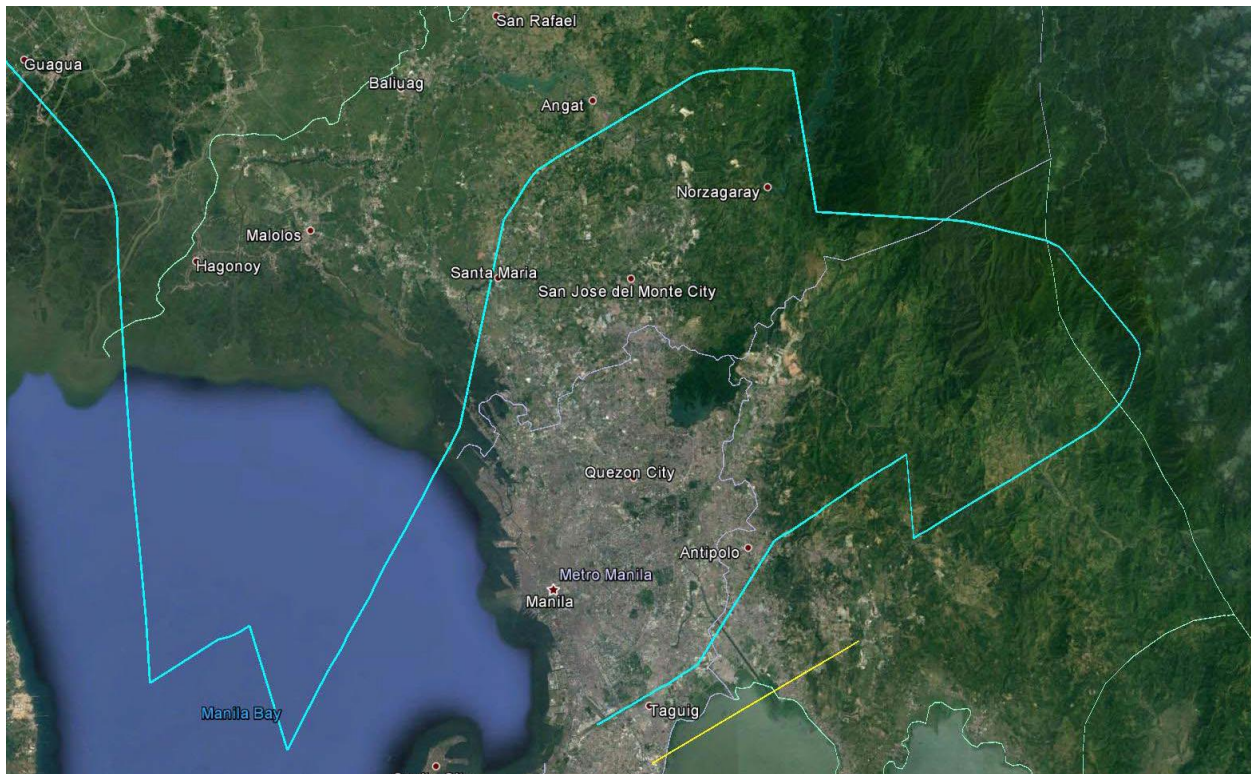
2.3 Noting the on-going worldwide deployments of automatic dependent surveillance – broadcast (ADS-B), harmful interference to GNSS will also adversely impact ATM operations. A degradation or complete interruption of ADS-B surveillance services will automatically occur as a consequence of GNSS signals being interfered. This adverse impact to ATM operations can be quite significant, especially in the area where ADS-B is deployed as the sole means of ATM surveillance.

Example of ADS-B track of aircraft flying under GNSS interference

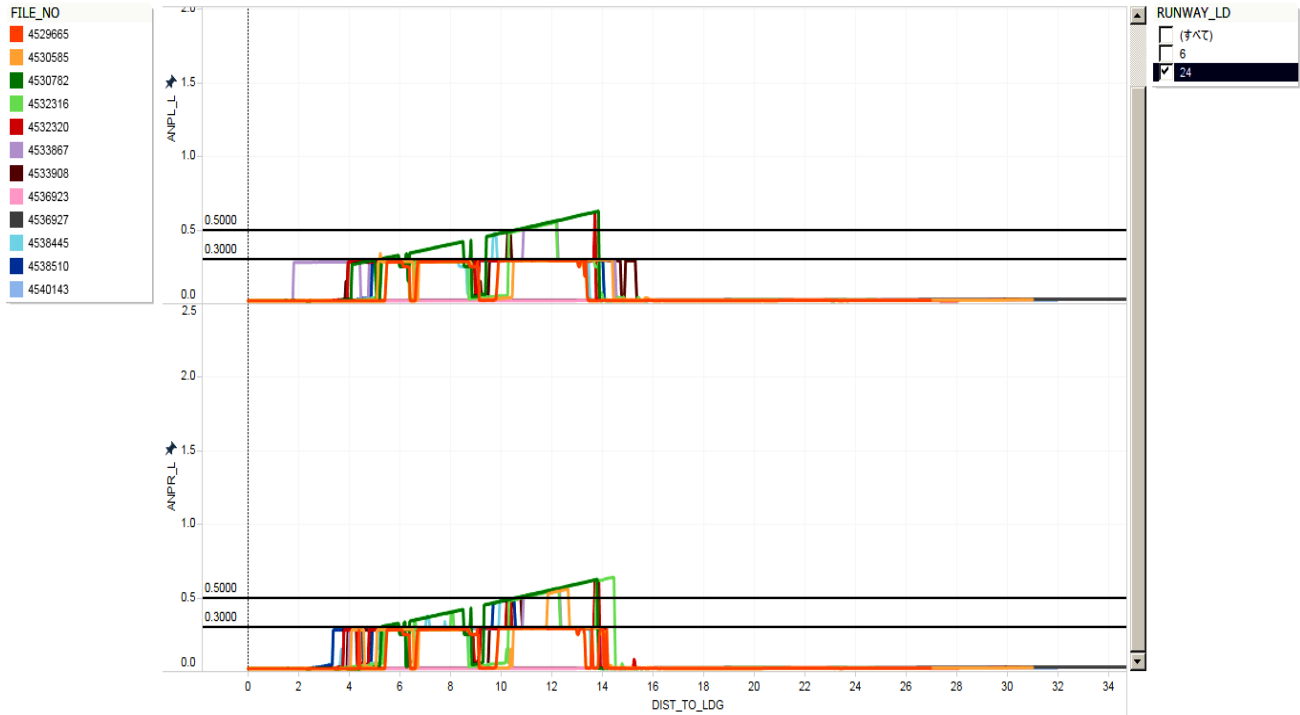
Figure 1 - Actual Navigation Performance recorded on aircraft

According to illustration data (Figure 1), you can recognize ANP (actual navigation performance) is over 0.5NM temporary at around 14 NM DME on line graph. And then, ANP have been within 0.3NM gradually. So we can expect that there is some cause like a tower for cell phone radio in around 14NM DME because almost JAL flight encountered unreliable ANP at 14NM DME as indication of data.

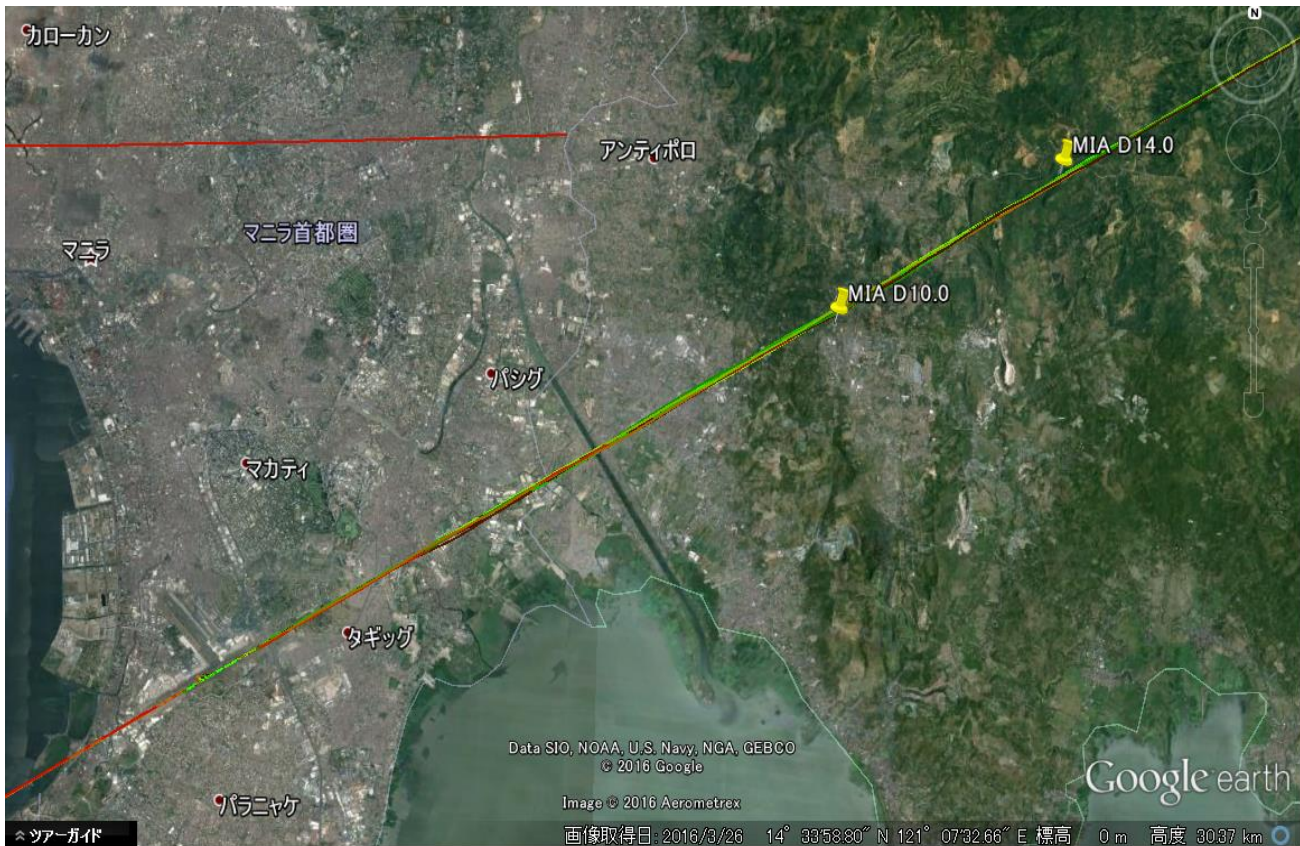
Figure 2 - 14 DME to Manila RWY24

2.5 This limited information was passed on to NTC after determining that there indeed was a cell phone tower within 1NM of the area on top of terrain approximately 1,300 feet high. Thus began CAAP and NTC's quest for the ultimate source of this GPS interference.

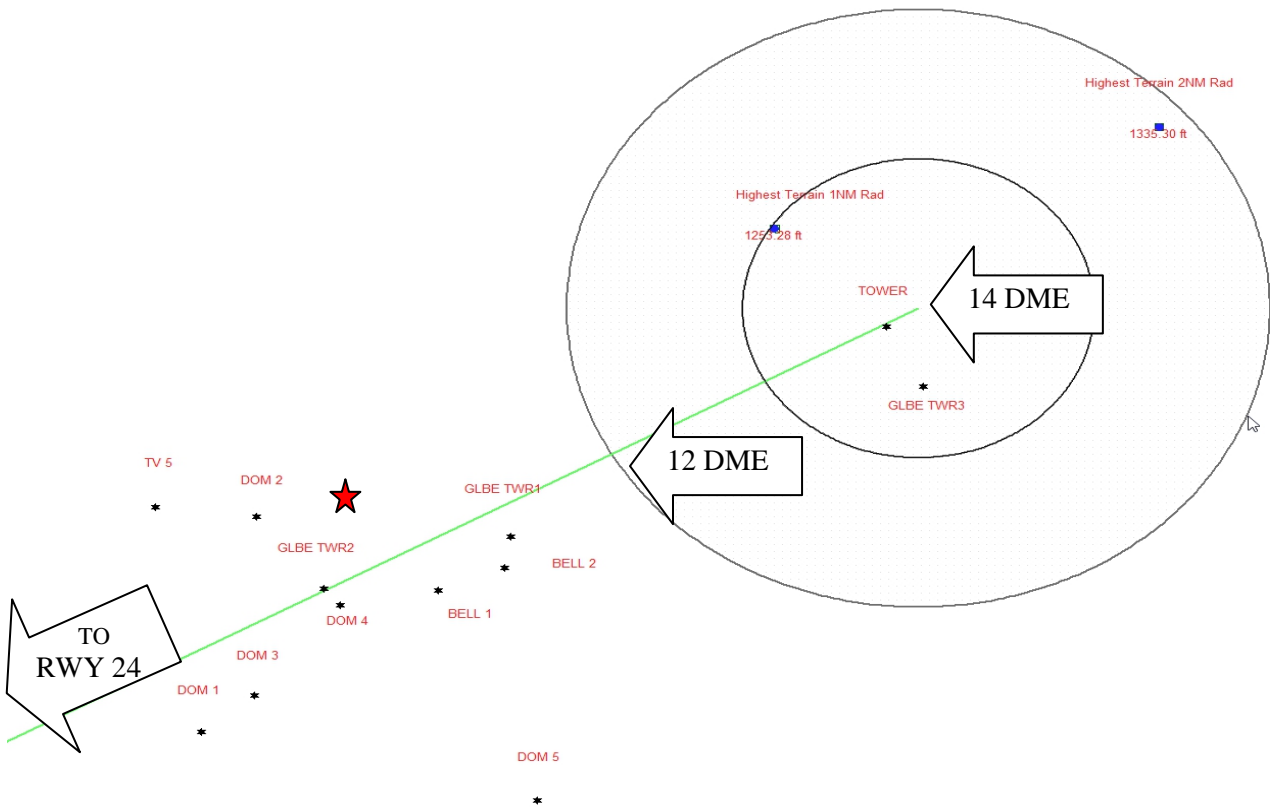
Figure 3 - Suspected Cell Phone and TV Broadcast Towers Location

2.6 The 1st suspect, after some initial investigation of the area, was not a cell tower but instead a TV broadcasting station tower. When we requested a momentary shutdown of their broadcast, CAAP’s flight check aircraft was able to received good GPS signal that led to good data to put Localizer RWY24 for use. GPS signal was lost again when flight check was about to be done on the glide slope for the ILS and thus the TV station was ruled out as the source.

2.7 The 2nd were various Cel towers, that initially indicated emitting transmissions specifically on the GPS frequency itself, were also investigated, tested, turned off with corresponding flight check but was later pronounced not the source again.

2.8 A 3rd suspect is again a TV broadcasting station of a very influential religious group in the Philippines. Letters have been dispatched after initial readings also indicate signals on the GPS frequency emanating from their compound. The whole process will be repeated again and hopefully we’ll have some good news before the next FSMP meeting.

2.7 In the interim, due to the continued reported occurrences of these events, CAAP continues to enforce the NOTAM advising the availability of other instrument approaches to runway 24 and the reported occurrences of GPS interference and signal degradation in the area.
