Air Accidents Investigation Branch

Accident Report No: **2/2008 (EW/C2005/10/05)**

Aircraft Type and Model: Airbus A319-131

Registration: G-EUOB

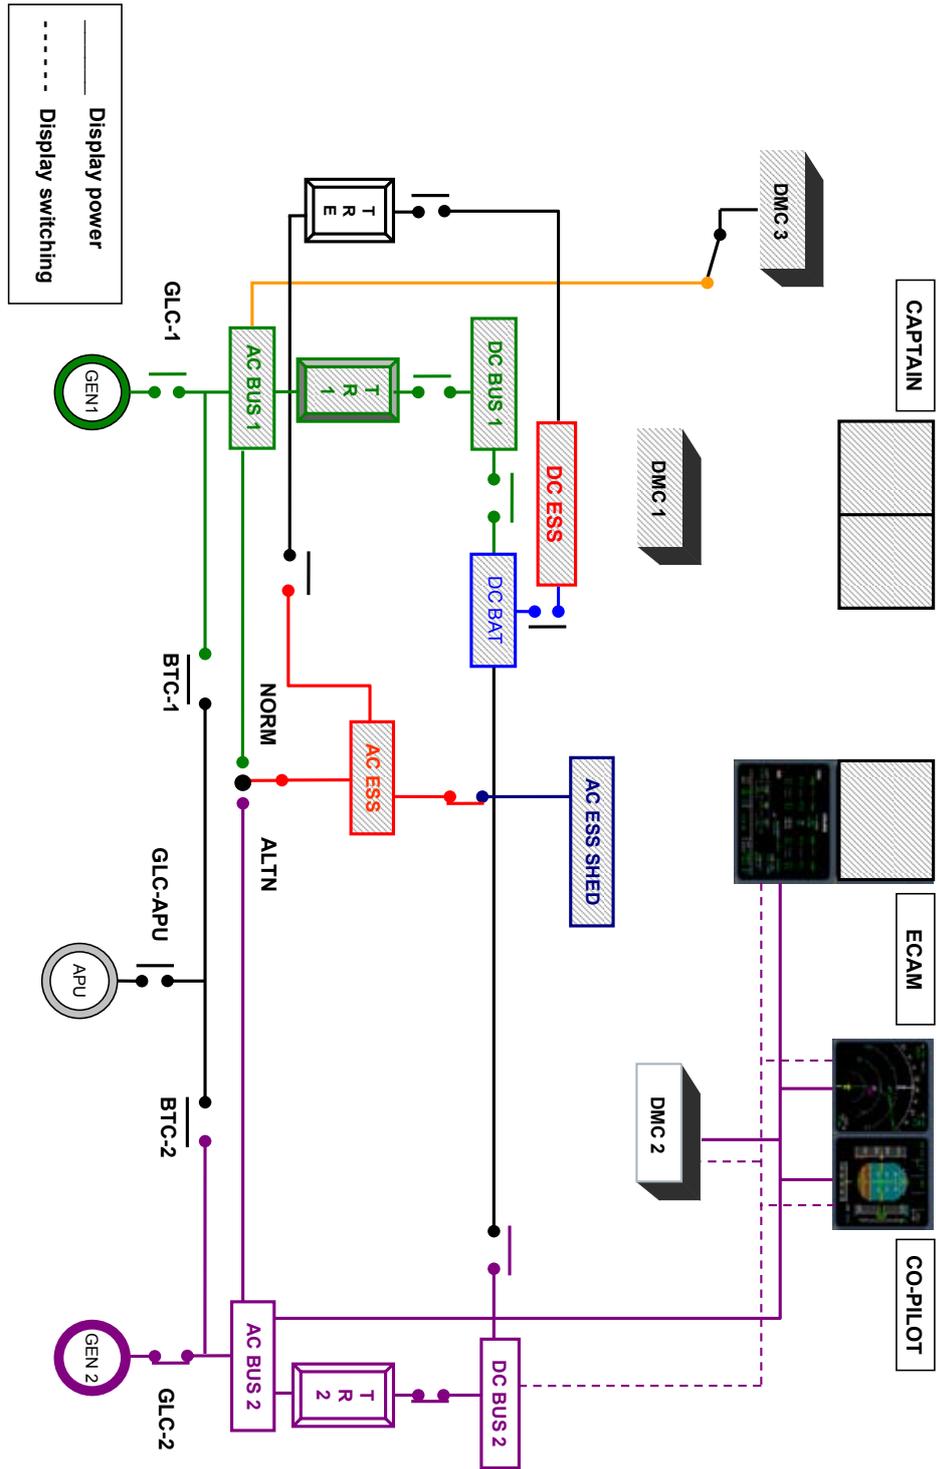
The normal EIS power supply configuration is shown in Figure 5. The expected effect on the EIS displays due to an AC BUS 1 failure is shown in Figure 6. Figure 7 shows the EIS power supply configuration after selection of the AC ESS FEED switch to 'ALTN'.

Figure 6
EIS Effects following AC BUS 1 Failure

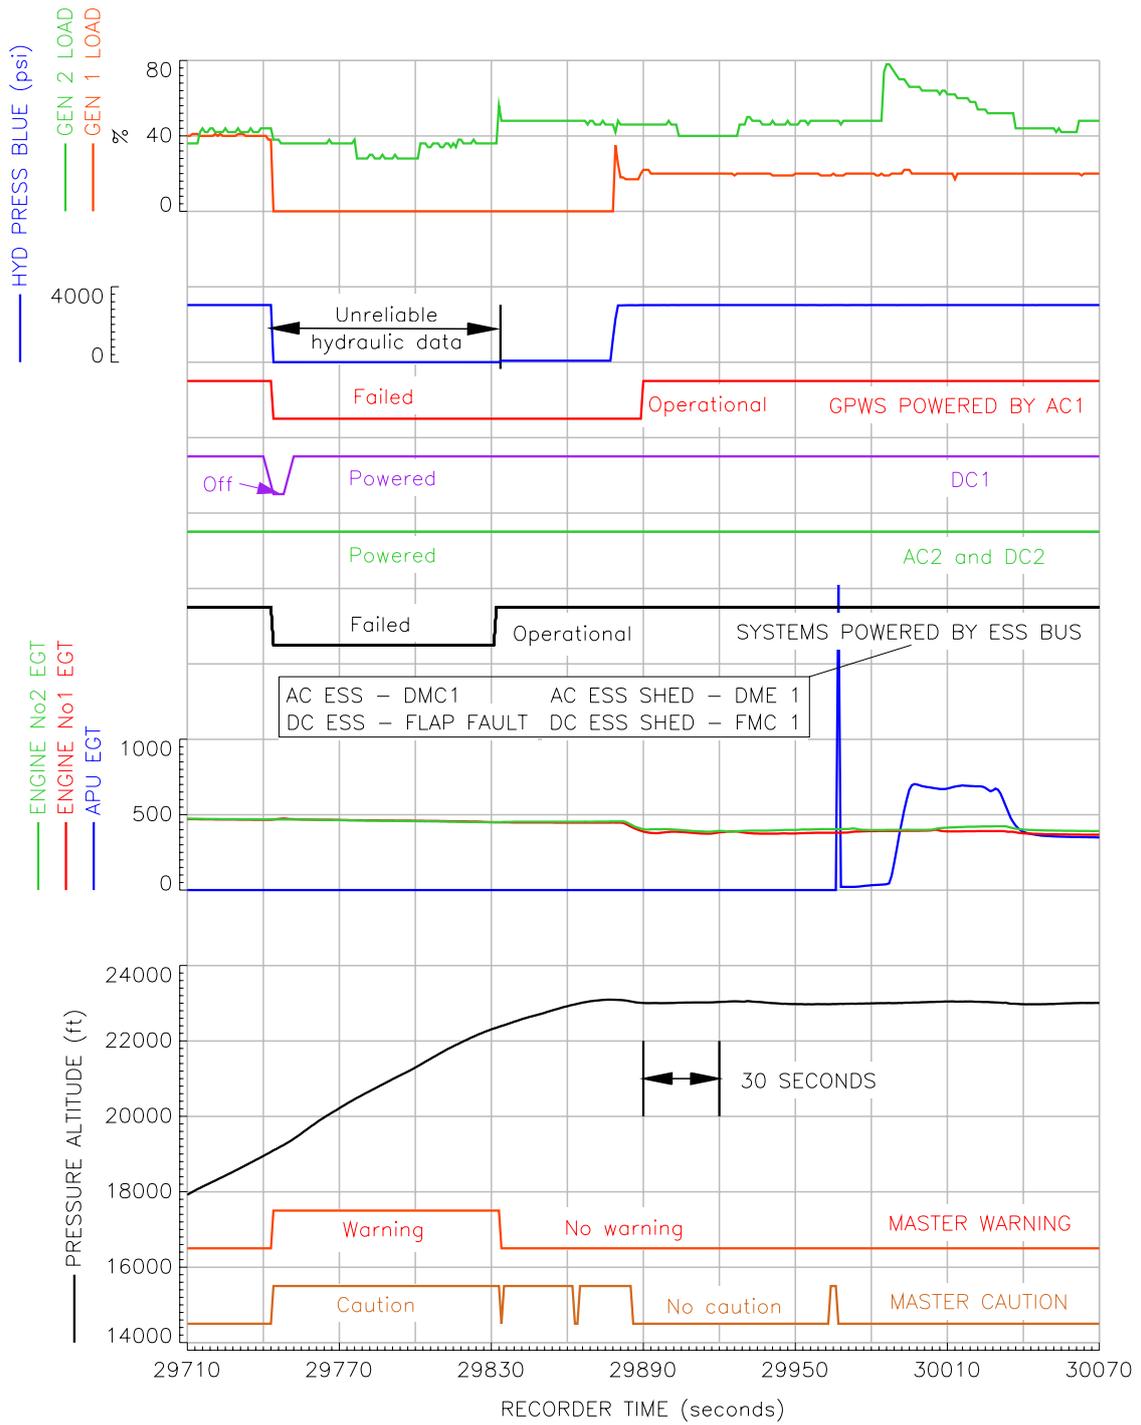
Figure 9

At 1926 hrs the No 1 generator load fell to zero. The recorded data does not indicate the cause of the loss of electrical power. At the time, the aircraft was climbing through FL190 at 2,100 feet per minute (fpm) with a Computed Air Speed (CAS) of 310 kt and a steady heading of 080°M. The wings were level, Autopilot 1 was engaged and autothrust was engaged. The last altitude selection prior to the power failure was FL230.

The DC BUS 1 showed a temporary failure for between 4 and 12 seconds (this parameter is sampled every four seconds). The continued good FMC2 and accelerometer data indicate that DC BUS 2 remained healthy throughout. Loss of FMC1 data points to the loss of power on the DC ESS SHED bus. Flap parameters reported by the Slat Flap Control Computer (SFCC) 1 became invalid indicating that the DC ESS bus lost power.

DAR derived data showing the power available on the aircraft.
 Note: the yellow and green hydraulic systems were unaffected.

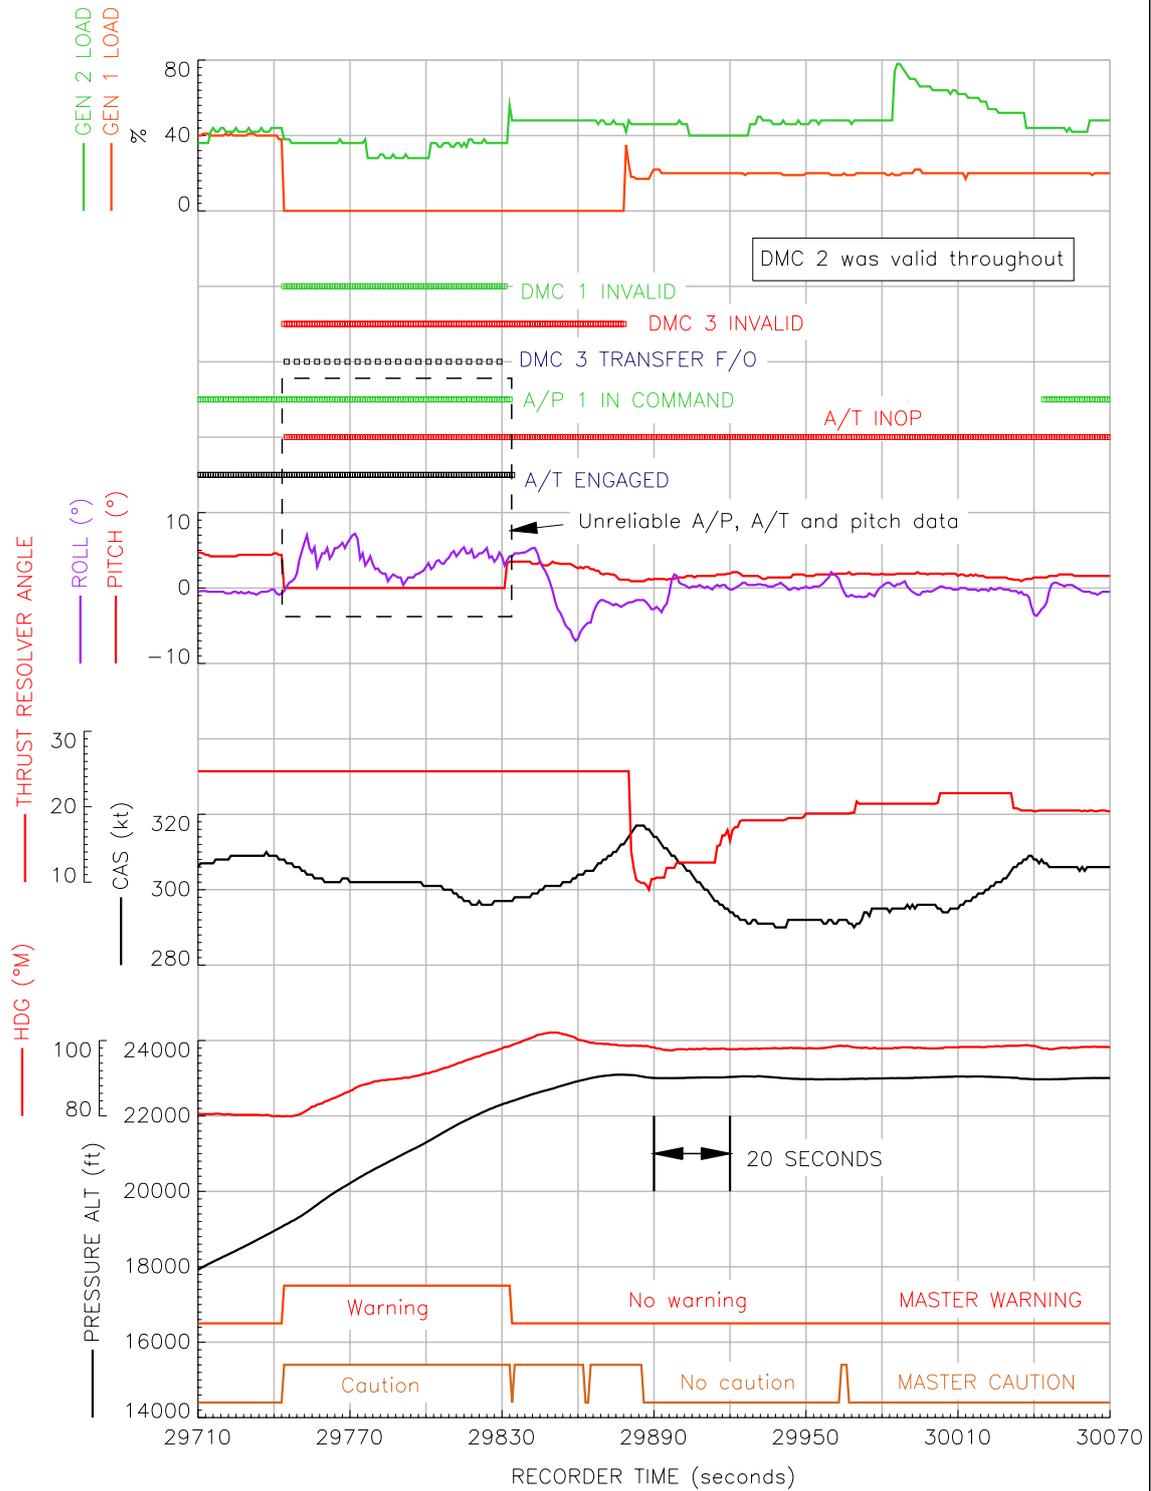
Figure 10

DAR derived data showing the parameters relating to the control of the aircraft.
