Investigation Report

7X010-0/07
February 2009

Type of occurrence:	Serious incident
Date:	23 August 2007
Location::	Mannheim
Type of aircraft:	Helicopter
Manufacturer / Model:	EUROCOPTER / EC135 P2+
Injuries to persons:	No injured persons
Damage to aircraft:	Aircraft not damaged
Other damage:	None
Source of information:	Investigation by BFU

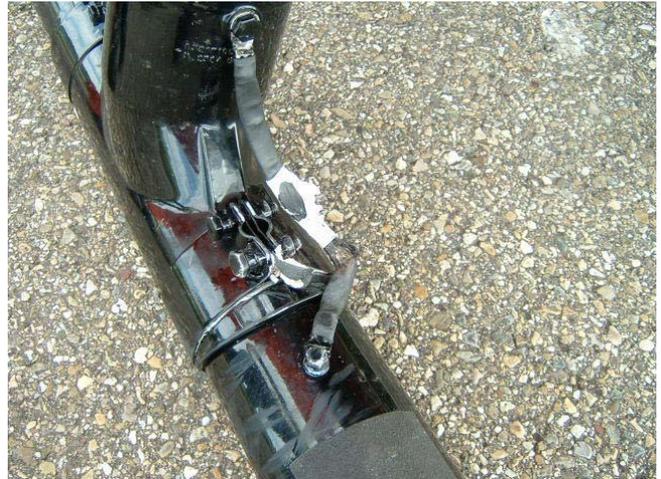
The helicopter lifted the front of the platform and dragged it for about 10 m. The outboard cable showed damaged areas directly at the voltage converter and at a length of 4,3 m.

There was no damage at the helicopter except for scratches in the paintwork.

The mast moment had been exceeded; an obligatory technical control performed after the incident did not show any objections. According to the technical findings, other limit values were not exceeded.

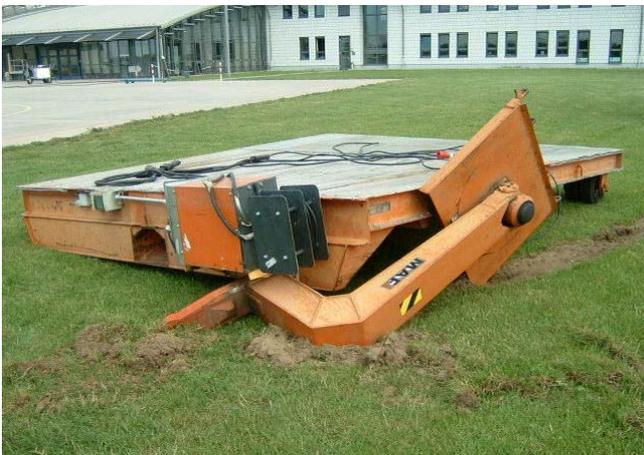
The helicopter transport platform had the dimensions of 4.0 m x 3.5 m; its weight was approximately 1,940 kg. The platform was an industrially manufactured cargo trailer for universal use. For operation at the Air Rescue Center, it was equipped with a voltage converter and corresponding cabling. The outboard power supply cable had a length of 5.9 m. A predetermined breaking point was installed 1.2 m in line before the cable end in form of a plug-in connection/quick release coupling. The cable harness diameter was 2 x 20 mm, the cables were sheathed with black material.

In this case, the emergency physician placed the connector on the ground without becoming aware that a cable loop had formed around the tip of the right skid. The missing color contrast between the black skid and the black cable may have contributed to this.

The helicopter platform was lifted at the front and dragged on the rear rollers, because the cable didn't tear and because there was no predetermined breaking point directly at the voltage converter. The existing predetermined breaking point was unable to fulfil its function because the cable was jammed to the skid in line before it. The reasons why an accident didn't occur were the facts that the cable tore after the turn of the helicopter and the pilot recovered control of the helicopter.

The affected Air Rescue Center responded with a conversion of the transport platform. The position of the voltage converter was changed from front left to front right, and the outboard power supply connection cable was laid fixed along the edge of the transport platform, so that only a short length of cable with installed quick-release coupling is used for connecting to the outboard power connection socket.
