## Synopsis

**Aircraft: Boeing 737-300**

**Registration: TF-ELN**

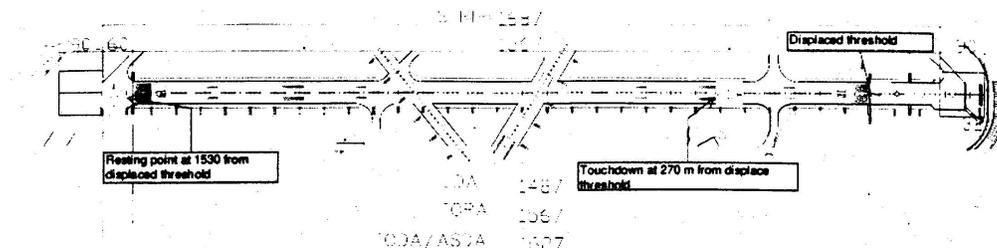
During the landing run the captain noticed that the aircraft did not decelerate as it should and therefore he applied maximum reverse thrust and maximum manual braking. The aircraft travelled down the centerline of the runway until a speed of 35 knots. At that point there was about 187 meters left of the available landing distance. The captain then attempted to turn the aircraft on the runway by first directing it to the right and then to the left. The aircraft came to a stop perpendicular to the runway centerline on the runway end safety area. The aircraft travelled a total distance of 1260 meters from the point where it first touched down or 1530 meters from the displaced runway threshold or 43 meters beyond the landing distance available (LDA 1487 meters). No damages were found on the aircraft or the airport.

The AAIB concluded that poor braking action of runway 01 was the cause of the incident in spite of reports of measured friction coefficients above 0.40 (Good estimated braking action).

Figure 1: Touchdown and final resting point of aircraft on Runway 01 (BIRK).

1. See to it that equipment used to measure runway friction, in use at airports under ICAA control, are calibrated according the manufacturer's recommendations and a calibration log kept up to date.

2. Monitor progress made in research on the International Runway Friction Index (IRJI) as it is specified in ASTM standard "E2 100-03 Standard Practice for calculating the International Runway Friction Index (IRFI)" and adopt at first opportunity or adopt the Canadian Runway Friction Index (CRFI) developed by Transport Canada.

3. Develop procedures for runway friction measurements that describe the execution of runway friction measurements, co-operation with the air navigation services, and airport authority, and persons involved in runway friction measurements according the ICAO Airport Services Manual Part 2, chapter 4, paragraph 4.2.6.

4. Setup recurrent training for runway friction measurements.
5. Inform pilots of uncertainty in runway friction measurements on slippery runways as research has shown.
