**AUTOMATIC DEPENDENT SURVEILLANCE –
BROADCAST SEMINAR AND ELEVENTH MEETING
OF AUTOMATIC DEPENDENT SURVEILLANCE –
BROADCAST (ADS-B) STUDY AND
IMPLEMENTATION TASK FORCE (ADS-B SITF/11)**

ADS-B AVIONICS ISSUES EXPERIENCED

(Presented by Australia)

This paper provides details about ADS-B avionics issues experienced by the Australian ANSP and makes recommendations for reporting these deficiencies

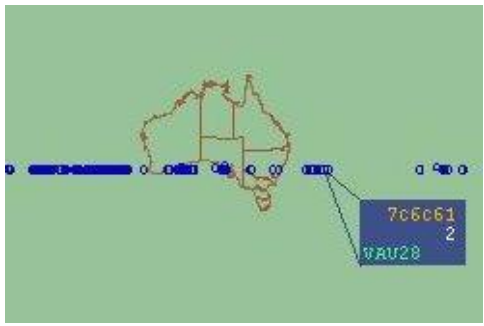
Reference	"Problem"	Cause	Presentation to ATC if allowed to display	Comments
<p>1.</p>	<p>Track Jumping problem with TPR901</p>

<p>Software issue with TPR901 transponder only affecting Boeing aircraft.</p> <p>Does not occur in all aircraft with this transponder.</p>	<p>Will present as a few wild/large positional jumps. Nearly all reports are tagged as low quality (NUC=0) and are discarded, however, some occasional non zero reports get through.</p> <p>Problem is very "obvious". Could result in incorrect longitudinal position of Flight Data Record track. Can trigger RAM alerts.</p>	<p>Problem identified and fix has been rolled out in fleets known to have been affected.</p> <p>Rockwell Collins released Service Bulletin TPR-901-34-503 on March 1, 2011 to correct this anomaly. This component service bulletin changes the part number to 822-1338-005.</p> <p>The fix has been proven to work. Airlines operating to Australia have been corrected.</p> <p>If a new case is discovered, an entry needs to be made to the black list until rectification has been effected.</p>

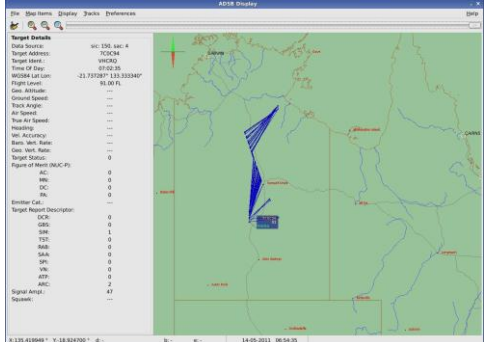
<p>2.</p>	<p>Rockwell Collins TDR94 Old version.</p> <p>The pattern of erroneous positional data is very distinctive of the problem.</p>

<p>Old software typically before version -108. The design was completed before the ADS-B standards were established and the message definitions are different to the current DO260.</p> <p>Rockwell has recommended that ADS-B be disabled on these models.</p>	<p>Will present as a few wild positional jumps. Nearly all reports are tagged as low quality (NUC=0) and are discarded, however, some occasional non zero reports get through. Also causes incorrect altitude reports.</p> <p>Problem is very "obvious".</p>	<p>Problem well known. Particularly affects Gulfstream aircraft which unfortunately leave the factory with ADS-B enabled from this transponder model.</p> <p>Rockwell has issued a service bulletin recommending that ADS-B be disabled for aircraft with this transponder software. See Service Information Letter 1-05 July 19, 2005. It is easy to disable the transmission.</p> <p>If a new case is discovered, an entry needs to be made to the black list until rectification has been effected.</p>

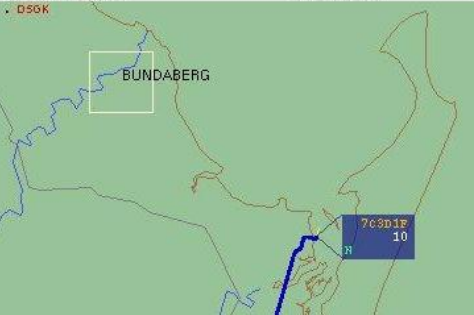
5.	<p>Garmin "N" Flight ID problem</p> <div data-bbox="197 592 669 794" style="border: 1px solid gray; padding: 5px;"> <p>Target Details</p> <p>Data Source: sic: 111, sac: 4</p> <p>Target Address: 7C3D1F</p> <p>Target Ident.: N</p> <p>Time Of Day: 01:52:43</p> <p>WGS84 Lat Lon: -25.357132° 152.921855°</p> <p>Flight Level: 9.50 FL</p> <p>Geo. Altitude: 1200.00 ft</p> </div>

<p>Installers of Garmin transponder incorrectly set "Callsign"/Flight ID. This is caused by poor human factors and design that assumes that GA aircraft are US registered.</p>	<p>Flight ID appears as "N". Inhibits proper coupling.</p>	<p>Can be corrected by installer manipulation of front panel. Does not warrant "black list" activity.</p>

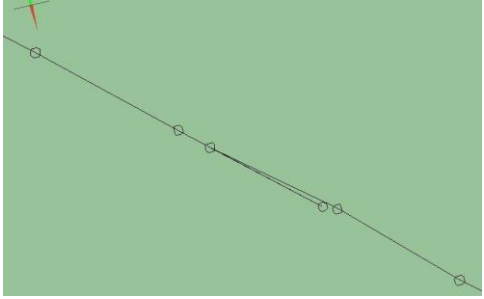
10.	<p>Occasional small position jump backwards</p>

<p>For some older Airbus aircraft, an occasional report may exhibit a small "jump back" of less than 0.1 nm</p> <p>Root cause not known</p>	<p>Not detectable in ATC due to extrapolation, use of latest data and screen ranges used.</p>	<p>ATC ground system processing can eliminate these.</p>
