# **RUNWAY SAFETY**

**MINISTRY OF TRANSPORT REPUBLIC OF INDONESIA**  
**DIRECTORATE GENERAL OF CIVIL AVIATION**  
**DIRECTORATE OF AIRWORTHINESS AND AIRCRAFT OPERATIONS**

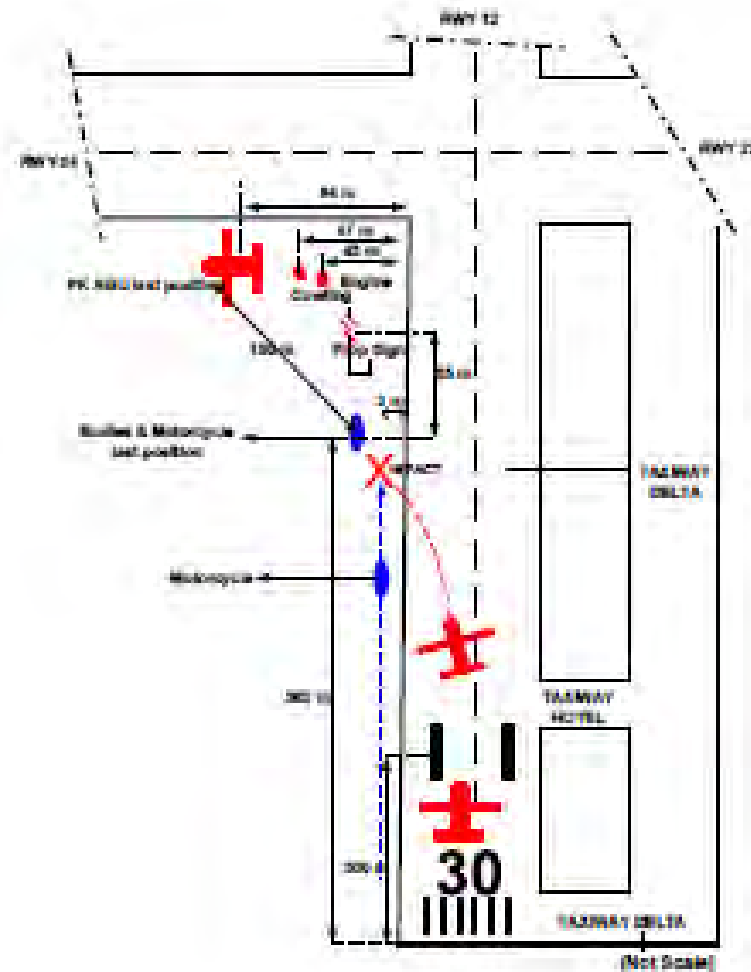
Figure 2: Aircraft Accident Scheme

During the second circuit of touch and go, the aircraft bounced and tend to the left then hit to a running motorcycle on runway.

At the time of accident, both of motorcycle riders were fatally injured. About three months later the flight instructor was fatally injured and the student pilot was serious injured.

The aircraft was substantially damaged.

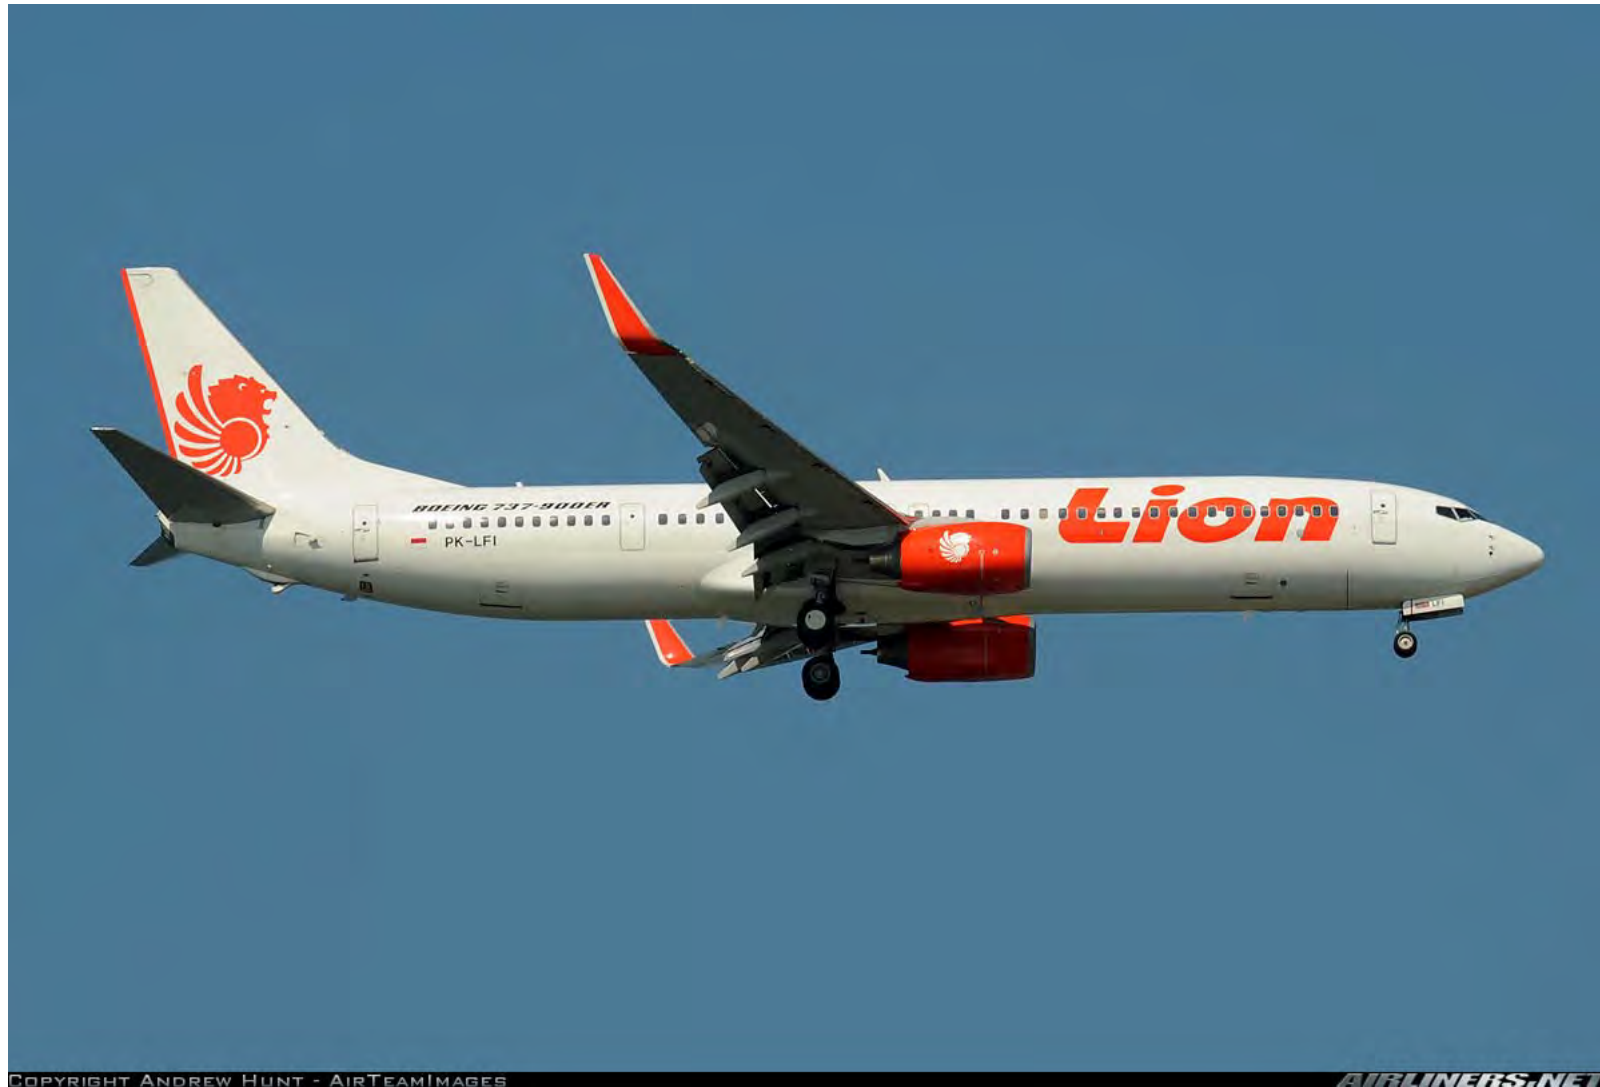
The aircraft landed and turning on end of runway 36, then over turn and the right main landing gear out of asphalt runway.

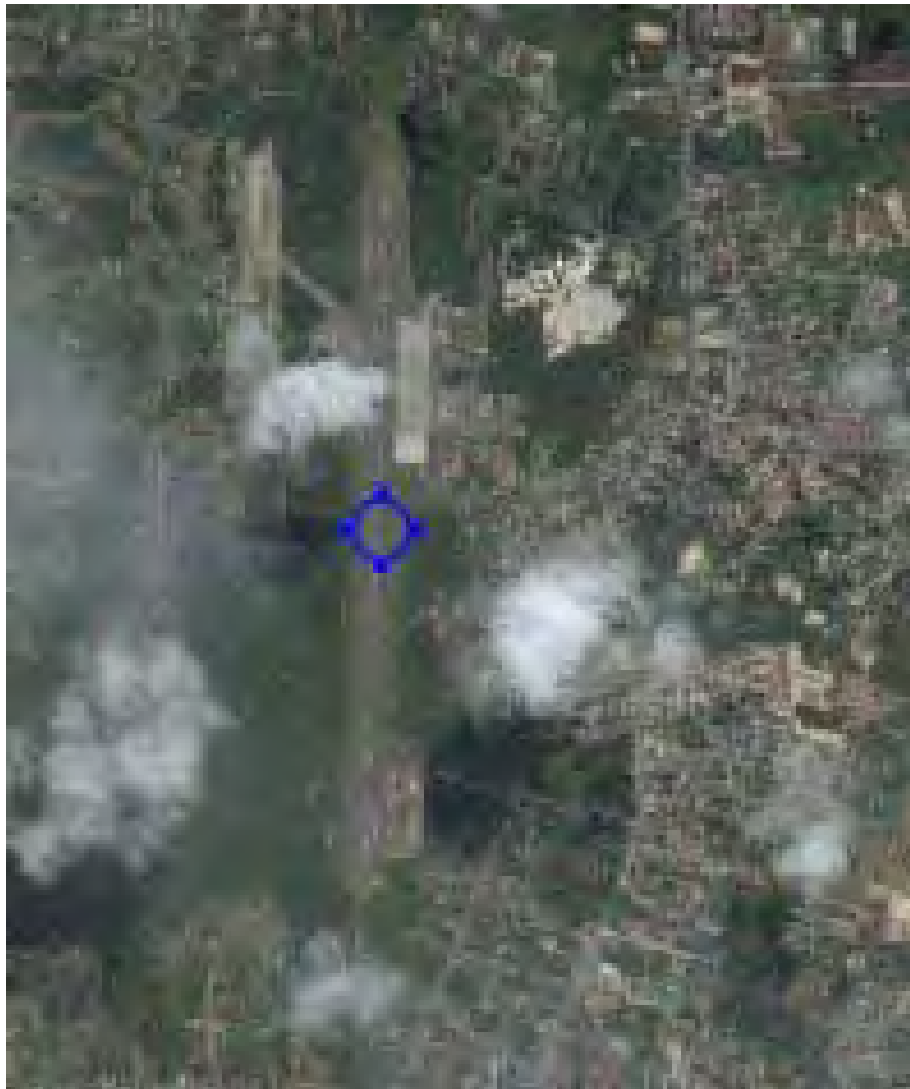
RWY BEARING 18/36  
RUNWAY ELEVATION 78 FT  
RUNWAY LENGTH 2,240 M  
RUNWAY WIDTH 30 M

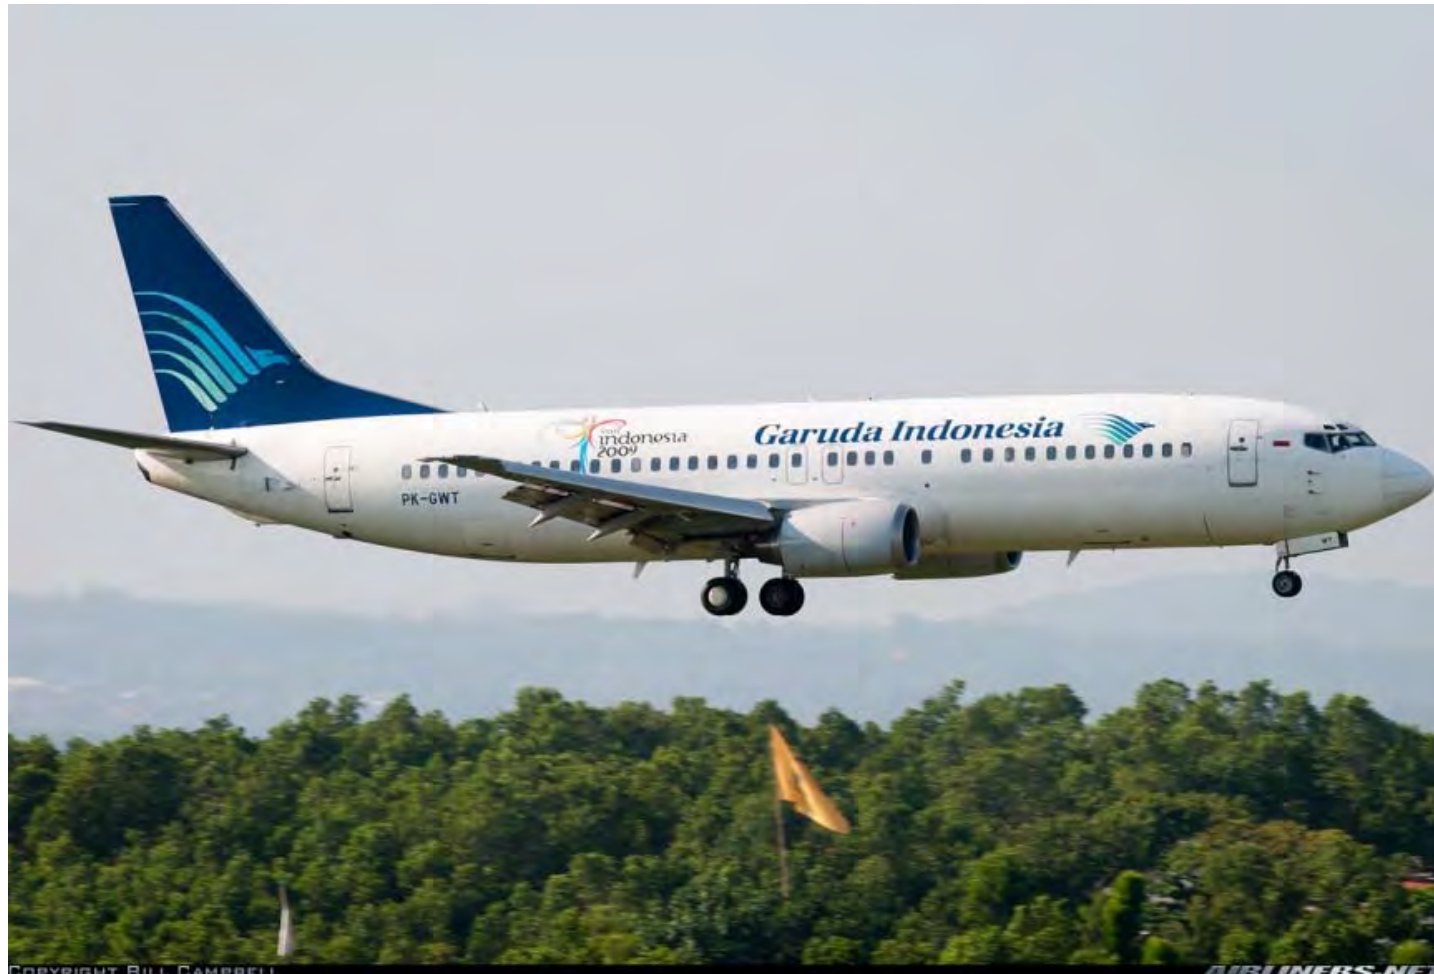
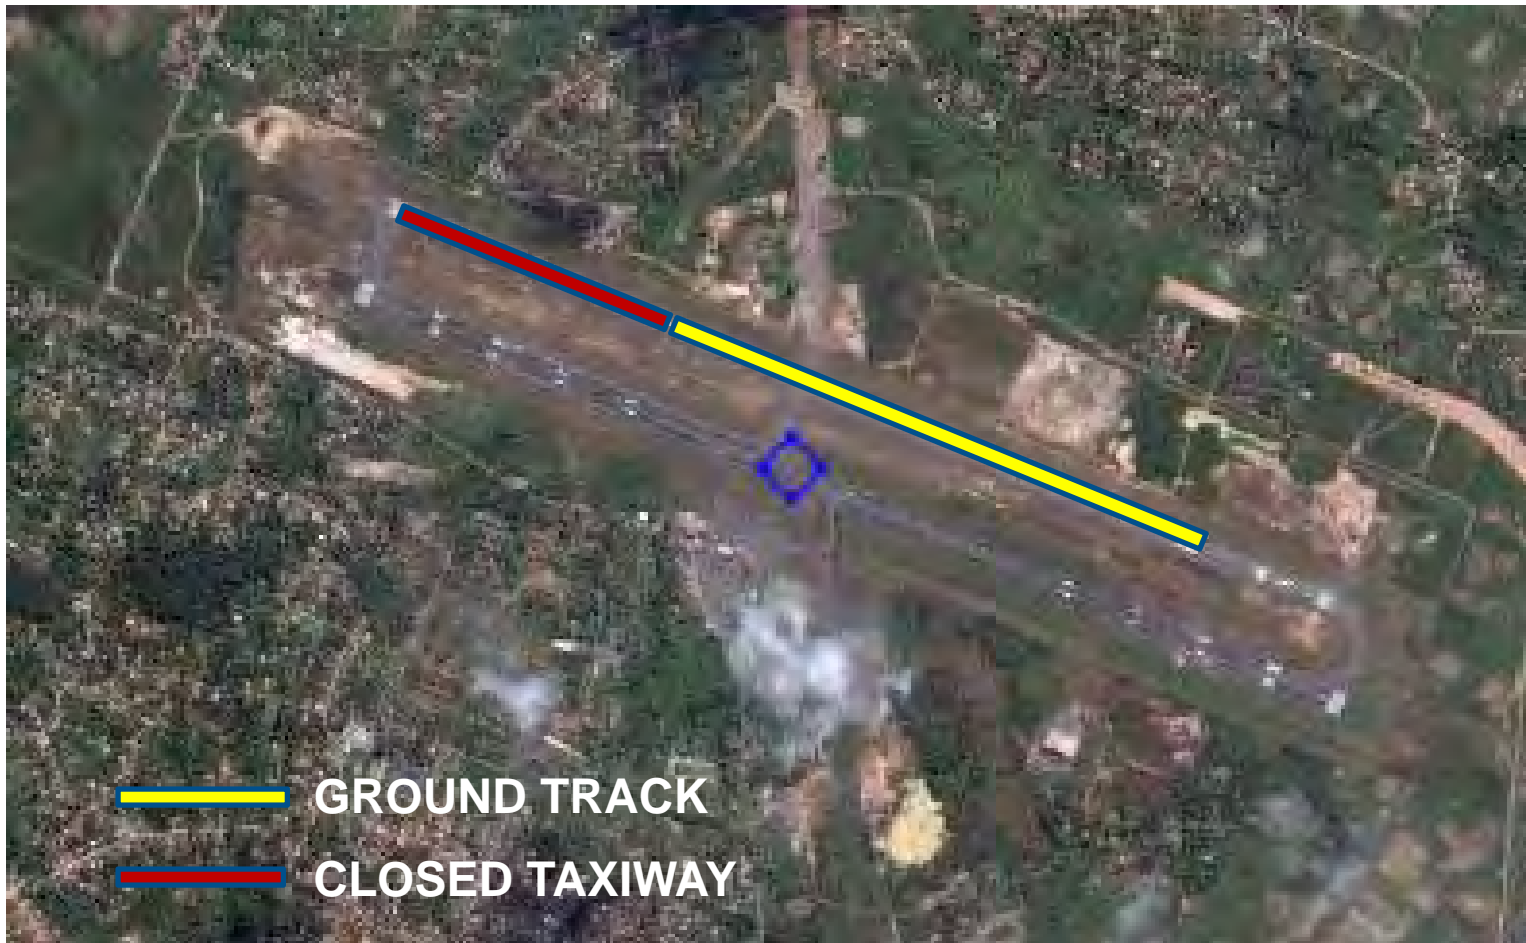
The ATC saw that the aircraft was not on the approach path properly and came close to the parallel taxiway, the aircraft landed on the parallel taxiway.

Both pilots were concentrating looking inside and not sufficiently cross checking to the outside situation. Pilot monitoring was not sufficiently looked outside to cross-check the flight path to the runway.

There was misalignment of the VOR approach path.
