**Second Meeting of the Asia Pacific Accident Investigation Group
(APAC-AIG/2)**

UNEXPECTED AUTOPILOT BEHAVIOUR ON ILS APPROACH

(Presented by Singapore)

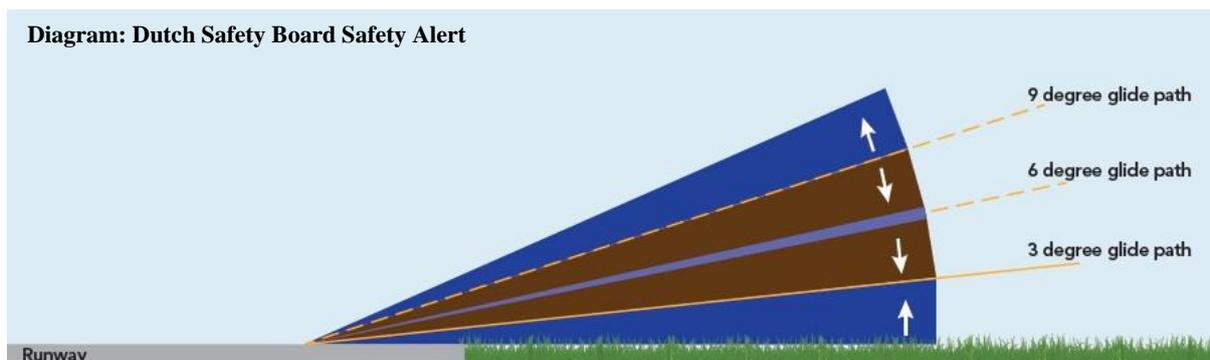
2.1 The M-array (Capture effect) ILS antenna, which is used around the world, exhibits signal reversal above the 3 degree glide path. The Dutch Safety Board identified that the signal reversal at the 9 degree glide path is always present. The signal reversal occurs occasionally at 6 degree, depending on the glideslope field. (See Figure 1)

Figure 1: Cross section view of the M-array ILS antenna glideslope signal. Blue indicates “Fly up” and brown indicates “Fly down”

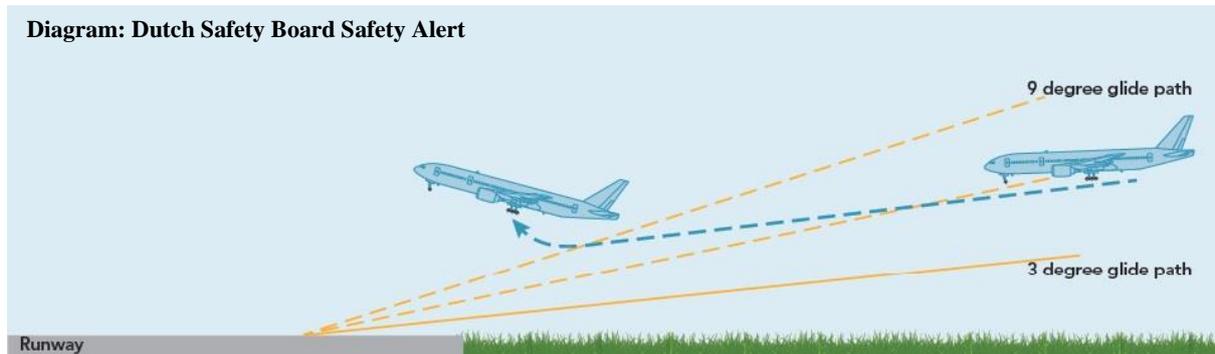
2.2 Depending on the descent profile of the aircraft, it may capture the ILS signal reversal above the 9 degree glide path. With the autopilot system engaged, an unexpected rapid pitch up command will be generated. The airspeed may drop rapidly to a near stall situation. (See Figure 2)

Figure 2: Sudden pitch up commanded by the autopilot system due to the signal reversal above the 9 degree glide path

- 1) Note the safety alert “Unexpected Autopilot Behaviour on ILS Approach” issued by Dutch Safety Board¹; and
- 2) Disseminate the information to individual State or Administration’s aviation authority and industry.
