**ELEVENTH MEETING OF THE SOUTHEAST
ASIA AND BAY OF BENGAL SUB-REGIONAL
ADS-B IMPLEMENTATION WORKING GROUP
(SEA/BOB ADS-B WG/11)**

BOEING 787 ADS-B DEFICIENCY UPDATE

(Presented by Australia with contribution from Boeing)

This paper provides an update on the ADS-B problem experienced with Boeing 787 aircraft and detail of rectification plans.

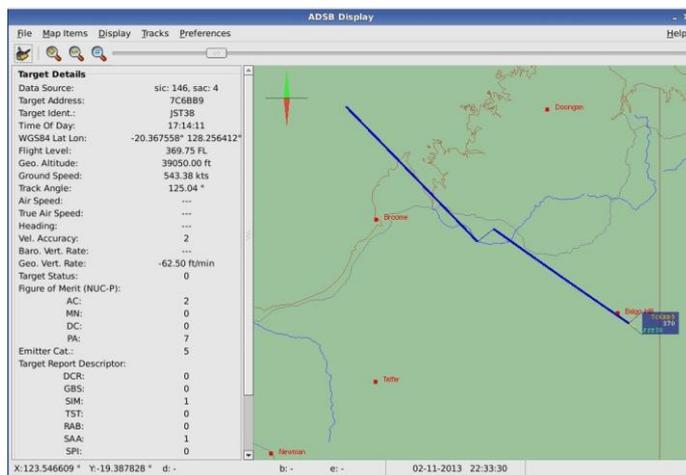
2.1 On 29th October 2014, an Australian registered B787 aircraft was observed by ATC to be transmitting inaccurate ADS-B positional data whilst declaring the data as high integrity.

2.2 In this case, following a heading change at a planned waypoint, the reported ADS-B data appeared to be extrapolated in a straight line with constant velocity along the previous heading until it auto-corrected. The correction was observed as a “jump” shown below. The aircraft is flying from the north-west towards the south-east.

2.4 With data from the above incidents, Boeing was notified and investigations undertaken. Boeing identified that the root cause was associated with the Surveillance processor within the B787 Integrated Surveillance System which computes assembles the ADS-B message, relating to the way in which latitude and longitude data were packaged for delivery to the transponder function. The B787 uses an onboard data network to deliver packetized data inputs from other airplane sensors. When the latitude and longitude information was split across different data packets, the transponder function did not process the position data, and instead commenced extrapolating the position at constant heading and velocity – until the position data was again contained within a single message packet. Geometric level was similarly affected and did not update during these periods of extrapolation.

2.5 The solution to be implemented by Boeing is to retrofit new software simultaneously with the software update which will provide the new DO260B Surveillance processor capability for the B787. The DO260B software proved to be not subject to the root cause defect (even though it had been developed prior to the issue being fully understood by Boeing).

Incorporation of Service Bulletin (SB) B787-81205-SB340005-00 will correct this issue.

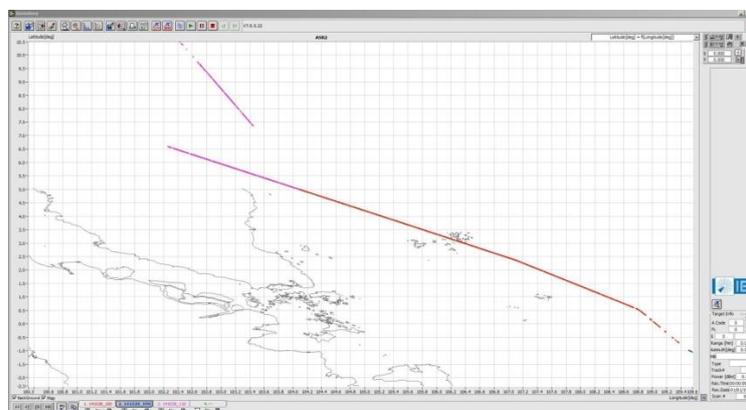
Trajectory provided by CAAS Singapore

2.3 Airservices subsequently became aware of similar incidents, both for this particular aircraft, and for other B787 aircraft operating internationally including Singapore, USA, Canada and Europe. Data was collected from a number of Asia Pacific ANSPs supporting the investigation. Another correction was observed as a “jump” shown below. The aircraft is flying from the south-east towards the north-west.
