# Problem Report Briefing

**FIT ASIA**  
**May 2016**

**Rochelle Perera**  
**[Rochelle.e.perera@boeing.com](mailto:Rochelle.e.perera@boeing.com)**

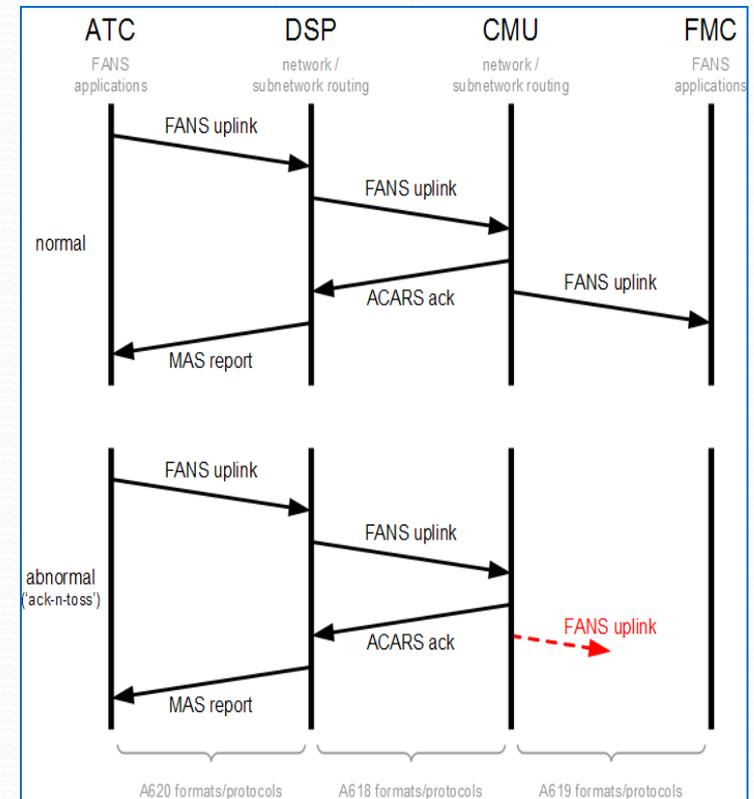
# “Ack-n-Toss” PRs

- CRA has received 17 PRs in which “Ack-n-Toss” has been a contributor
  - Also several reports from FAA Data Comm program
  - Reported events involve multiple airplane models
  - Common denominator is Rockwell-Collins CORE -012 CMU
- Rockwell- Collins (RCI) has not yet reproduced problem in lab
- RCI concurs that problem is in CMU
- RCI requests operators experiencing issue to provide CVR data (if they have datalink recording capability)
- PR will be closed once a fix for this issue is available for incorporation.
