**TWELFTH MEETING OF THE SOUTH EAST ASIA
AND BAY OF BENGAL SUB-REGIONAL ADS-B
IMPLEMENTATION WORKING GROUP
(SEA/BOB ADS-B WG/12)**

Guangzhou, China, 08 – 10 November 2016

BOEING 787 ADS-B DEFICIENCY UPDATE

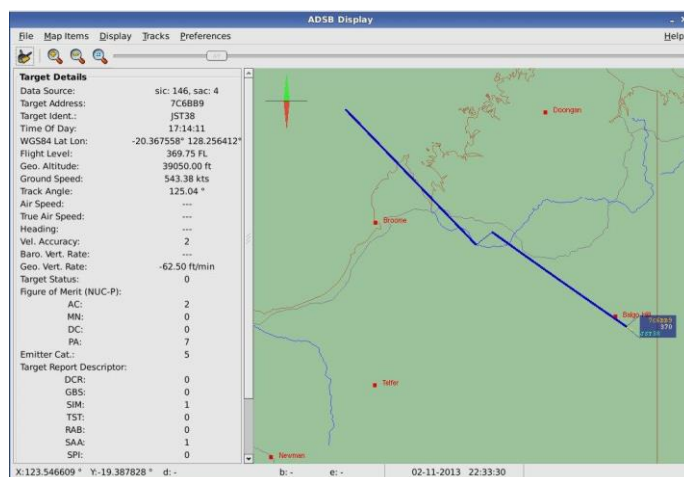
2.1 On 29th October 2014, an Australian registered B787 aircraft was observed by ATC to be transmitting inaccurate ADS-B positional data whilst declaring the data as high integrity.

2.2 In this case, following a heading change at a planned waypoint, the reported ADS-B data appeared to be extrapolated in a straight line with constant velocity along the previous heading until it auto-corrected. The correction was observed as a “jump” shown below. The aircraft is flying from the north-west towards the south-east.

2.4 Boeing identified that the root cause was associated with the Surveillance processor within the B787 Integrated Surveillance System (ISS) which computes and assembles the ADS-B message, relating to the way in which latitude and longitude data were packaged for delivery to the transponder function. When the latitude and longitude information was split across different data packets, the transponder function did not process the position data, and instead commenced extrapolating the position at constant heading and velocity – until the position data was again contained within a single message packet.

2.5 In late 2015, Boeing and Rockwell Collins finalized development of the DO-260B upgrade for the B787 fleet. As well as correcting the original extrapolation issue, and supporting DO-260B, the upgrade provided other reliability benefits for the avionics. The 787 Type Certification has been amended to include the software upgrade - Service Bulletin (SB) B787-81205-SB340005-00. The upgraded ADS-B Out function is compliant with FAA AC 20-165A, EASA CS-ACNS Subpart D (Surveillance) and TSO-C166b.

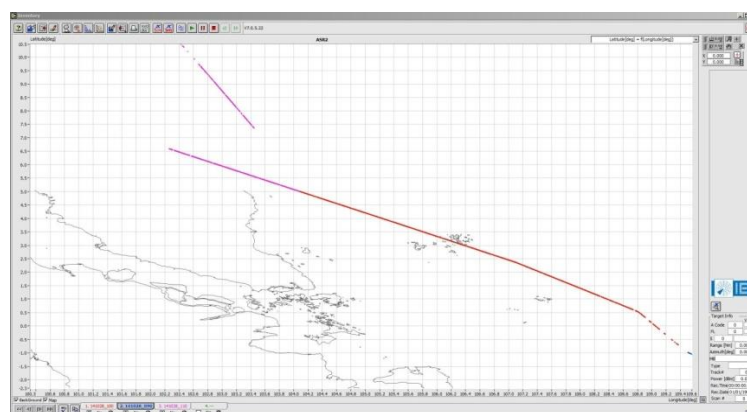
Trajectory provided by CAAS Singapore

2.3 Airservices subsequently became aware of similar incidents, both for this particular aircraft, and for other B787 aircraft operating internationally including Singapore, USA, Canada and Europe. Data was collected from a number of Asia Pacific ANSPs supporting the investigation. Another correction was observed as a “jump” shown below. The aircraft is flying from the south-east towards the north-west.

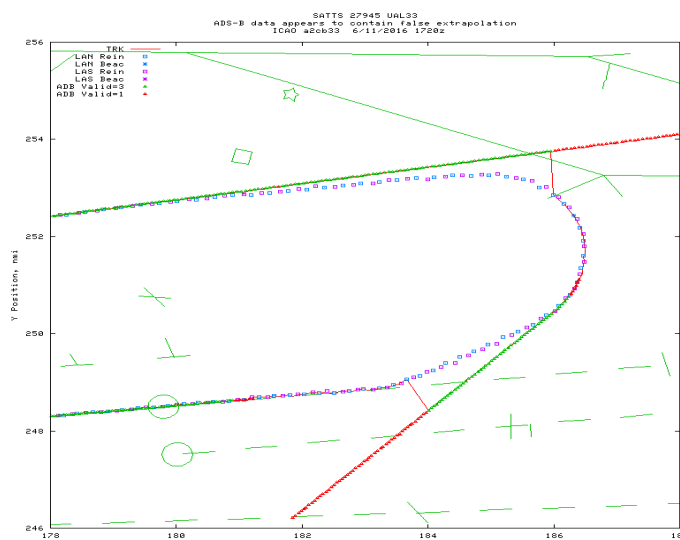
Trajectory provided by FAA

3.1 In June 2016, the FAA reported 2 instances of similar incorrect ADS-B position extrapolation errors; 1 x United Airlines B787 at Los Angeles (shown below), and 1 x Aeromexico B787 at Tijuana, despite having been upgraded to the latest software version (DO-260B).

3.2 The extrapolation errors were investigated by Boeing and Rockwell Collins. It was quickly determined that the original cause – splitting of data packets for position as transmitted to the transponder (and fixed in the above Service Bulletin) was not at fault, but that another fault mode was responsible.

3.3 The fault mode was subsequently identified as occurring when the internal timing between different elements of the Integrated Surveillance System became synchronized, resulting in data packets (for both GNSS position and also for altitude), not being distributed to the transponder. The potential for “stale” altitude data also impacts TCAS system logic.

4.2 Software changes to elements of the Integrated Surveillance System (ISS) have been identified to fix the root cause and include:

4.2.1 Reducing the rate of data exchange – this change is complete and addressed the TSO non-compliance so the “stop shipment” could be lifted. This change is included on currently shipped ISS units from Rockwell Collins.

4.2.2 Adding defensive code to prevent extrapolation/coasting exceeding 3 seconds
