**FIFTEENTH MEETING OF THE ADS-B STUDY AND IMPLEMENTATION  
TASK FORCE (ADS-B SITF/15)**

**BOEING 787 ADS-B DEFICIENCY UPDATE**

(Presented by Australia with contribution from Boeing)

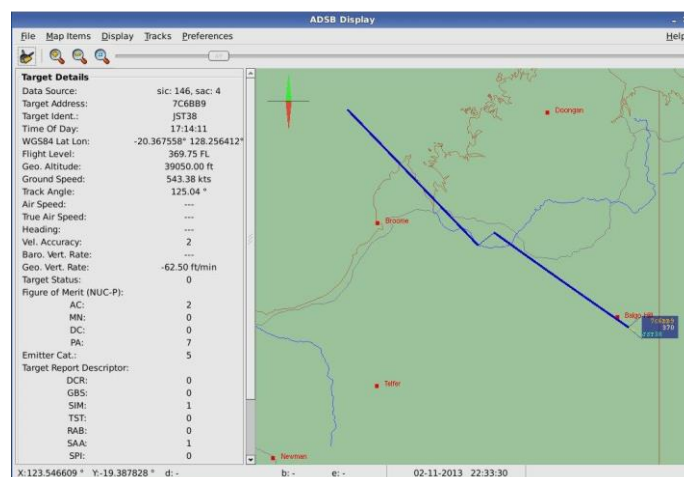
2.1 On 29<sup>th</sup> October 2014, an Australian registered B787 aircraft was observed by ATC to be transmitting inaccurate ADS-B positional data whilst declaring the data as high integrity.

2.2 In this case, following a heading change at a planned waypoint, the reported ADS-B data appeared to be extrapolated in a straight line with constant velocity along the previous heading until it auto-corrected. The correction was observed as a "jump" shown below. The aircraft is flying from the north-west towards the south-east.

2.4 With data from the above incidents, Boeing was notified and investigations undertaken. Boeing identified that the root cause was associated with the Surveillance processor within the B787 Integrated Surveillance System (ISS) which computes and assembles the ADS-B message, relating to the way in which latitude and longitude data were packaged for delivery to the transponder function. The B787 uses an onboard data network to deliver packetized data inputs from other airplane sensors. When the latitude and longitude information was split across different data packets, the transponder function did not process the position data, and instead commenced extrapolating the position at constant heading and velocity – until the position data was again contained within a single message packet. Geometric level was similarly affected and did not update during these periods of extrapolation.

2.5 The solution being implemented by Boeing is to install a single software update which also provides the new DO260B Surveillance processor capability for the B787. The DO260B software is proven to be not subject to the root cause defect (even though it had been developed prior to the issue being fully understood by Boeing). The new DO260B capability satisfies the airspace mandates in Europe and the United States in 2020.

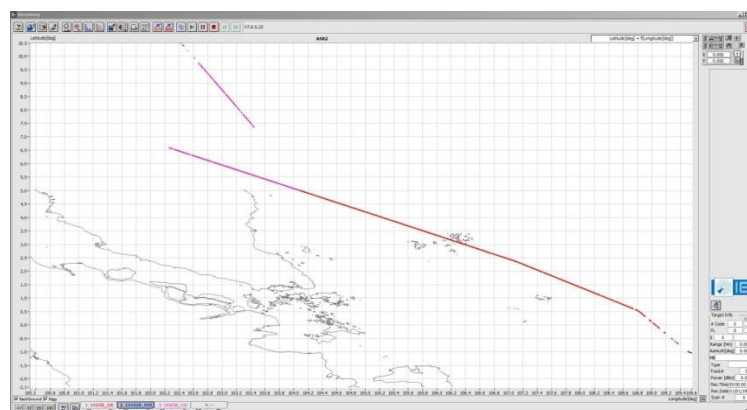
Trajectory provided by CAAS Singapore

2.3 Airservices subsequently became aware of similar incidents, both for this particular aircraft, and for other B787 aircraft operating internationally including Singapore, USA, Canada and Europe. Data was collected from a number of Asia Pacific ANSPs supporting the investigation. Another correction was observed as a “jump” shown below. The aircraft is flying from the south-east towards the north-west.
