**REGIONAL PREPARATORY GROUP (RPG) MEETING FOR
WRC-2019**

**GPS INTERFERENCE/SIGNAL DEGRADATION IN MANILA, PHILIPPINES
AFFECTING FLIGHT AND ATM OPERATIONS**

(Presented by Charlemagne Gilo, Philippines)

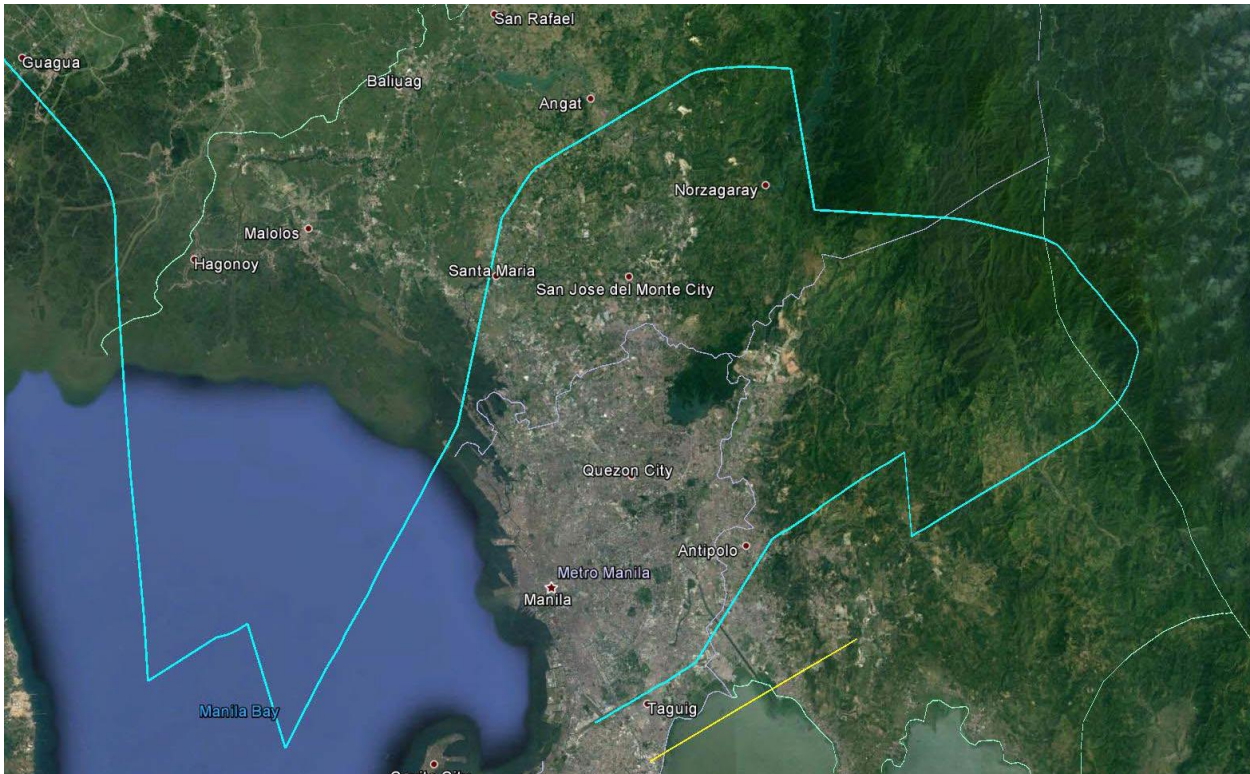
2.3 Noting the on-going worldwide deployments of automatic dependent surveillance – broadcast (ADS-B), harmful interference to GNSS will also adversely impact ATM operations. A degradation or complete interruption of ADS-B surveillance services will automatically occur as a consequence of GNSS signals being interfered. This adverse impact to ATM operations can be quite significant, especially in the area where ADS-B is deployed as the sole means of ATM surveillance.

Example of ADS-B track of aircraft flying under GNSS interference

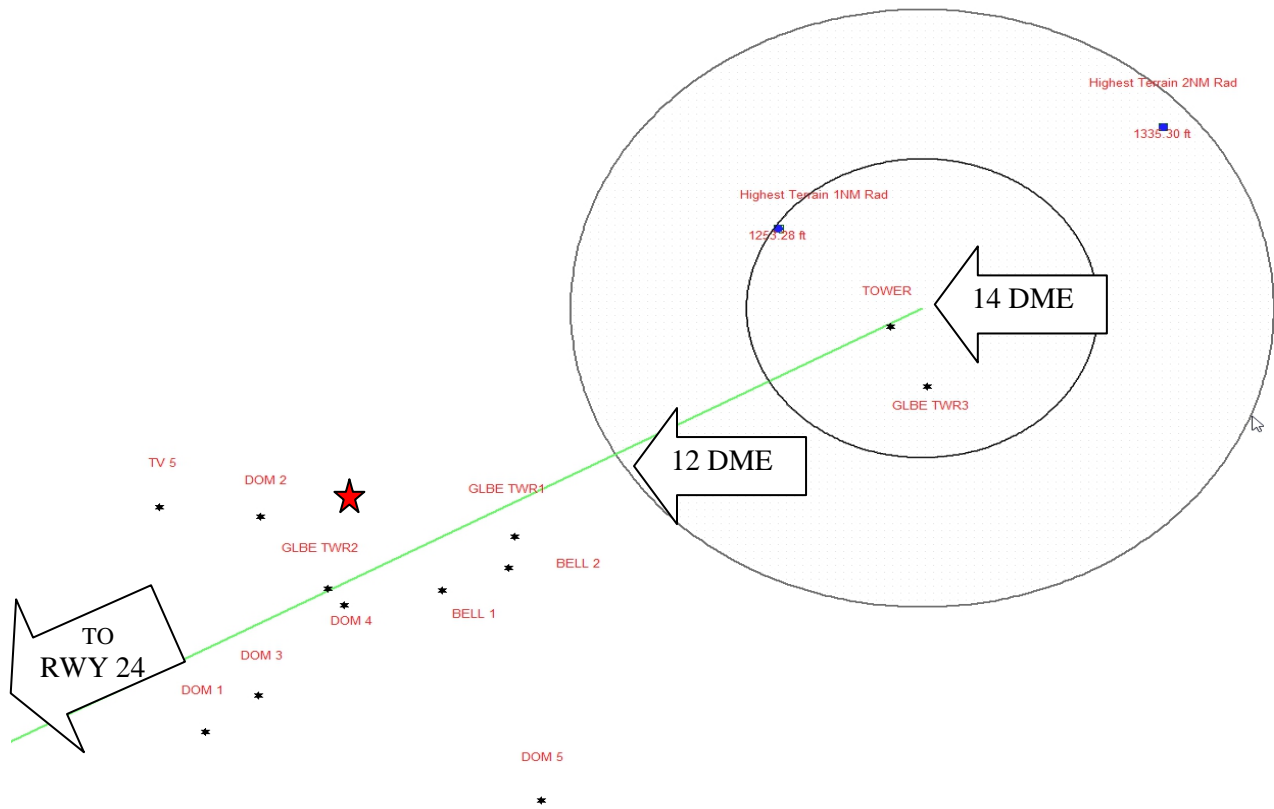
Figure 3 - Suspected Cell Phone and TV Broadcast Towers Location

2.6 The 1st suspect, after some initial investigation of the area, was not a cell tower but instead a TV broadcasting station tower. When we requested a momentary shutdown of their broadcast, CAAP’s flight check aircraft was able to received good GPS signal that led to good data to put Localizer RWY24 for use. GPS signal was lost again when flight check was about to be done on the glide slope for the ILS and thus the TV station was ruled out as the source.

2.7 The 2nd were various Cel towers, that initially indicated emitting transmissions specifically on the GPS frequency itself, were also investigated, tested, turned off with corresponding flight check but was later pronounced not the source again.

2.8 A 3rd suspect is again a TV broadcasting station of a very influential religious group in the Philippines. Letters have been dispatched after initial readings also indicate signals on the GPS frequency emanating from their compound. The whole process will be repeated again and hopefully we’ll have some good news before the next FSMP meeting.

2.7 In the interim, due to the continued reported occurrences of these events, CAAP continues to enforce the NOTAM advising the availability of other instrument approaches to runway 24 and the reported occurrences of GPS interference and signal degradation in the area.
