Learjet 35 A vs. Eurofighter Typhoon

23.06.2014 near Olsberg-Elpe (Germany)

German Federal Bureau of Aircraft Accident Investigation

Investigation Report

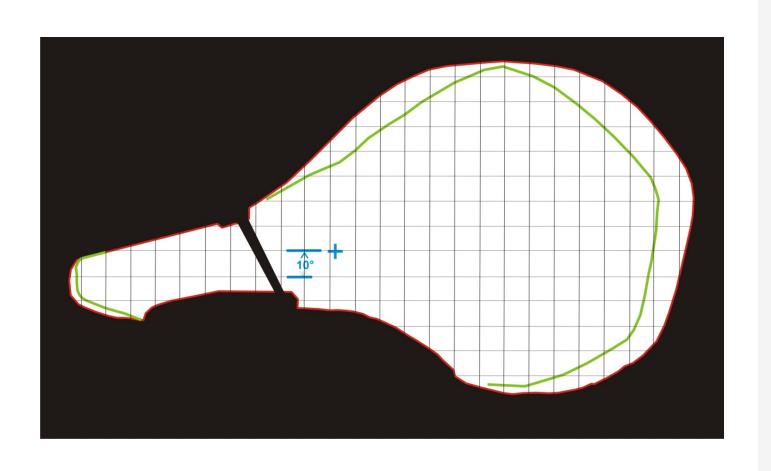
Copilot's field of Vision

- During positioning for the intervention the collision risk due to unexpected manoeuvres of the intercepted airplane was not sufficiently taken into consideration.
- The Learjet crew did not take into account the risks due to possible limitations of the field of vision and the distraction by using the computer when deciding about the task distribution.

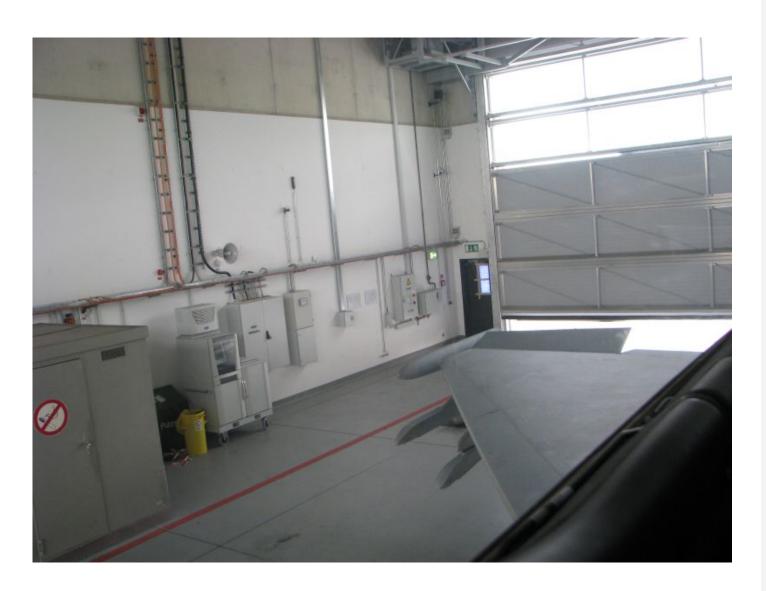
Eurofighter Pilot's field of Vision

Due to insufficient situational awareness during the intervention, the Learjet crew continued the turn with an excessive bank angle despite the loss of visual contact with the Eurofighter flying at the inside of the turn.
