Third Meeting (ATM SG/3)
(Cairo, Egypt, 22 – 25 May 2017)

WAKE TURBULENCE SEPARATION IN RVSM AIRSPACE

Interim Report

Type of Occurrence:	Accident
Date:	7 January 2017
Location:	Enroute, above the Arabian Sea
Aircraft:	<ol style="list-style-type: none">1) Airplane2) Airplane
Manufacturer / Model:	<ol style="list-style-type: none">1) Bombardier / CL-600-2B16 (604 Variant)2) Airbus / A380-861
Injuries to Persons:	<ol style="list-style-type: none">1) Two severely injured passengers, two passengers and one flight attendant suffered minor injuries2) None
Damage:	<ol style="list-style-type: none">1) Aircraft severely damaged2) None
Other Damage:	None
State File Number:	BFU17-0024-2X
Published:	May 2017

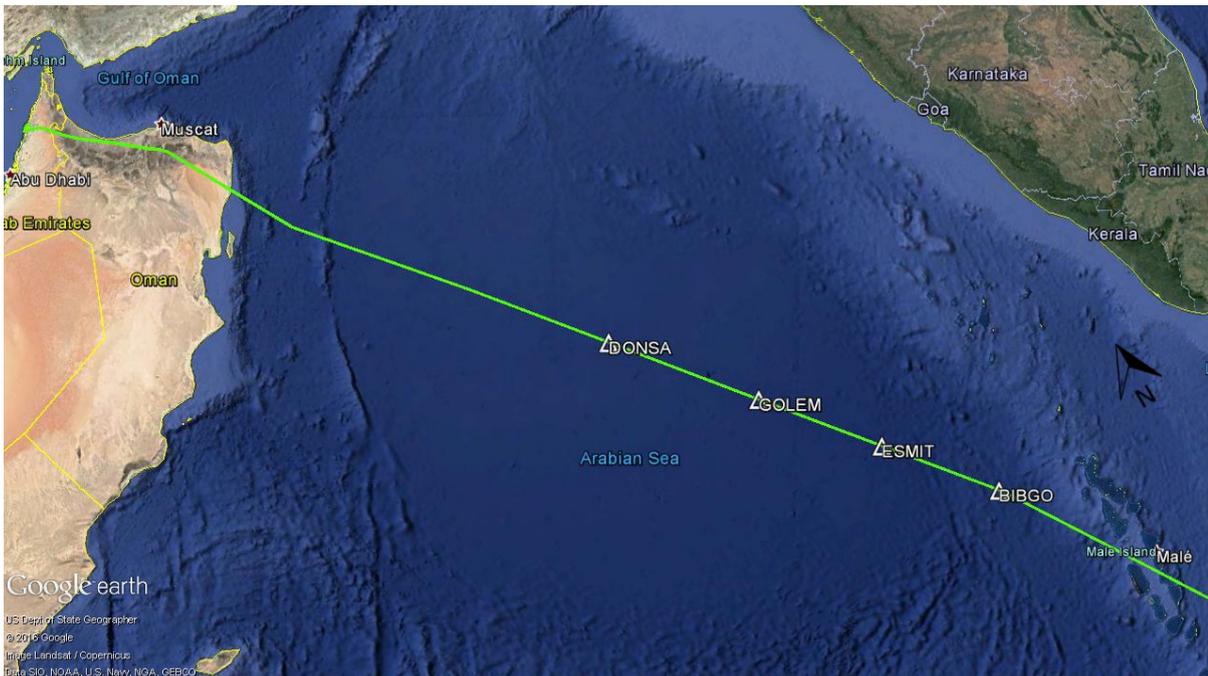
Reconstruction of the A380 flight path (according to DAR data)

Using DAR data the flight path of the A380 was reconstructed.

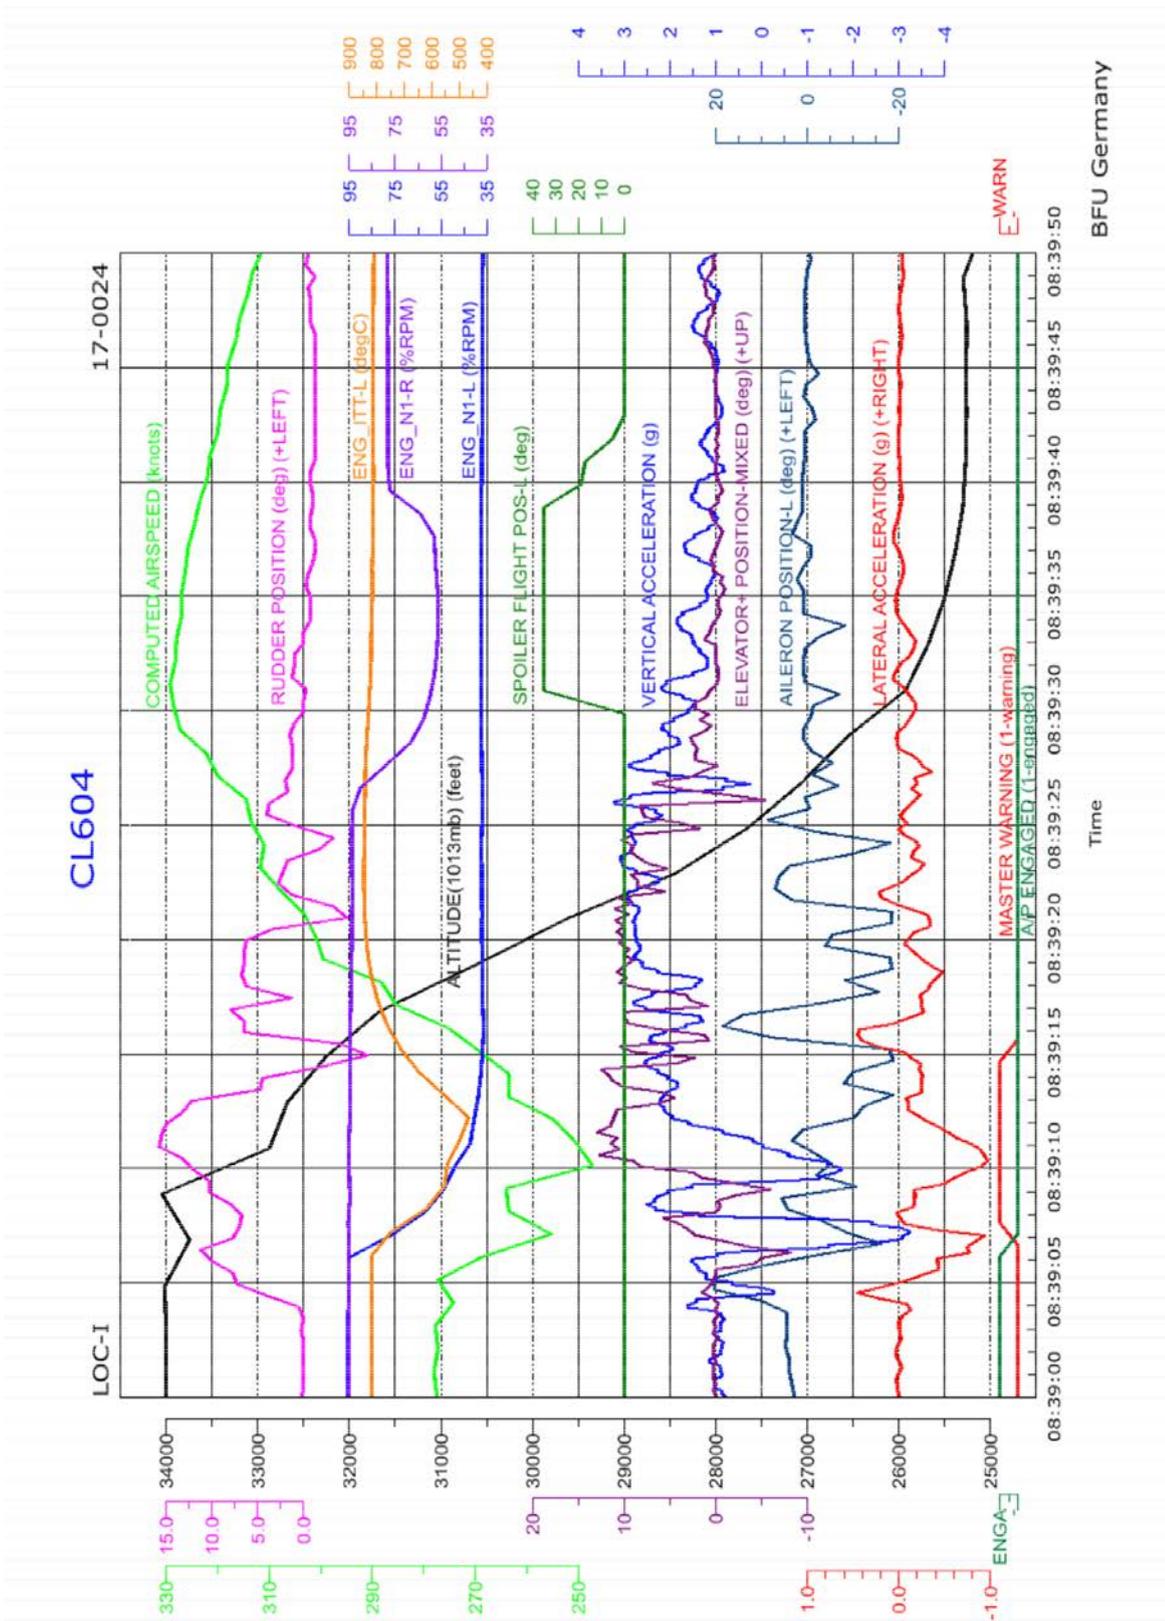
Excerpt of the CL604 FDR during altitude loss

Both IRS stop sending valid data
