AIIG 2 Meeting/Workshop, Jeddah, 13 Sep 2022

Fan Hub Rupture

© Copyright Airbus 2022 / A Never Give Up Story

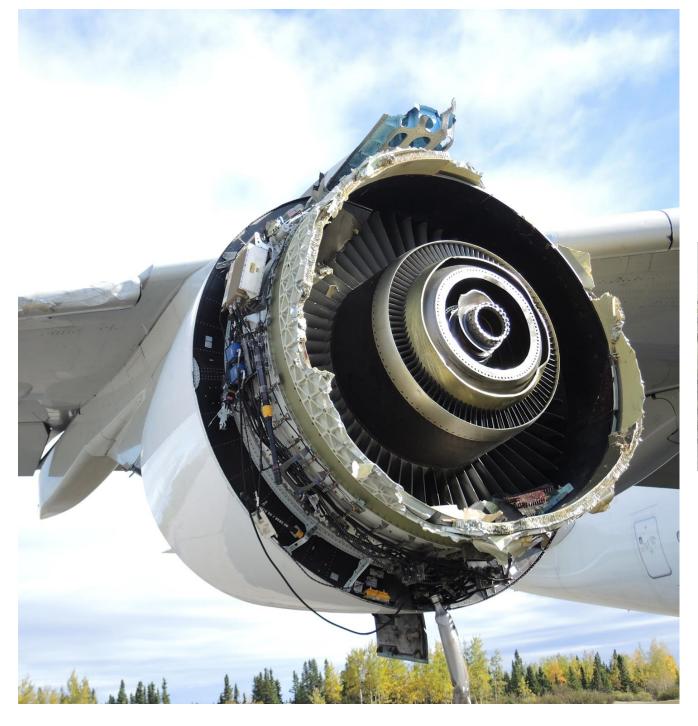
- On-ground inspection of the engine indicated fan hub rupture
 - Two main debris trajectories according to hardware damage

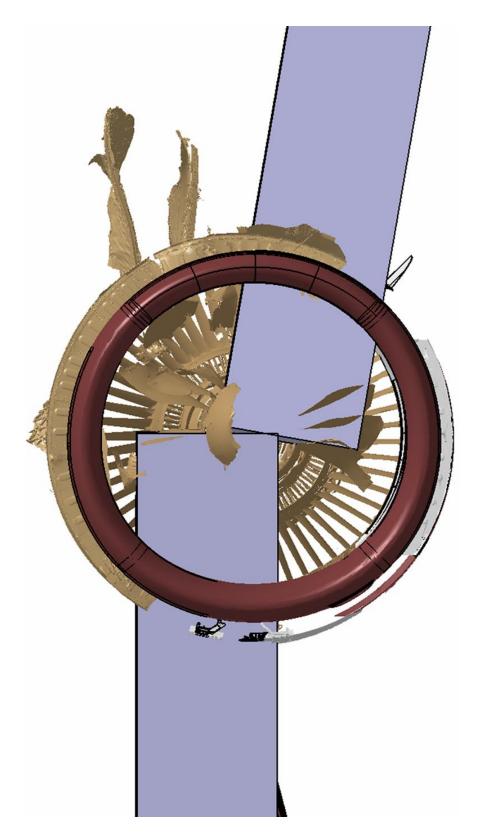
- Engine fan case, air inlet and blade fragments recovered during initial survey
 - No hub fragments
- Initial root cause analysis based on in-service experience

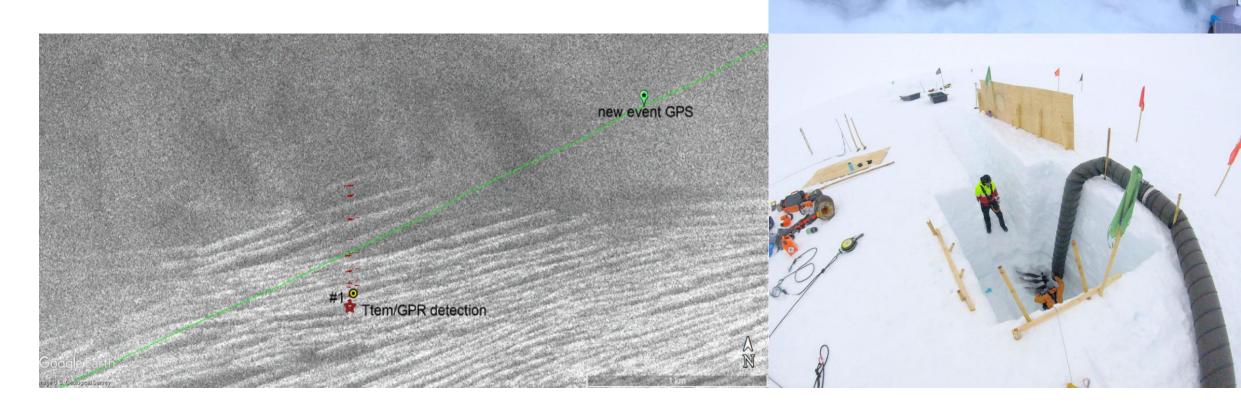
- Further processing of radar data by ONERA
- One high-confidence target identified
- May 2019 ground expedition confirmed consistency with a hub fragment
- Extraction in June 2019
- 2 years effort

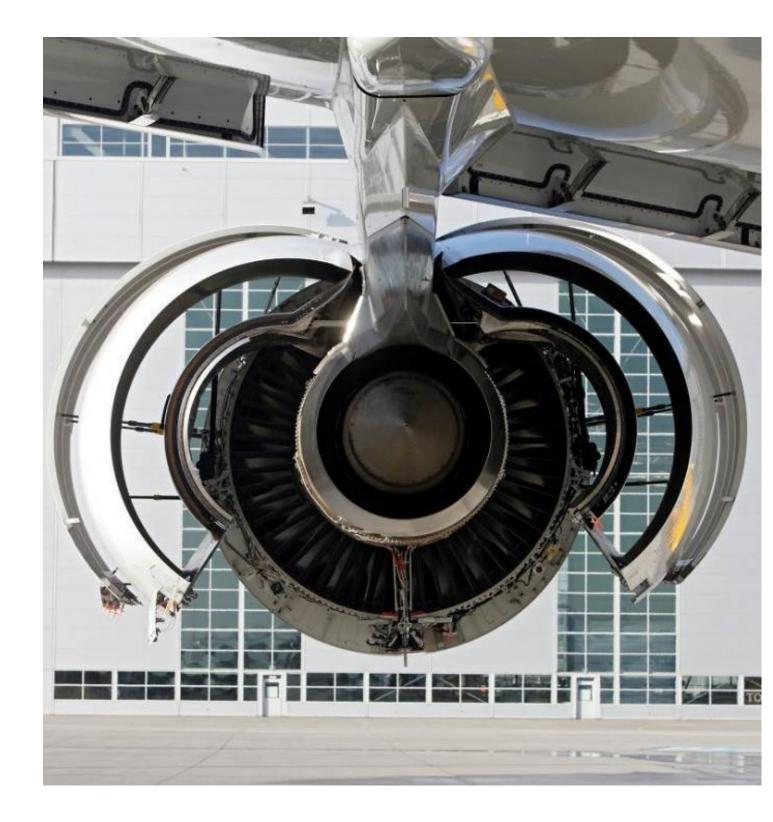
- Maintenance damage hypothesis dismissed with facts
- Root cause identified
 - Titanium material issue
 - Fatigue failure due to Micro Texture Regions
 - Refer to <u>BEA report</u> for details
- Repetitive NDT fleetwide inspection of the EA GP7200
- The whole Airbus fleet reviewed with engine OEM's for susceptibility to the identified failure mode
 - No fleet actions needed on other products
- Standards for future products discussed at industry level
