AAIB Bulletin S2/2015

SPECIAL

ACCIDENT

Aircraft Type and Registration:	Embraer EMB-505 Phenom 300, HZ-IBN	
No & Type of Engines:	2 x Pratt & Whitney Canada PW535E turbofans	
Year of Manufacture:	2010 (Serial no: 50500040)	
Location	Blackbushe Airport, Hampshire	
Date & Time (UTC):	31 July 2015 at 1408 hrs	
Type of Flight:	Private	
Persons on Board:	Crew - 1	Passengers - 3
Injuries:	Crew - 1 (Fatal)	Passengers - 3 (Fatal)
Nature of Damage:	Aircraft destroyed	
Commander's Licence:	Airline Transport Pilot's Licence	
Commander's Age:	57 years	
Flying experience:	11,000 hours (of which 1,180 were on type) Last 90 days - 23 hours Last 28 days - 5 hours	
Information Source:	AAIB Field Investigation

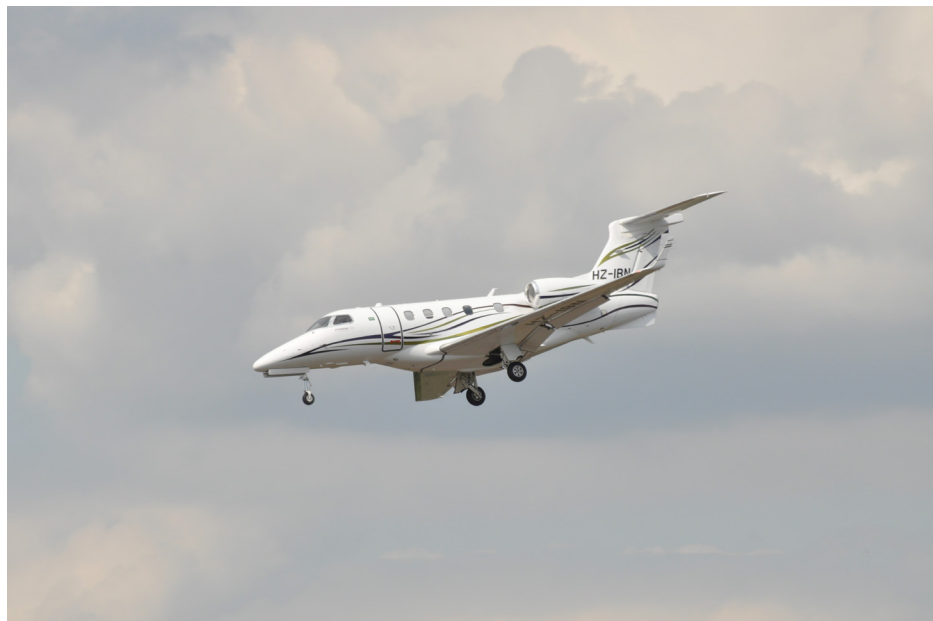
Figure 1

The aircraft (Figure 1) was on a private IFR flight from Milan, Italy, to Blackbushe, with the commander and three passengers on board. Following descent from its cruise level, it was handed over from controllers at London Control to Farnborough Approach. They provided a radar service to the aircraft, before instructing the pilot to contact Blackbushe Information, a few miles prior to its entry into the Blackbushe Aerodrome Traffic Zone. The weather at Blackbushe was fine with light and variable winds, visibility in excess of ten kilometres, and no low cloud.

HZ-IBN on approach to Runway 25 shortly before the accident
(photograph taken by Geoff Pierce)

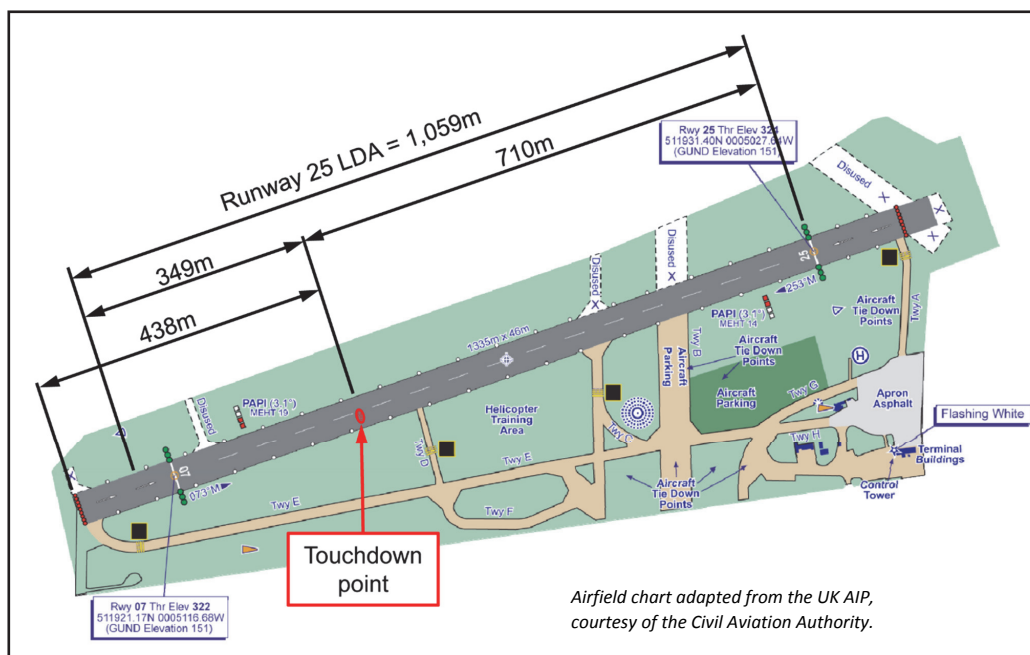
Figure 2

Tyre marks made by the aircraft at touchdown indicated that it landed approximately 710 m beyond the Runway 25 threshold. Runway 25 has a declared Landing Distance Available (LDA) of 1,059 m; therefore the aircraft touched down approximately 349 m before the end of the declared LDA, 438 m before the end of the paved runway surface.

Blackbushe aerodrome chart, showing LDA and approximate touchdown point
