FINAL REPORT

AAIU Formal Report No: 2008-023

Operator: Aer Lingus

Location: Approach to Runway (RWY) 22R,
Chicago O'Hare Airport (KORD), USA

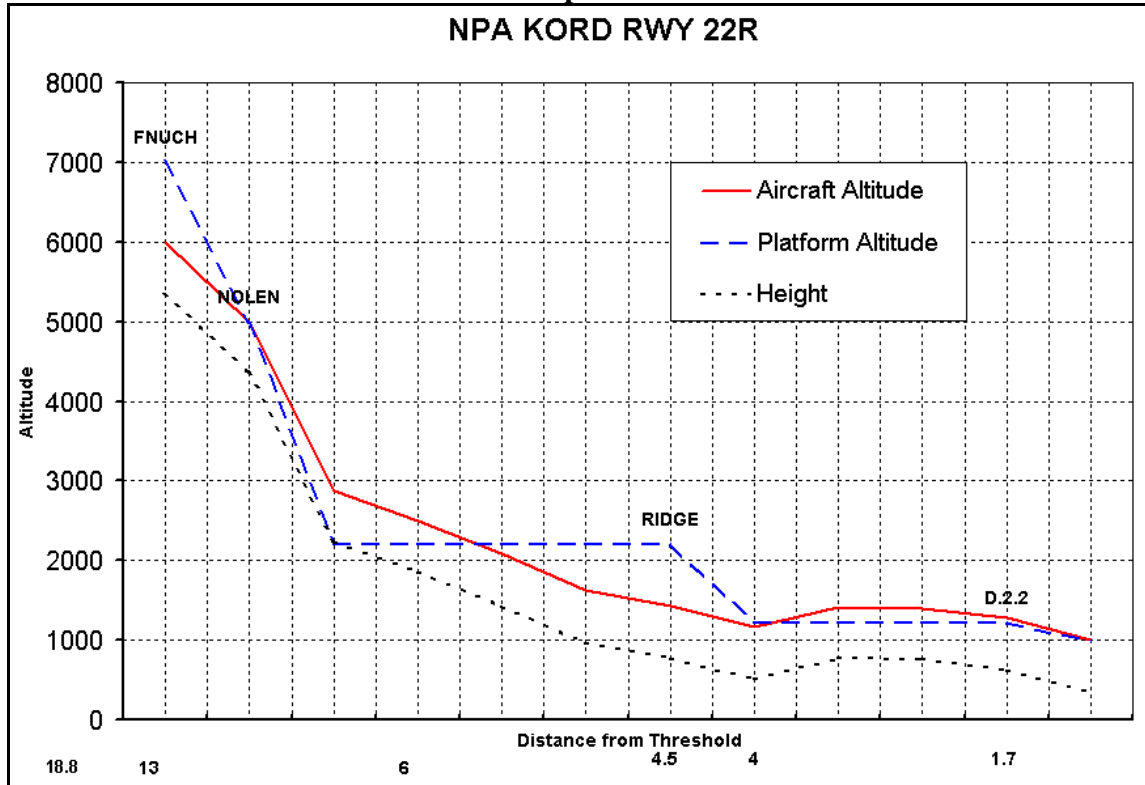
Graphic 2

The data showed the flight crossing waypoint FNUCH at 6,000 ft or 1,000 ft lower than the published approach height. This is a common ATC procedure. Passing NOLEN the aircraft was correctly positioned on the vertical profile. At 6 nm from the runway, it had descended 120 ft below platform. It continued the descent and reached its maximum deviation (774 ft) at RIDGE, 4.5 nm from the runway threshold.

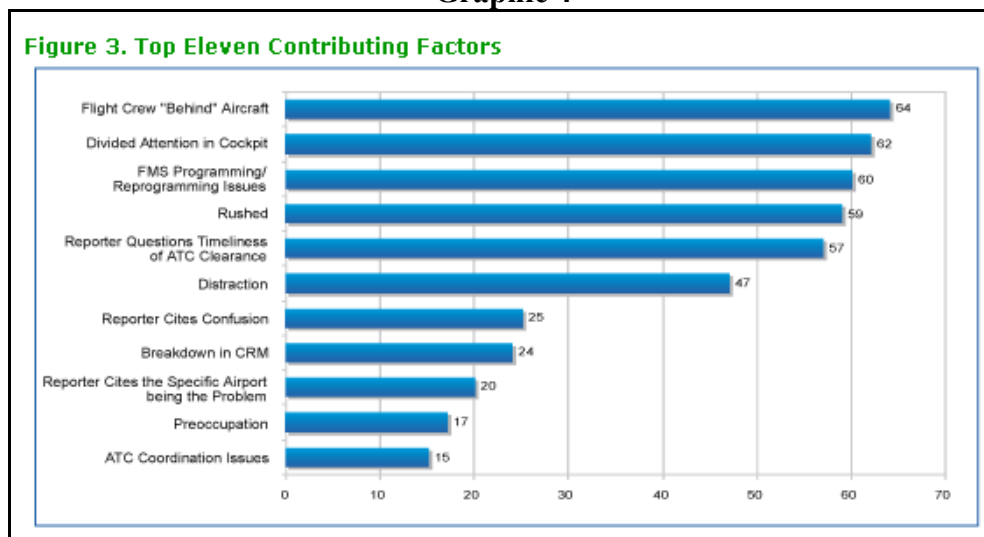
Graphic 4

It is noteworthy that the ASRS's analysts identified Flight Crew Human Performance as the most frequently occurring primary problem. The report also lists Contributing Factors as follows in **Graphic 4**.

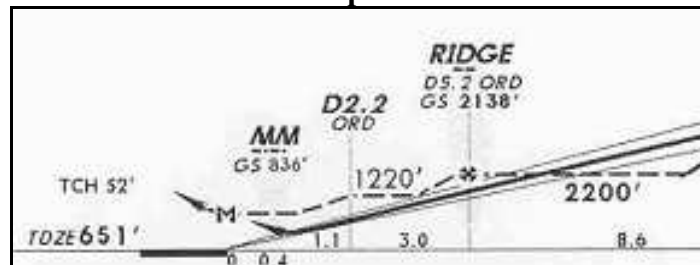
Graphic 5

The *G/P Angle* column identifies the descent angle of the platform heights for the published non-precision localiser approach to RWY 22R at KORD. Although the published glide slope angle is 3°, and that is the only vertical profile angle information available to the pilot, calculation shows that at the Final Approach Fix RIDGE the glidepath is 3.27° and at D2.2 it is 3.57°. This is reflected by platform heights on the Jeppesen approach chart showing above the glide slope, at RIDGE, at D2.2 and at Minima on the approach chart. In addition, the inter-fix angles confirm that picture. It is noted that there is no visual depiction of an NPA flight path on the AIP chart.

The visual picture presented on the approach chart is quite distracting and confusing to a pilot unsure of his vertical flight path. In examining the approach chart non-precision vertical profile, the aircraft is depicted as high at both RIDGE and D2.2, if it maintains platform heights. This visual depiction is correct, as was borne out by the analysis of the flight path. However it is confusing, especially to a pilot who intends to perform a stabilised 3° glide path, in accordance with his SOPs. At a quick glance all he knows is that if he follows the platform altitudes he will be high, and that is not a good option when faced with a short runway. It is possible that this confusion contributed to the pilot's decision to ignore the platform height at RIDGE and concentrate on his height/distance profile, which he had incorrectly calculated.

As the FPA selector of the aircraft is calibrated to a tenth of a degree and aircraft can fly to that level of accuracy, the Investigation is of the view that the published final glide slope angle should reflect reality. As the approach procedure has been constructed in accordance with TERPS and, as all the fixes are movable reference positions, the Investigation is unaware of any reason why the approach cannot be designed to provide a singular flight path angle and so facilitate stabilised approaches. The Investigation therefore believes that the FAA should review the KORD RWY 22R published glide slope and glidepath design.
