Investigation report

C11/2010L

A330 Jetliners' Engine Bleed Air System Failures: Serious Incidents on 11 and 22 December 2010

AIRBUS A330-302

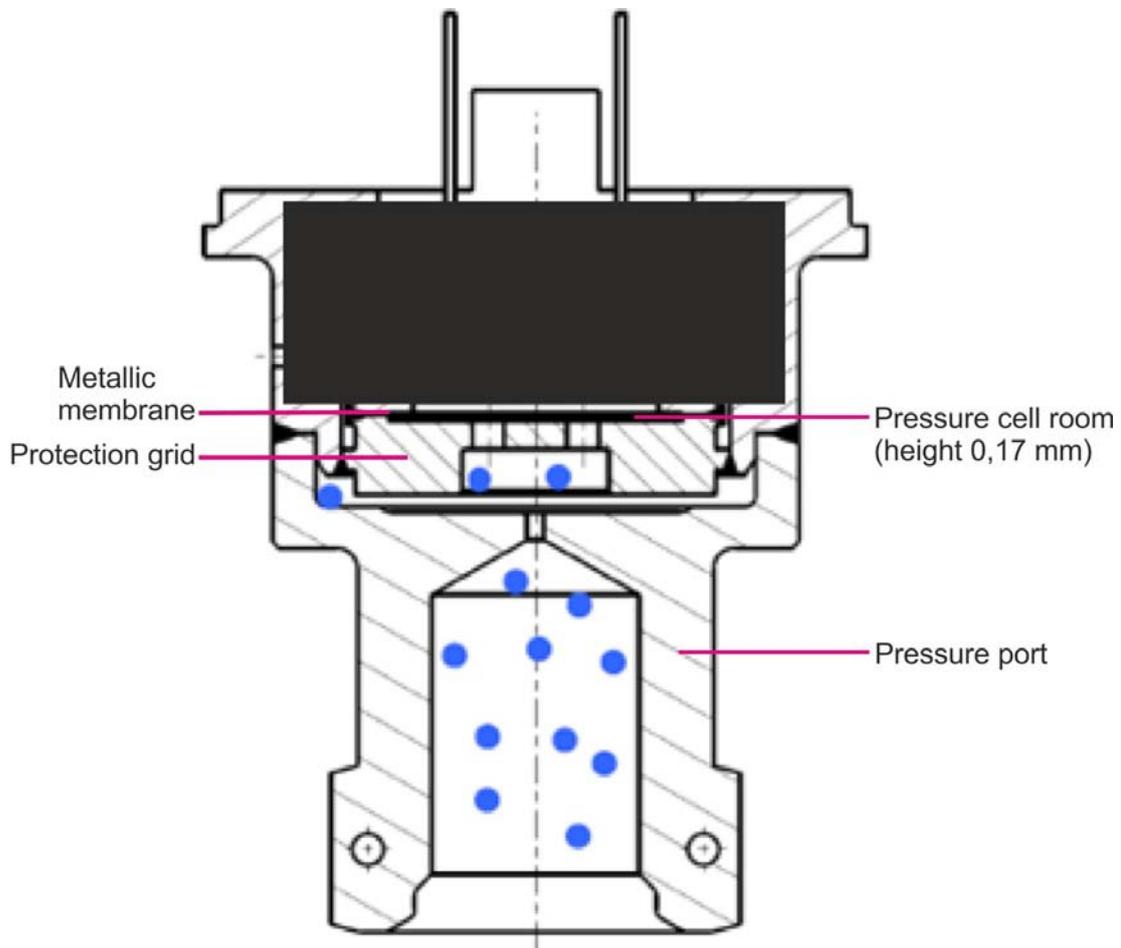
Figure 15. A cross-sectional view of the pressure port and pressure cell room of pressure transducer p/n ZRA380-00. The blue dots represent water droplets. Part of the pressure cell's design is masked on the request of the manufacturer. Source: Esterline-Auxitrol³.

No pressure transducer version prevents the accumulation of moisture inside the pressure cell room. Temperature changes and changes in humidity may cause moisture condensation in bleed air system's sense lines and pressure transducer's pressure ports. Condensed water droplets may travel to the pressure cell room and condensation may also directly occur in that space.

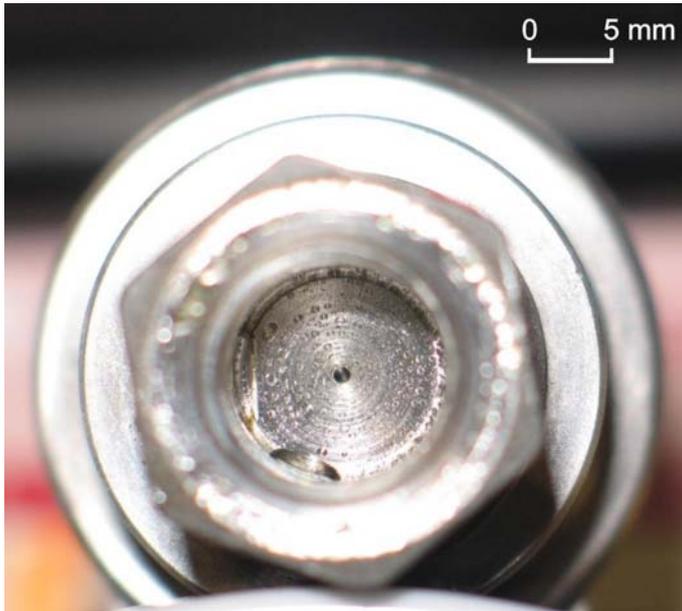
Both pressure transducers of the right engine were replaced at Helsinki-Vantaa airport on 12 Dec 2010. A couple of small water droplets were found at the Pr pressure port area. No similar water signs was observed at the Pt pressure port area. After the transducers had been replaced the engines' bleed air system was checked during an engine test run. The system worked perfectly.

On the next flight, 12 Dec 2010, the flight crew received a transient AIR ENG 1 BLEED FAULT ECAM warning. Upon arrival at Helsinki-Vantaa airport on 13 Dec 2010 both of the left engine's pressure transducers were replaced. Figure 16 shows that the pressure transducer Pr which had been removed contained several water droplets. Pressure transducer Pt was dry. After the transducers had been replaced the engines' bleed air system worked flawlessly during an engine test run.

Figure 16. Pressure transducer Pr that was removed from the left engine's bleed air system on 13 Dec 2010. A large drop of water is visible at seven o'clock inside the pressure port. Source: Finnair Technical Services Ltd.

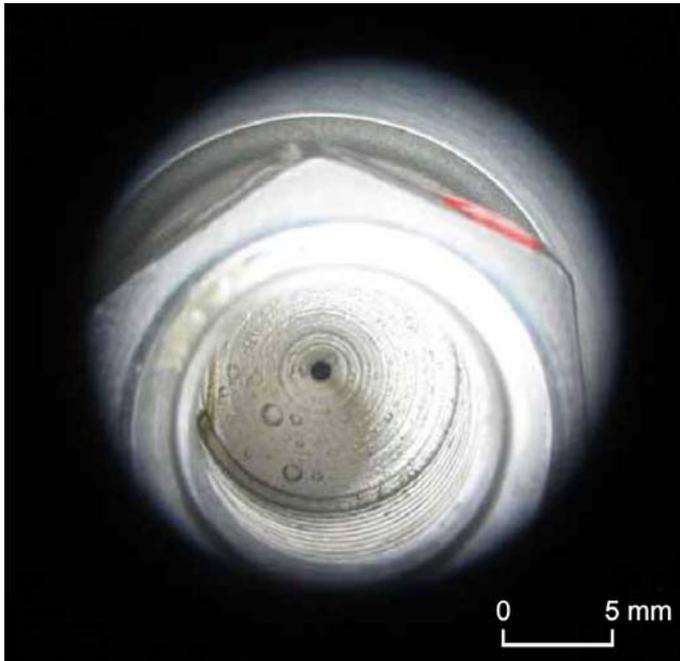
Figure 17. Pressure transducer s/n ASA12735 of OH-LTO. Source: Esterline-Auxitrol⁴.

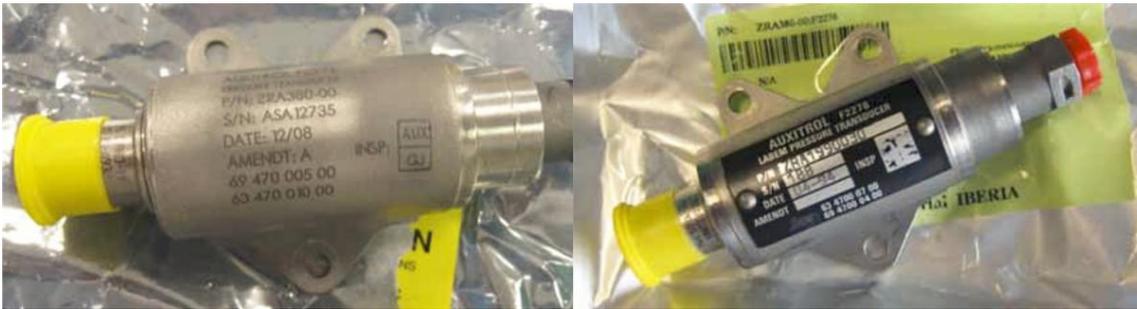
Pressure transducers removed from OH-LTO's left engine; s/n ASA12735 on the left and s/n 188 on the right.

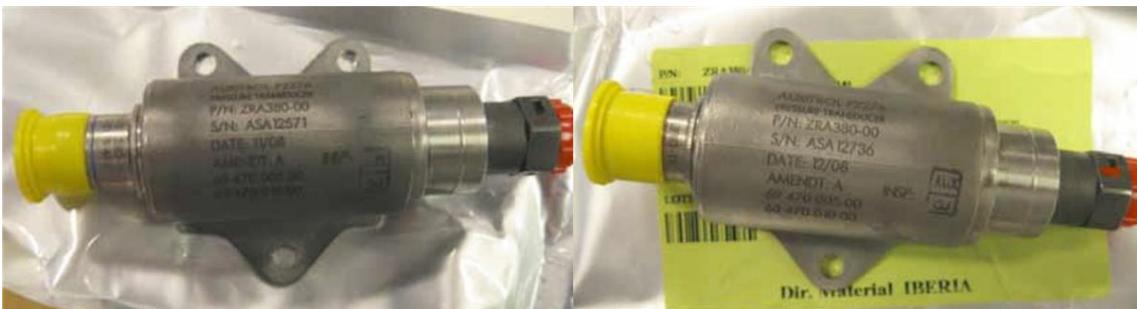
Pressure transducers removed from OH-LTO's right engine; s/n ASA12571 on the left and s/n ASA12736 on the right.

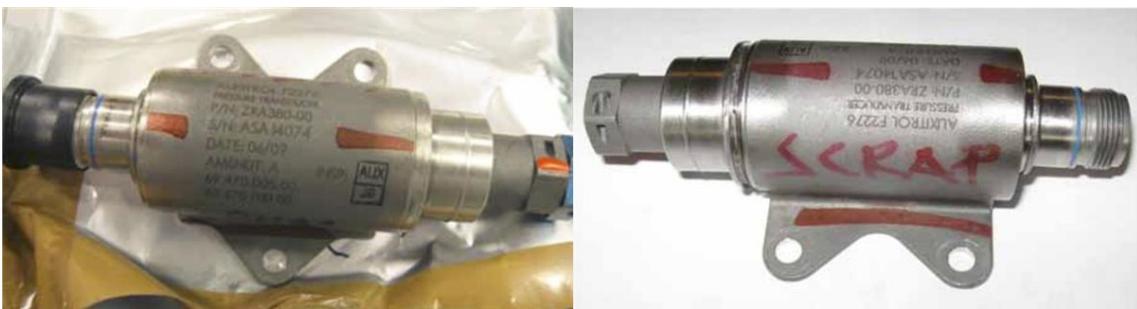
When the aircraft arrived at Helsinki-Vantaa airport on 22 Dec 2010 each of the four pressure transducers were replaced. Moisture condensation was detected in the transducers of the left engine. No moisture was discovered in the sense lines leading to the pressure transducers. The right engine's transducers were dry. No water was discovered in the sense line leading to the Pr. On the other hand, there was water in the sense line leading to the Pt.

Pressure transducer s/n ASA14074 removed from OH-LTS's left engine.
