A U S T R A L I A N T R A N S P O R T S A F E T Y B U R E A U

AVIATION SAFETY INVESTIGATION

BS/20010005

Investigation into Ansett Australia maintenance safety deficiencies and the control of continuing airworthiness of Class A aircraft

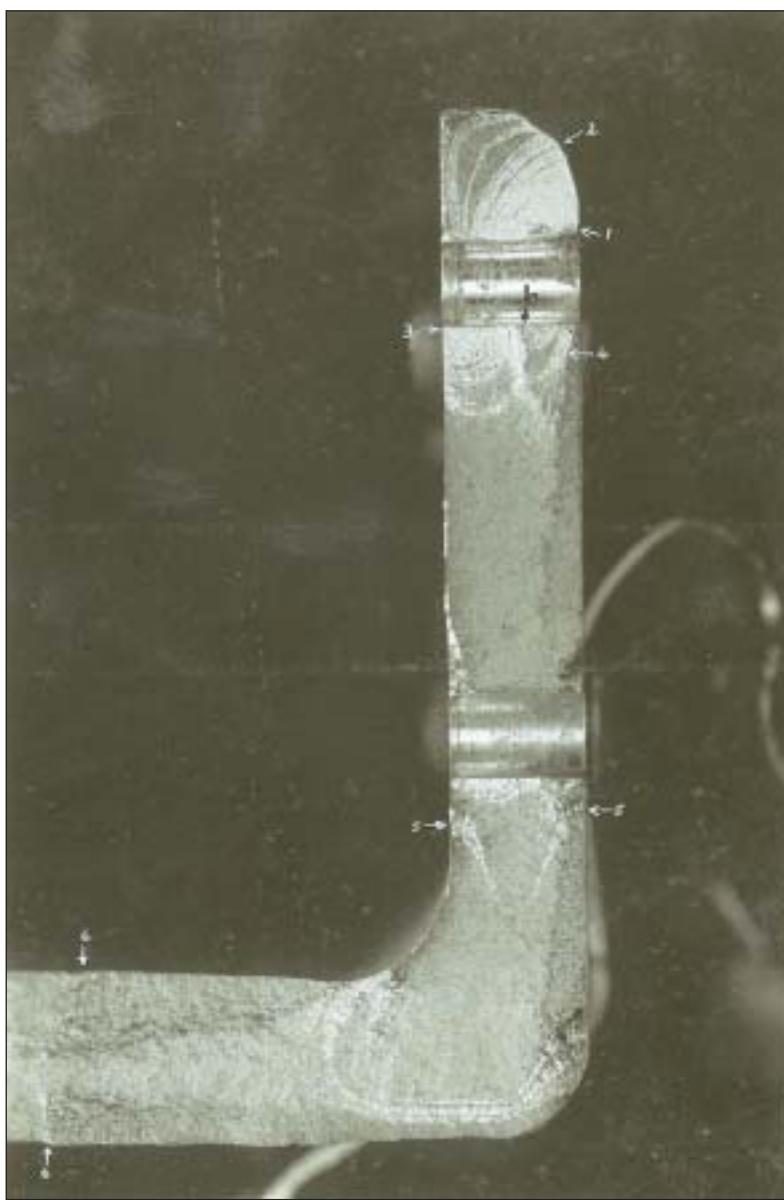
FIGURE 11:
Fracture surface of an aircraft main spar boom fatigue failure

1. Primary fatigue crack origin
2. Localised area of rapid crack growth
3. Secondary fatigue crack origin
4. Extent of secondary fatigue cracks
5. Small zone of slow growing fatigue cracks
6. Small zone of slow growing fatigue cracks

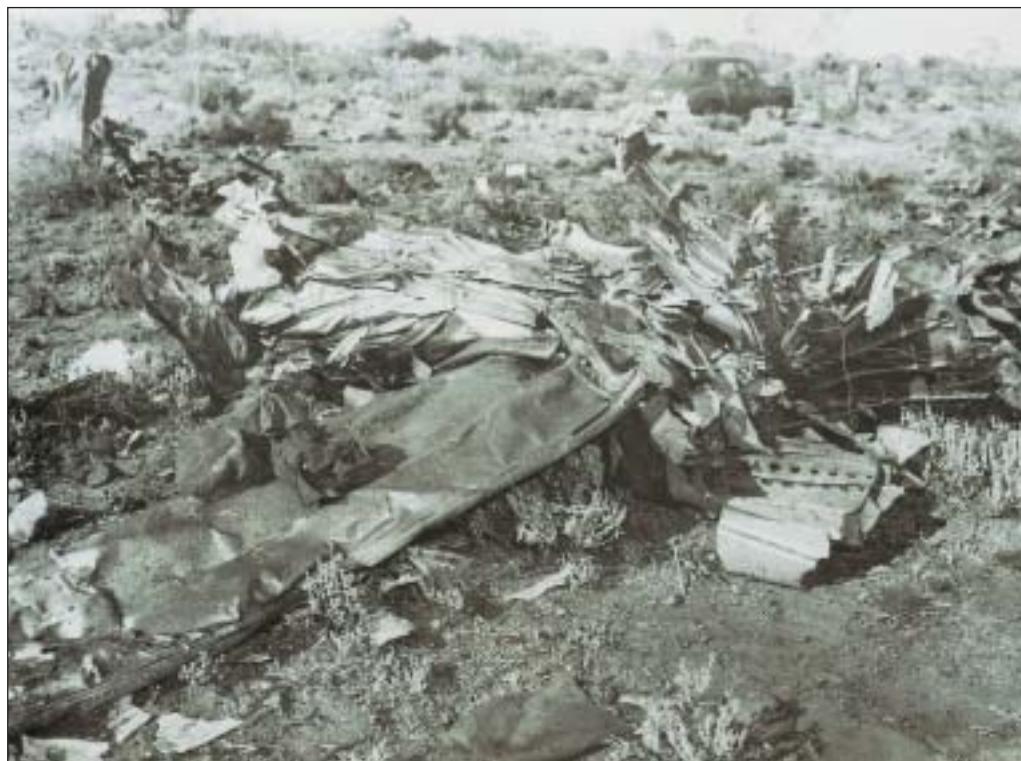
FIGURE 12:
Rear fuselage and empennage of de Havilland Dove VH-AQO

Prior to the VH-AQO de Havilland Dove accident, and similar structural failures in the USA of Martin 202s, structural fatigue was not widely believed to be a significant threat to civil aircraft. The potential effect of in-service operation resulting in fatigue of the aircraft structure was not fully realised.

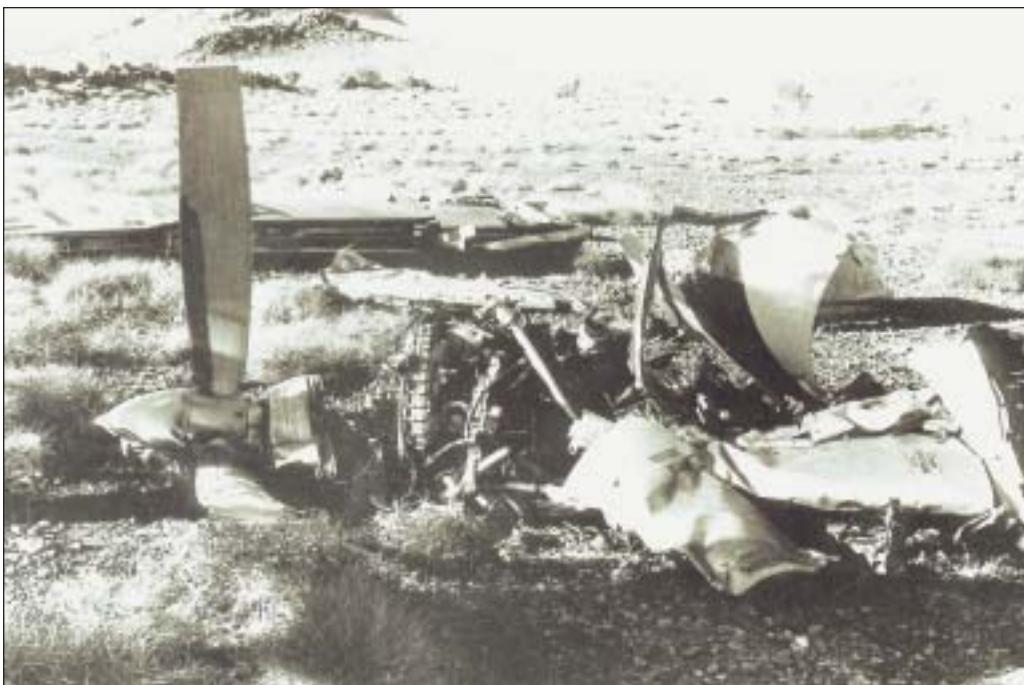
FIGURE 13:
No. 4 engine and wing wreckage of Vickers Viscount VH-RMQ

The investigation into the VH-RMQ accident found that the right wing of the aircraft had separated in flight due to fatigue cracking of the inner wing main spar lower boom. The fatigue endurance of the boom had been substantially reduced by an incorrect maintenance procedure. Following the accident, similar cracks were found in other Viscount aircraft and at least three aircraft were at significant safety risk. Revised fatigue calculations required the immediate replacement of the booms in a large number of Viscount aircraft in many countries.

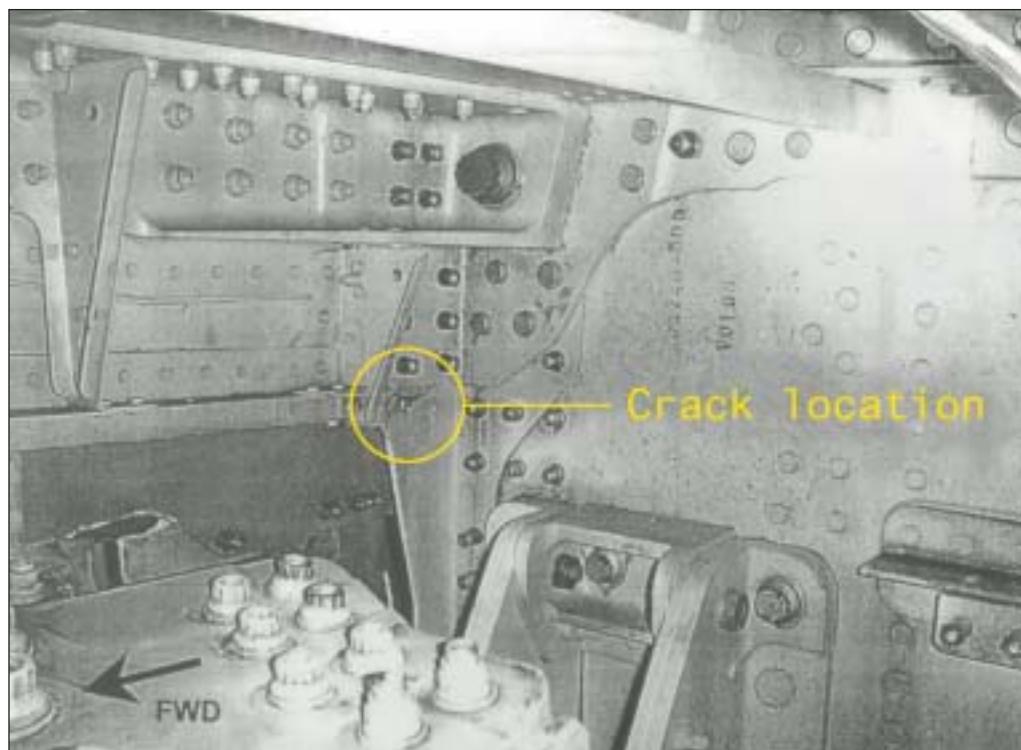
Boeing analysis at the time indicated that if the fatigue cracks in the bulkhead chord were not found and repaired, then cracks could develop in the adjacent structure. Adjacent structure cracks could result in expensive repairs and unscheduled removal of the aircraft from service (see section 6.4.1).

Fatigue crack in an Ansett B767 Body Station 1809.5 bulkhead outer chord

Ansett did not submit further major defect reports on subsequent Body Station 1809.5 bulkhead defects as it was of the opinion that CASA had already been alerted to the problem with the initial reports (see section 7.7).

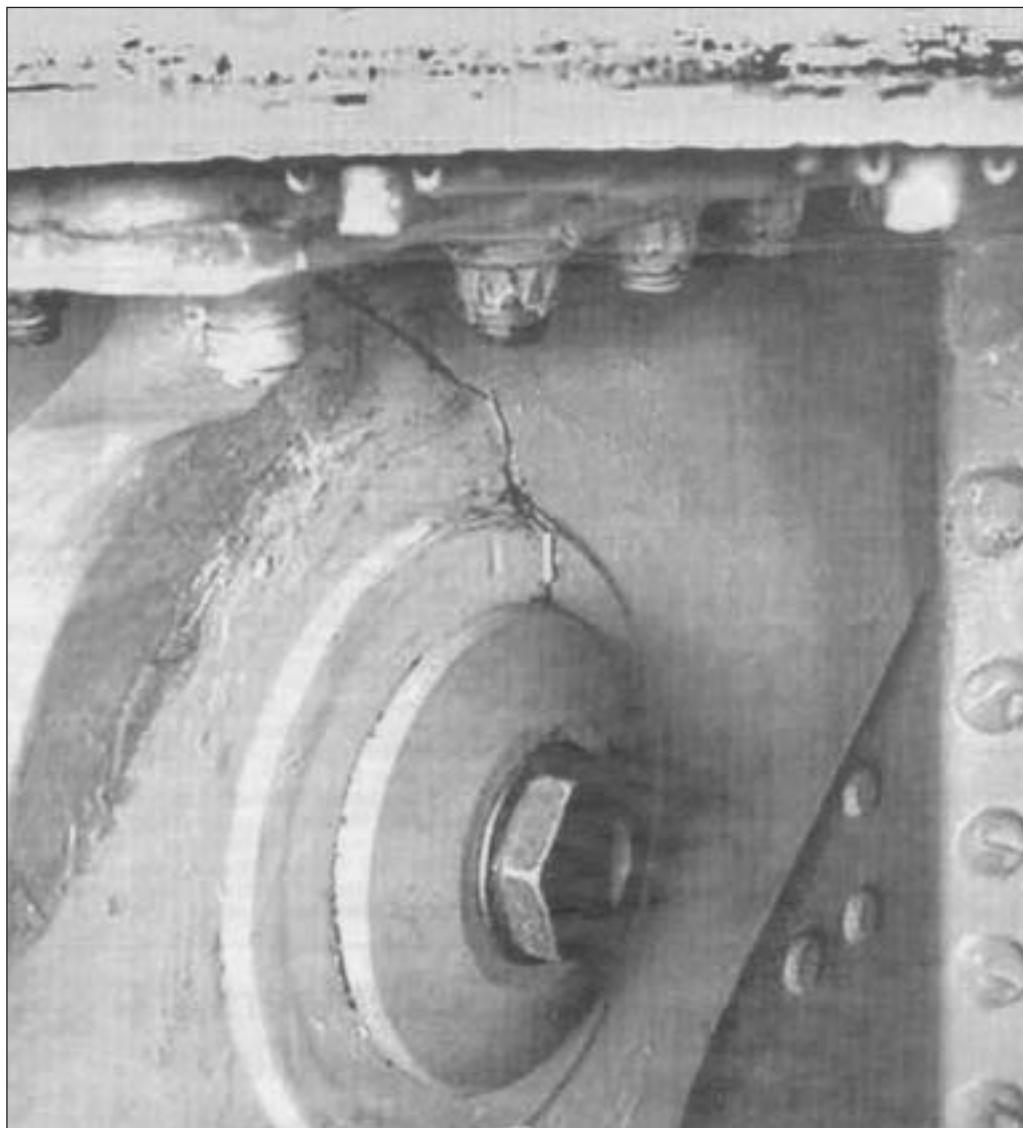
The wing front spar outboard pitch load fitting was part of the upper link load path between the engine and the wing. Cracks in the wing front spar pitch load fitting could have caused possible loss of the upper link load path and separation of the strut and engine from the wing.

FIGURE 30:
Fatigue crack in an Ansett B767 wing front spar outboard pitch load fitting

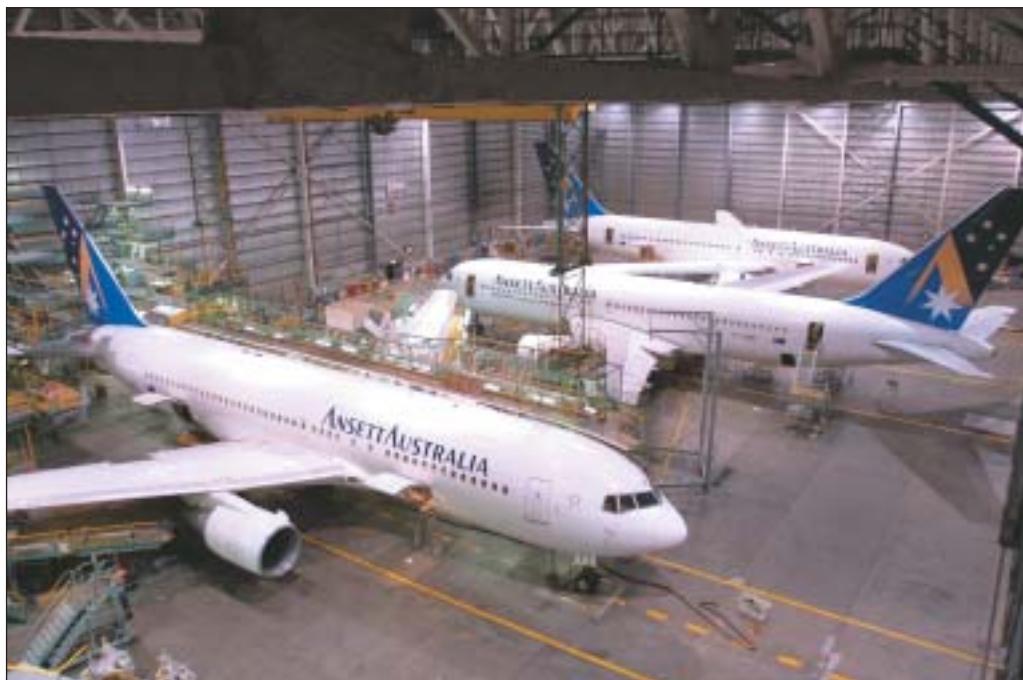
FIGURE 31:
Ansett B767 aircraft undergoing inspection
