Failure to Capture Localizer Guidance

The Fifteenth Meeting of the ICAO Asia-Pacific
Regional Aviation Safety Team [APRAST/15]

Flight Standards and Airworthiness Division
Civil Aviation Department
Hong Kong, China

24/25 June 2020

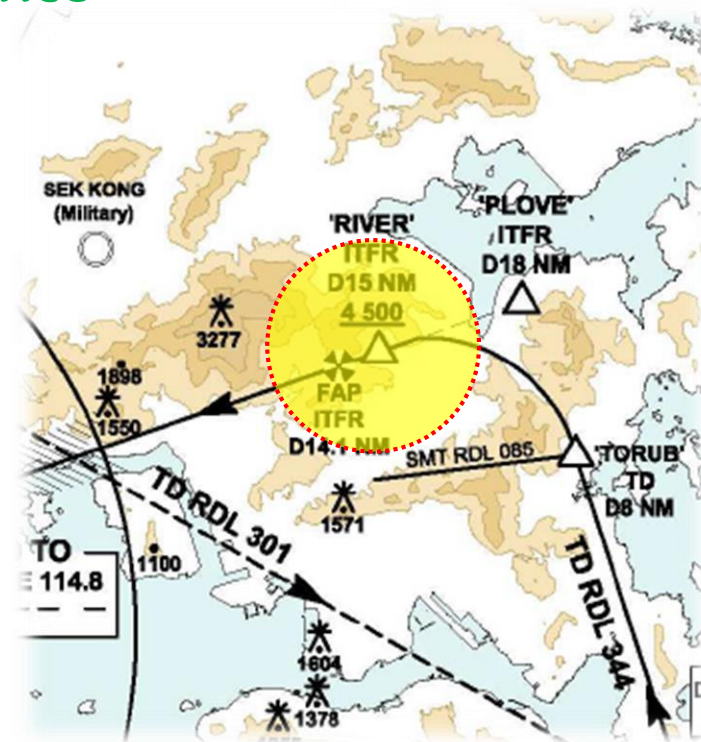
From June 2019 to April 2020, there were seven (7) cases concerning B787 aircraft failing to properly intercept the LOC track during ILS Runway (RWY) 25 approach into HKIA.

With collaborative efforts from industry partners such as the operators involved, the aircraft manufacturer and relevant National Civil Aviation Authorities (NCAAs), an aircraft Autopilot Flight Director System (AFDS) software issue has been identified to have contributed to these anomalies.
