**Fifth Meeting of the Surveillance Implementation
Coordination Group (SURICG/5)**

RECENT ADS-B AVIONICS ISSUES OBSERVED IN THE UNITED STATES

(Presented by United States/Federal Aviation Administration)

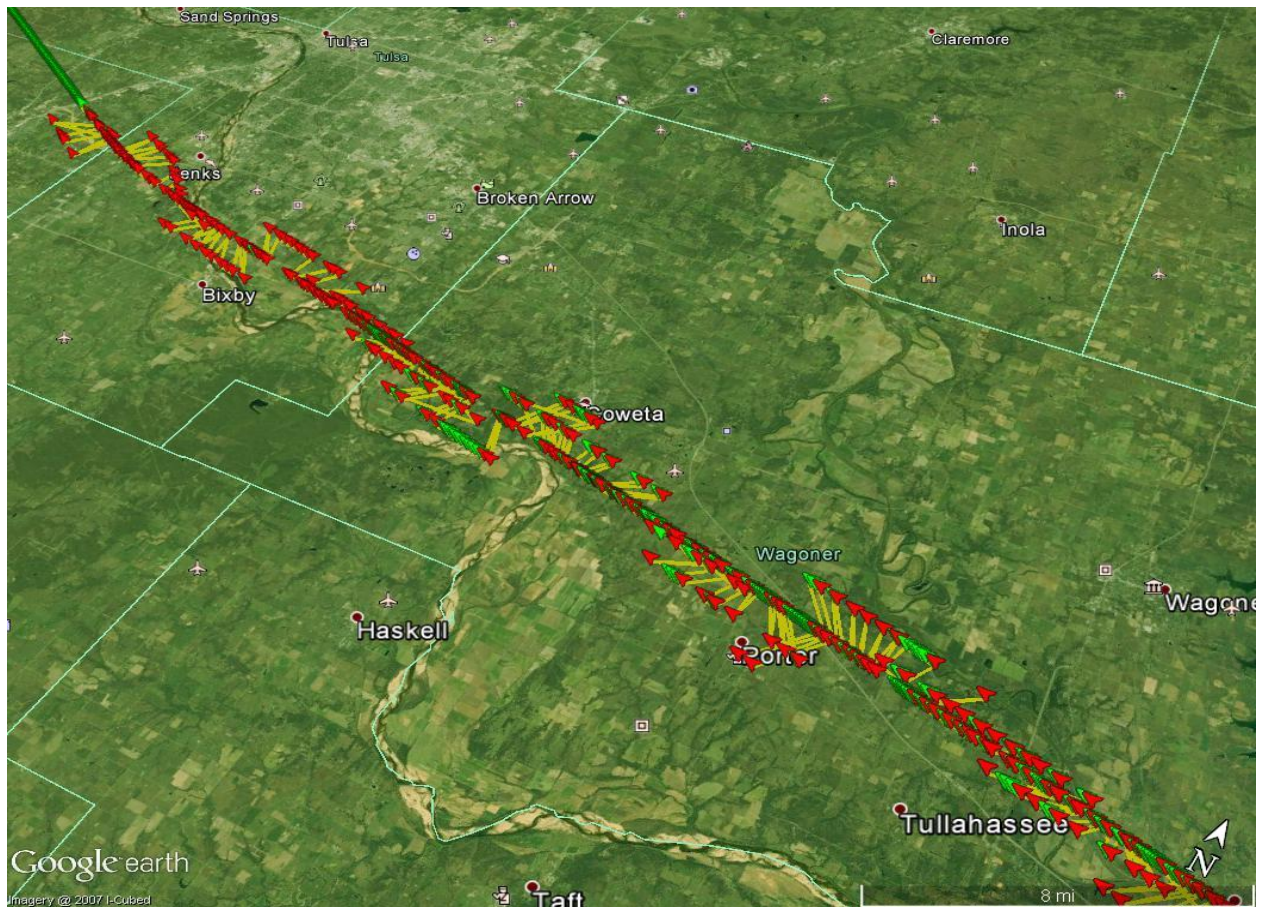
In early 2018, FAA monitoring observed ADS-B position jumping by an Embraer 175 regional jet equipped with Honeywell Version 2 transponders. As illustrated in the below graphic, the APM will designate green for compliant ADS-B Data and red for noncompliant ADS-B Data. The graphic is from a flight on 17 Jan 2018; the aircraft was flying from right to left. The transponders were removed from this aircraft, and provided to Honeywell engineering for bench testing.

This was not the FAA’s first observation of this problem with an Embraer E17x regional jet. In late October 2016, a Skywest E175 was detected exhibiting similar “track jumping” behaviour. FAA Air Traffic personnel notified FAA Flight Standards, who then contacted the operator and ordered replacement of the aircraft’s transponders. Unfortunately, these transponders were returned to a service center without notification to Honeywell engineering, and no “root cause” testing was performed. In late July and early August 2017, FAA detected two E175 aircraft from two different airlines exhibiting “track jumping” behaviour. FAA notified both operators and the transponders were removed from the respective aircraft and sent to Honeywell engineering for additional testing. Bench testing revealed no apparent issues.

In all but one of the observed cases, the issue has never recurred on the same aircraft after the transponders were removed. Bench testing of the removed transponders has revealed no faults or anomalies to date.

The FAA learned from communications with Embraer that the most recent events detected by FAA generated an “ADS-B NOT AVAIL” Crew Alerting System (CAS) message. When flight crews report this message, airline maintenance replaces the transponder(s), which resolves the problem. To date, this has consistently occurred before FAA monitoring detected the problem and FAA personnel could engage with the airline. Occurrence of this issue is rare, as FAA did not observe an occurrence of this issue between November 2018 and March 2020, even though over 500 E17x aircraft were operated daily in the U.S. during this period. The root cause for this issue remains unknown.
