**NINTH MEETING OF THE ASIA PACIFIC ACCIDENT INVESTIGATION  
GROUP (APAC-AIG/9)**

**EXTENSIVE SEARCHES IN GREENLAND LEADING TO DETERMINATION OF ROOT  
CAUSE OF AN A380 UNCONTAINED ENGINE FAILURE**

*(Presented by France)*

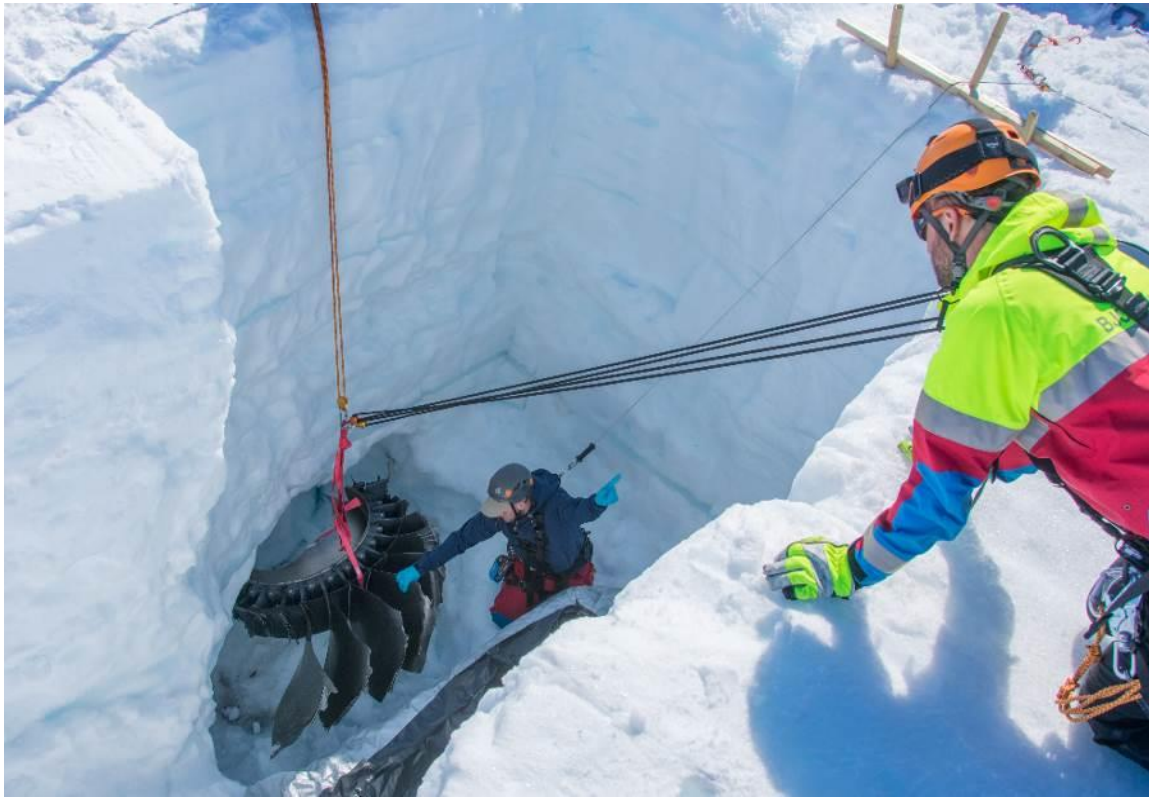
2.11 The engine manufacturer carried out engine failure simulations considering a fan hub "bore to rim" fracture, the results of which were used to update the ballistic computations and refine the search zone. At the end of 2018, the HydroGeophysics Group (HGG) of Aarhus University (Denmark) offered help to the investigation when it modified its electromagnetic detection system so as to be able to detect a titanium part at a distance of five to six metres under the snow. In parallel, ONERA completed its post-processing of the radar data acquired during phase II. ONERA sent the coordinates of one high-probability target and of two less obvious targets to the investigation team. The decision to carry out a new expedition was taken at the end of February 2019 for a departure in May 2019. The expedition kick-off was delayed due to weather, which shortened the mission duration. At the very end of the campaign, at the most promising spot indicated by ONERA, an unambiguous signal was recorded. Its position was close to the spot where the GPR had already made a detection, indicative of buried metal. The detection was situated one metre north of a four-metre-wide crevasse which had a six-metre thick bridge. The presence of the crevasse meant that it was not possible for the team to dig and retrieve the fragments at that time. An excavation campaign was organized in June 2019, which was able to carefully extract a fan hub fragment (Figure 1) and transport it to an examination lab.

Figure 1: extraction of fan hub fragment (source: Austin Lines)
