**THE FOURTH MEETING OF MODE S DOWNLINKED
AIRCRAFT PARAMETERS WORKING GROUP
(MODE S DAPs WG/4)**

ANALYSIS OF INCORRECT RA CODE ON MODE S RADAR

(Presented by China)

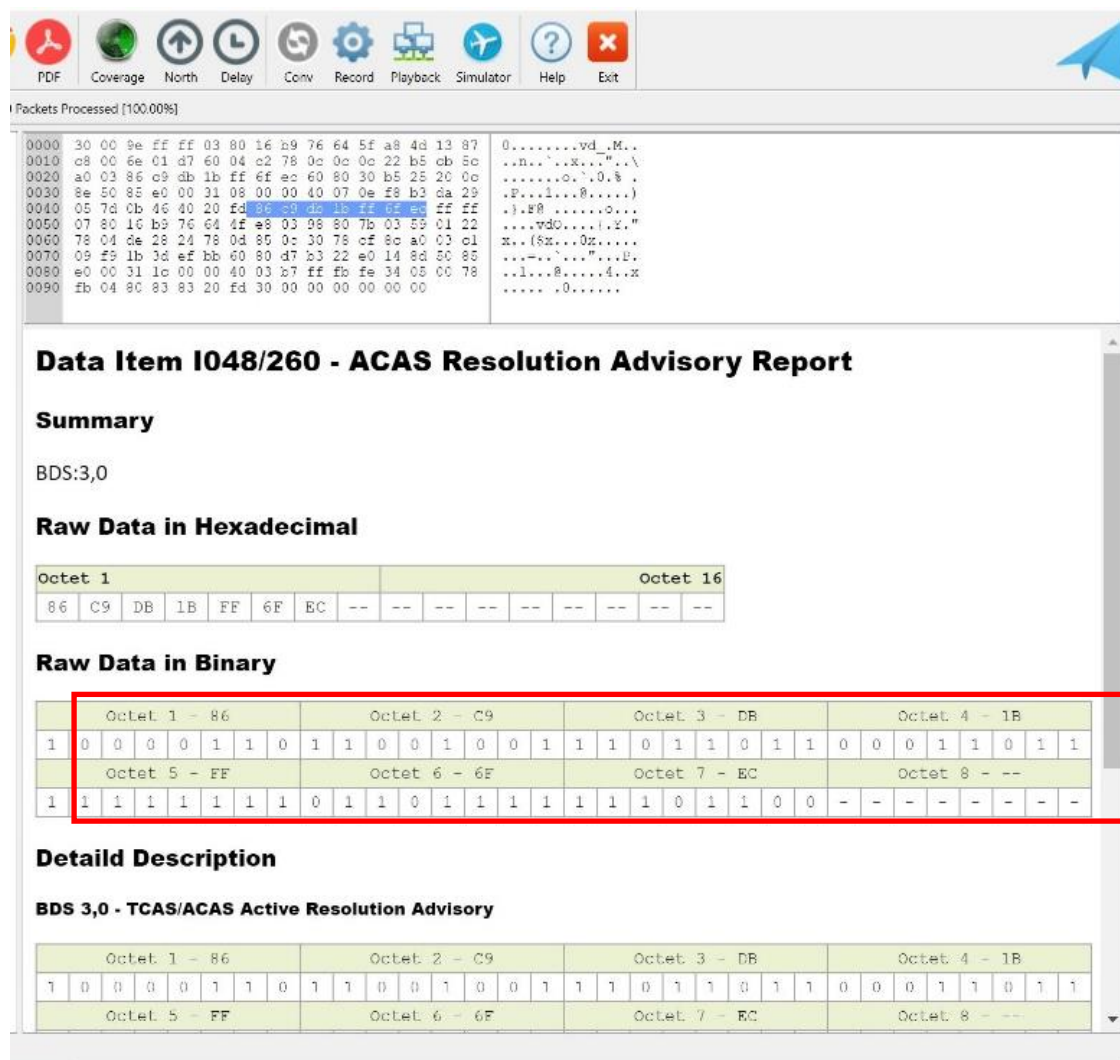
- The Cat048 / item 260 does not start with "30" (hexadecimal) and all data are invalid, as shown in figure 1. (see Appendix 2. basic principles)
- The radar data of Cat048 / item 250 BDS 6,0 is the same as Cat048 / item 260 BDS3,0 in all four RA warning events, as shown in figure 2.

Figure 1. Incorrect first byte data of Asterix Cat048/ item 260.

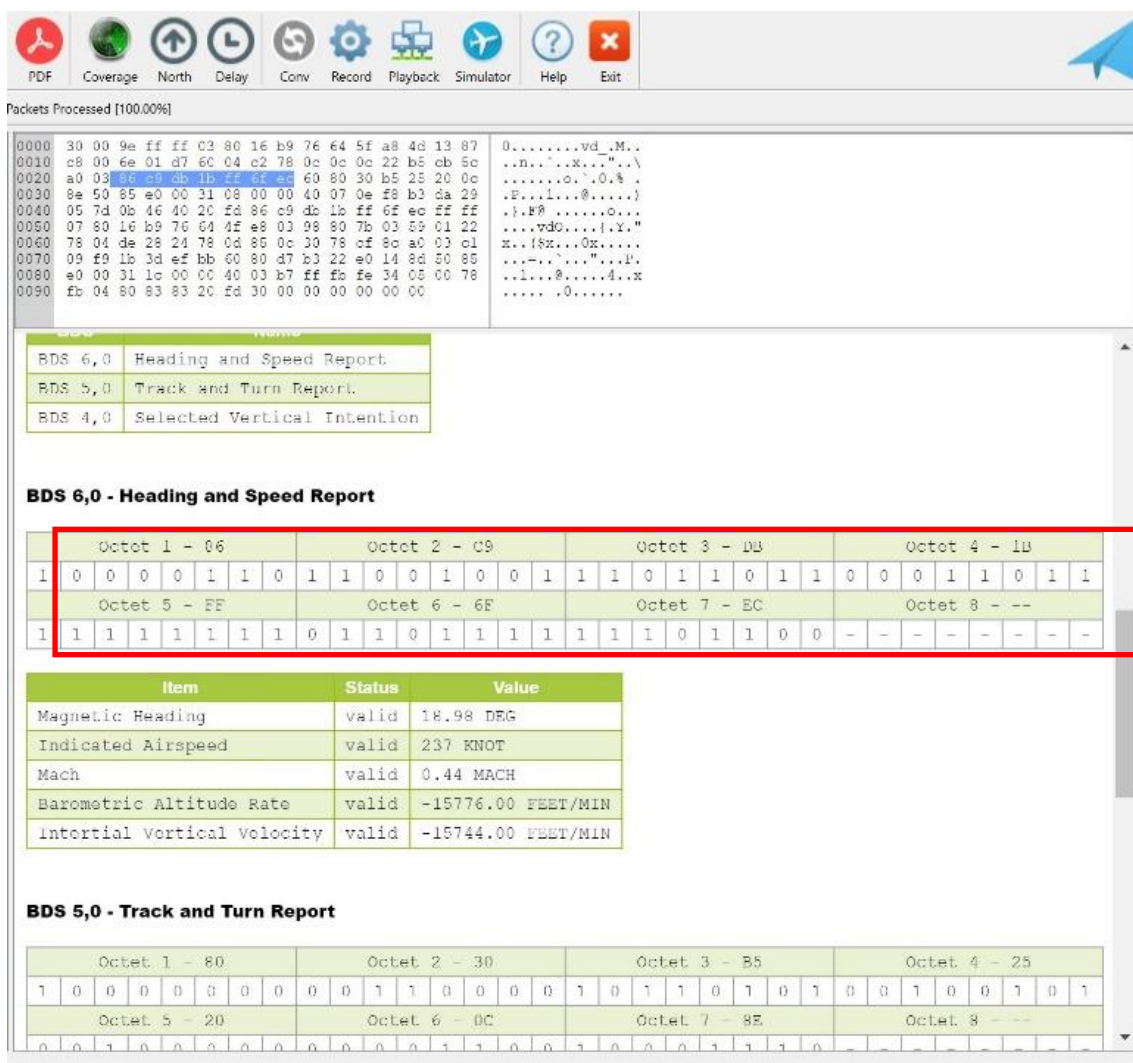
2.2 When the type of BDS data interrogated by the Mode S radar is inconsistent with the type of BDS data sent by the aircraft transponder at the same time, we call this phenomenon "BDS swap". BDS swap may occur in all BDS data. After analysis, the data of Cat048 / item 250 BDS 6,0 is the same as Cat048 /item 260 BDS3,0 in four incorrect RA warning events, which means that BDS swap occurs.

Figure 2. The data of BDS 3,0 and BDS 6,0 are the same

2.5 After analysis, the reason caused of the four incorrect RA warnings is that the aircraft transponder received both BDS3,0 and BDS 6,0 information requests from different Mode S radars almost at the same time, and only replied BDS6,0 information. Since the radar only checks whether the received information code is correct or not, it does not judge whether the replied information is comply with the requested information or not, this results in the radar outputs wrong RA information to the ATM automation system.

2.6 Short term solution in radar improvement: The new type Mode S radar (Thales radar RSM970s DP16.01) in Beijing Daxing International Airport has been able to process the incorrect data after BDS swap, it checks the data flag bits of BDS10, 20, and 30, and checks the consistency of UF / DF.

- It rejects BDS contents (BDS 1,0; 2,0 and 3,0) in case of flag bits error.
- It rejects data of BDS content or replies in case of difference between UF and DF.

The "Overlay" function is introduced in the fifth edition of Volume IV of ICAO document annex 10. In the downlink reply DF20 / 21, the DP (data parity) field is introduced to replace the AP field to check the BDS register number, to solve the problem of BDS swap from the source.
