**Sixth Meeting of the Surveillance Implementation
Coordination Group (SURICG/6)**

RECENT ADS-B AVIONICS ISSUES OBSERVED IN THE UNITED STATES

(Presented by United States/Federal Aviation Administration)

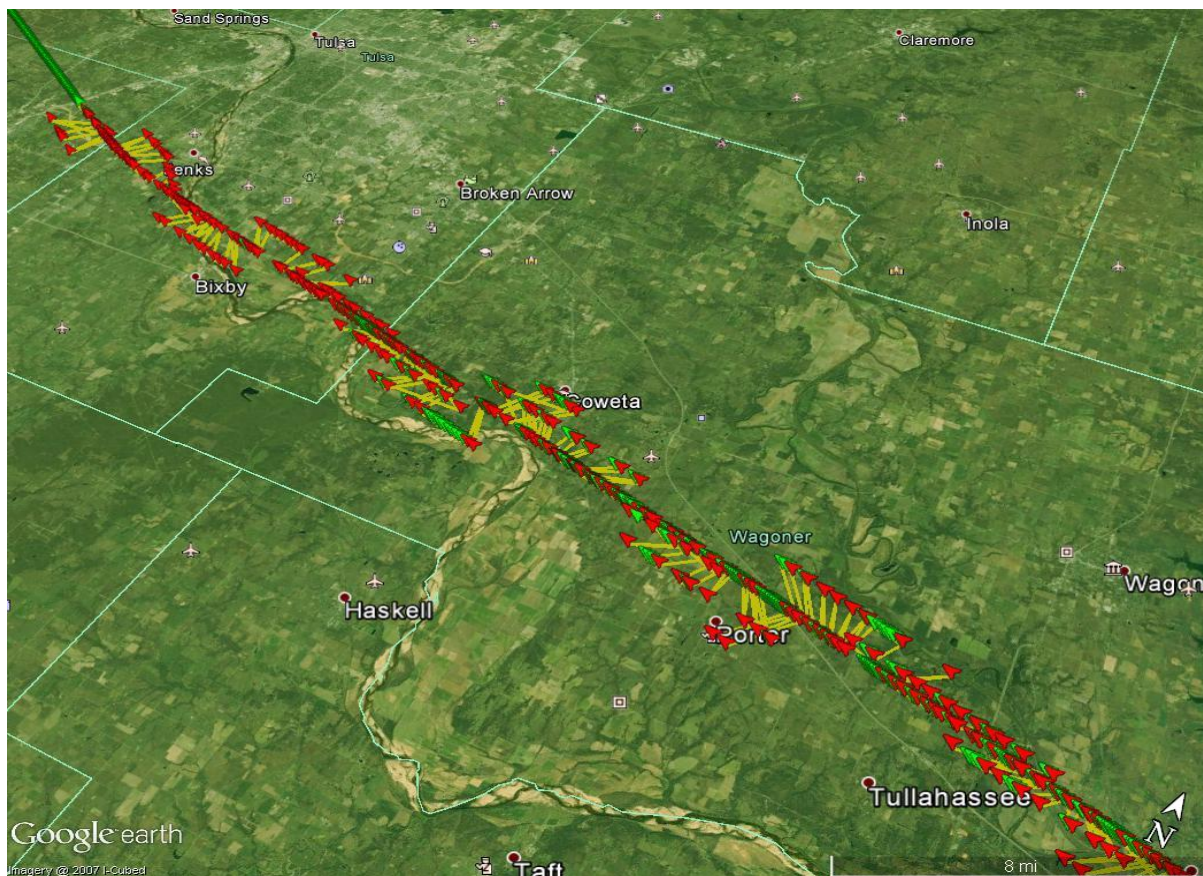
2.1.1 In early 2018, FAA monitoring observed ADS-B “track” jumping by an Embraer 175 regional jet equipped with Honeywell Version 2 transponders. As illustrated in the below graphic, the APM will designate green for compliant ADS-B data and red for noncompliant ADS-B Data. The graphic is from a flight on 17 January 2018; the track depicts the aircraft flying from the right side of the graphic to the left. The transponders were removed from this aircraft, and provided to Honeywell engineering for bench testing.

2.1.2 This was not the FAA’s first observation of this problem with an Embraer E17x regional jet. In late October 2016, a Skywest E175 was detected exhibiting similar “track jumping” behaviour. FAA Air Traffic Control (ATC) personnel notified FAA Flight Standards, who then contacted the operator and ordered replacement of the aircraft’s transponders. Unfortunately, these transponders were returned to a service center without notification to Honeywell engineering, and no “root cause” testing was performed. In late July and early August 2017, FAA detected two E175 aircraft from two different airlines exhibiting “track jumping” behaviour. FAA notified both operators and the transponders were removed from the respective aircraft and sent to Honeywell engineering for additional testing. Bench testing revealed no apparent issues.

2.1.3 In all but one of the observed cases, the issue has never recurred on the same aircraft after the transponders were removed. Bench testing of the removed transponders has revealed no faults or anomalies to date.

2.1.4 The FAA learned from communications with Embraer that the most recent events detected by FAA generated an “ADS-B NOT AVAIL” Crew Alerting System (CAS) message. When flight crews report this message, airline maintenance replaces the transponder(s), which resolves the problem. To date, this has consistently occurred before FAA monitoring detected the problem and FAA personnel could engage with the airline. Occurrence of this issue is rare, as FAA has only observed one recent occurrence of this issue since March 2020. This is the second occurrence in which swapping the transponders has not resolved the issue. Prior to that occurrence, there were no events identified between November 2018 and March 2020, even though over 500 E17x aircraft were operated daily in the U.S. during this period. The root cause for this issue remains unknown.
