**Sixth Meeting of the Surveillance Implementation  
Coordination Group (SURICG/6)**

## DIAGNOSIS AND MAINTENANCE ABOUT A SSR TARGET DEVIATION FAULT

(Presented by China)

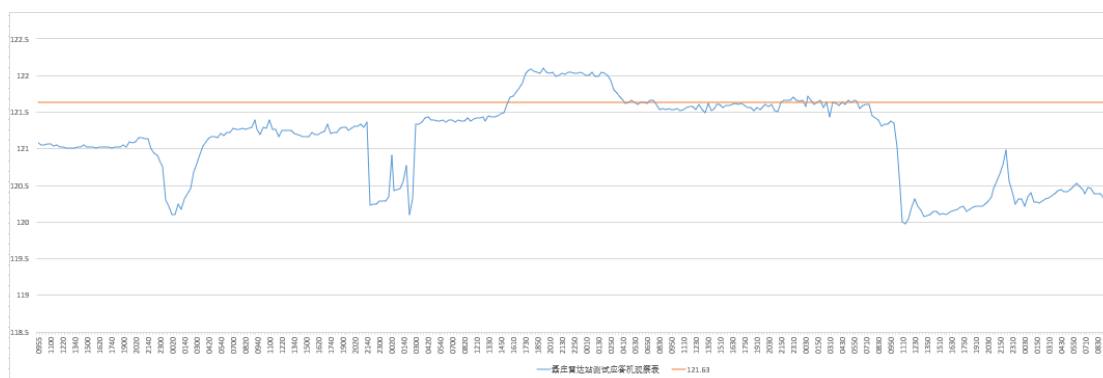
1.1 From October 30, 2020, a Mode-S secondary radar in china has the phenomenon that the detection position of the aircraft deviates from its true position. The phenomenon is that the azimuth of detection target deviates from its true value, and the deviation changes irregularly over time, as shown in Figure 1.

Figure 1A 120-hour azimuth data map of test transponder recorded by a faulty SSR

2.3 It can be seen from Figure 1 that the difference between the maximum value and the minimum value of the recorded azimuth data for test transponder is  $1.9^\circ$ , and there is no obvious rule to follow the error trend.

a) **Improving the regular monitoring methods of azimuth data for SSR:** It is recommended to pay attention to, and regularly monitor the changes of indicators which are related with detection azimuth of SSR in daily maintenance and inspection. For example, Figure 1. If conditions permit, it is recommended to carry out the gyroscope test of RASS regularly, and the recommended test cycle is once a year.

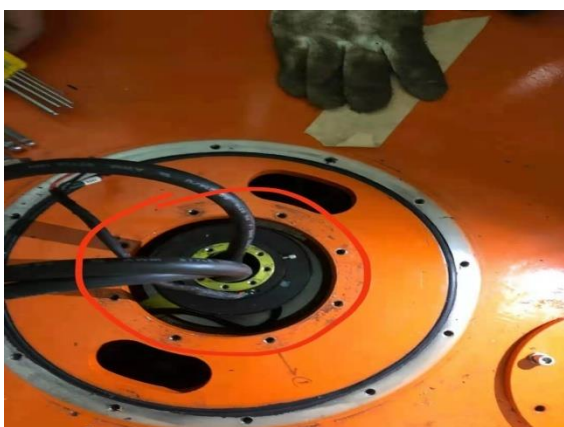
Figure 2

a) ATMB immediately started the special maintenance, after removing the antenna of SSR, it was found that the double diaphragm coupling of the principal axis was out of position.

b) In other words, the principal axis is not exactly at the center of the circle, as shown in Figure 2.

c) The top cover of the antenna pedestal was further disassembled, and it was found that some nuts of the coupling had fallen off, what caused the radial swing of the coupling. (Normally, the coupling can only axial swing.)

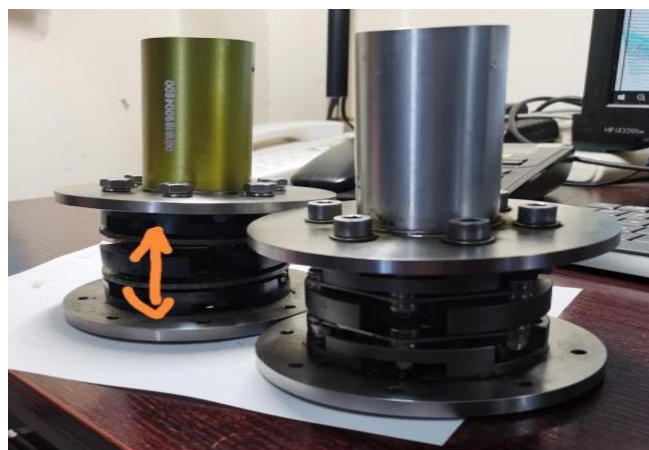
Figure 3

d) The comparison between the faulty double diaphragm coupling of the principal axis and the replacement parts is shown in Figure 3.

3.1 The result shows that the main cause of target deviation for this SSR is as follows: Some nuts of the double diaphragm coupling had fallen off, what caused the radial swing of the coupling. During the operation of the antenna with load, the radial swing of the coupling caused the irregular radial deviation of the principal axis. As a result, the speed ratio of the double diaphragm coupling, encoder synchronization gear and main bearing inside the antenna pedestal was non-uniform, what resulted in excessive ACP deviation of the SSR and the fault of target deviation.

2.5 For reliable maintenance, on the basis of replacing the double diaphragm coupling of the principal axis, ATMB continued to replace mechanical parts such as main bearing, slip ring, and encoder synchronization gear.

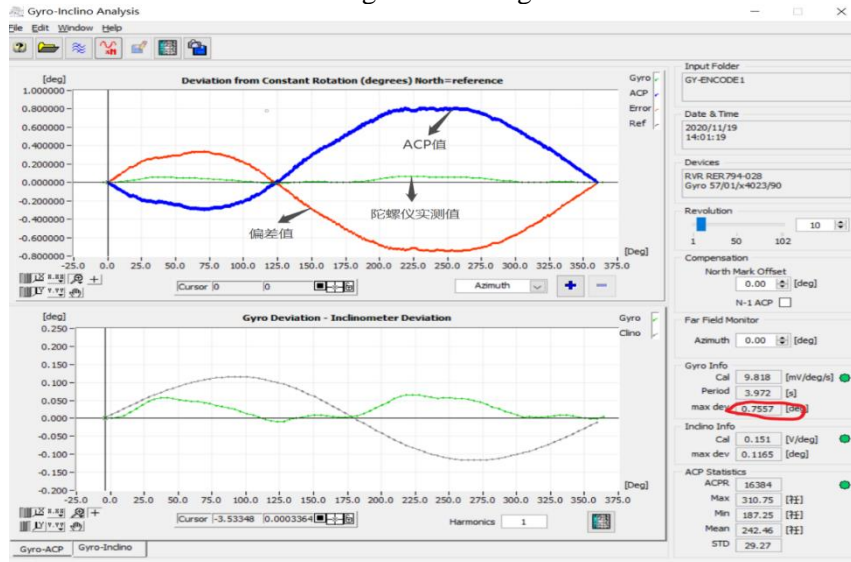
2.6 Before and after maintenance, the gyroscope test of RASS was used to obtain the deviation data of ACP, the results show that the ACP deviation in all directions is significantly reduced, and the maximum value of ACP deviation drops from  $0.7557^{\circ}$  to  $0.1347^{\circ}$ . The test results before and after maintenance are shown in Figure 4 and Figure 5.

Figure 4 the maximum value of ACP deviation is  $0.7557^{\circ}$  (Before maintenance)

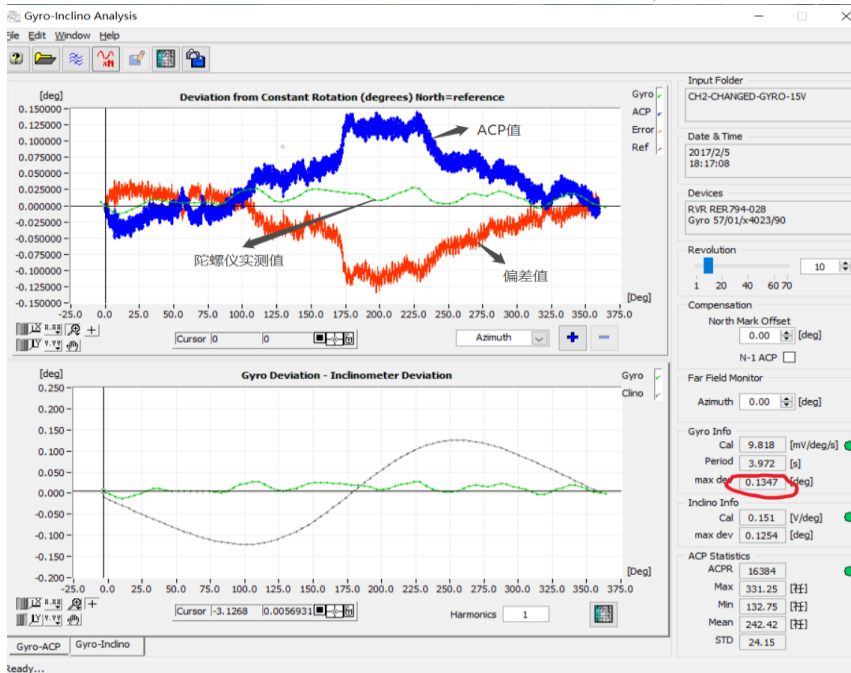
Figure 5 the maximum value of ACP deviation is  $0.1347^{\circ}$ (After maintenance)
