## Sixth Meeting of the Surveillance Implementation Coordination Group (SURICG/7)

### INCONSISTENT ICAO AIRCRAFT ADDRESS AND TARGET IDENTIFICATION BETWEEN SURVEILLANCE DATA AND FLIGHT PLAN

(Presented by Hong Kong, China)

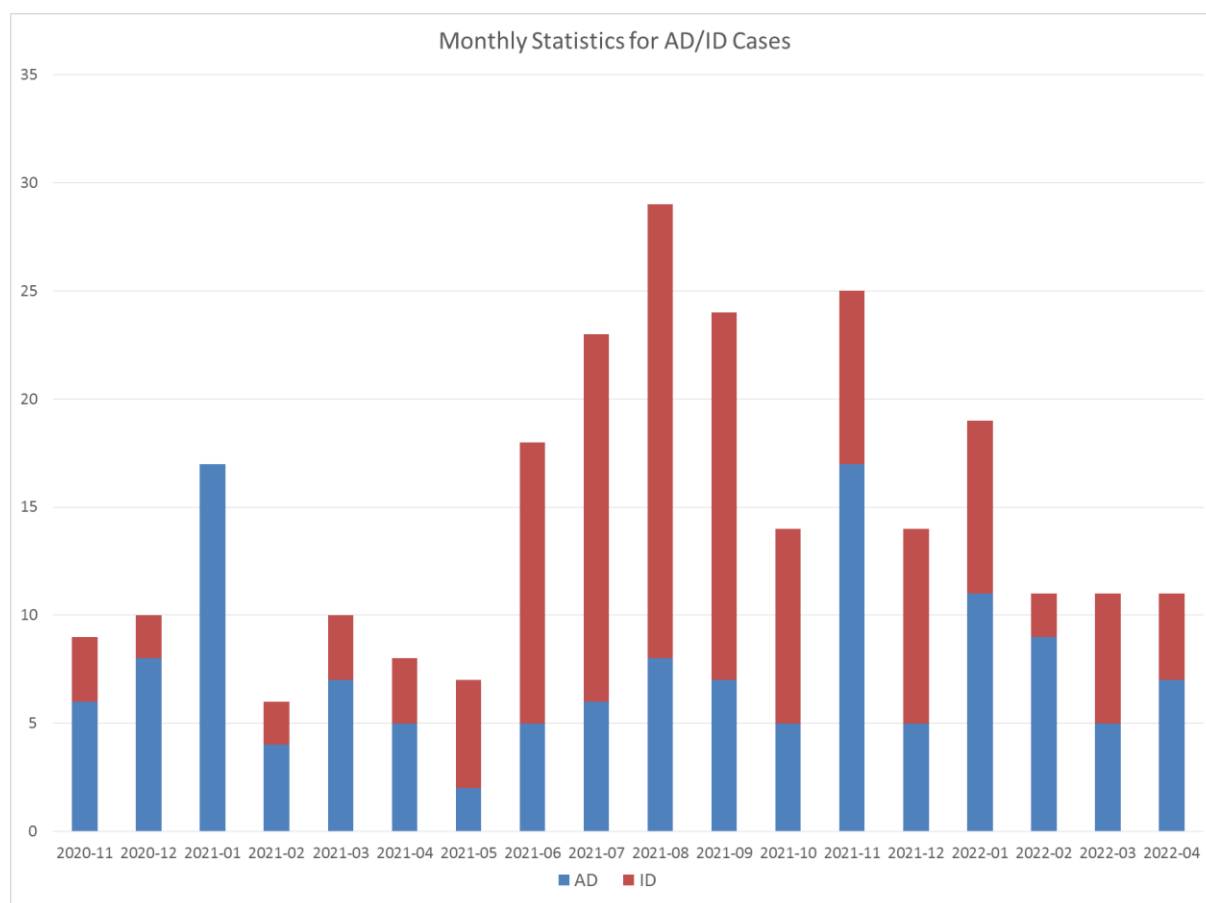
2.1 Repeated efforts have been spent in investigating and following up on each discrepancy case. Recurrence and relapse (after some improvement) are still observed with some air operators. The latest statistics of “Aircraft Address” (AD) / “Target Identification” (ID) discrepancies are summarized as follows:

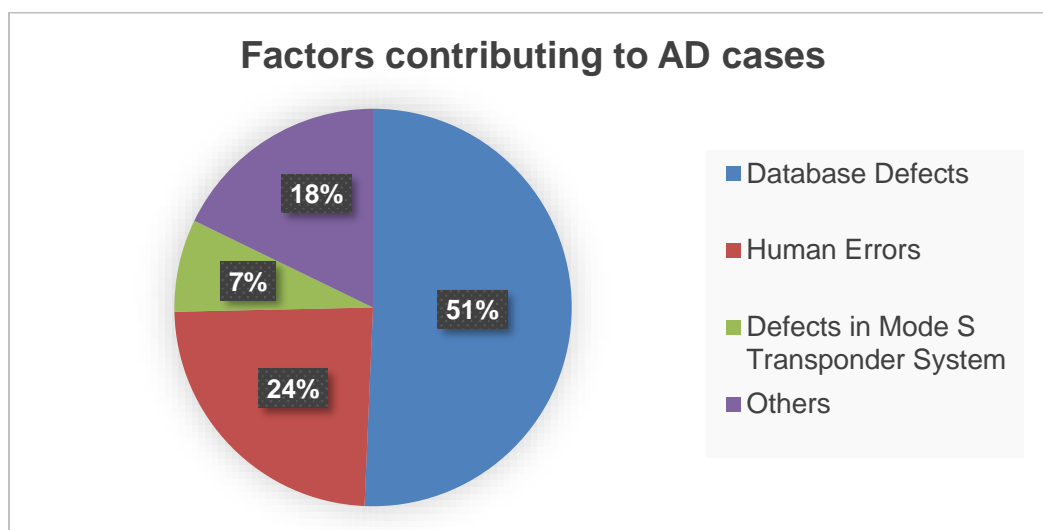
3.1.1 The major contributory factors on AD discrepancies are summarised as follows:

3.1.2 While the underlying factors behind AD discrepancies vary, over 50% of AD discrepancies concern about avionics database integrity and associated deficiencies, which can be further categorised as follows:

Types of avionics database defects revealed	Percentage
Failure to update 24-bit aircraft address upon change of aircraft registration or after aircraft maintenance	42%
Software defects in flight planning system of airline operators / ground handling agents	32%
Incorrect initial entry of aircraft data	11%
Others	15%

- a) The following measures are employed to cope with database-related defects:
  - Overhauling checking and update of the entire database of the operators' fleet;
  - Adopting procedure to ensure timely removal of obsolete aircraft data;
  - Devising communication protocol for sharing of aircraft information between the engineering team and flight operations, in case of revised aircraft registration and acquisition of new aircraft;
  - Developing new system and software providing for automatic update of aircraft database.
- b) Reminders and safety notices issued by operators to reduce the likelihood of human errors.
- c) Aircraft defects are usually effectively tackled by a timely maintenance of the defective part(s).

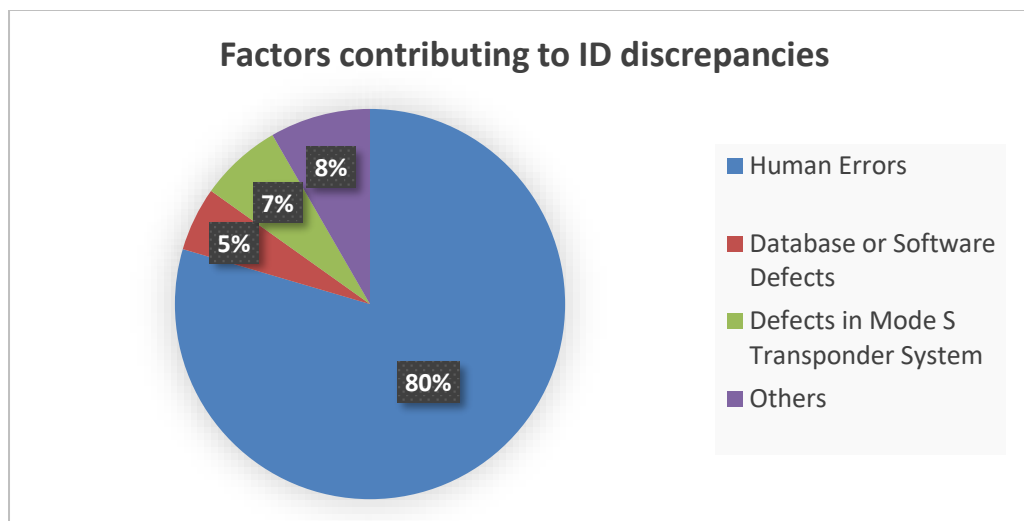
3.2.1 The major contributory factors on ID discrepancies are summarised as follows:

3.2.2 In contrast to AD discrepancies, ID discrepancies are predominantly attributed to human factor-related issues. Amongst the ID discrepancies, about 80% can be ascribed to human errors. With further probing into the precise nature of the human errors involved, we can categorise the errors as follows:

Types of human errors committed	Percentage
Typological error of cockpit crews, flight dispatchers and/or ground handling agents	46%
Misuse of IATA airline designators in ICAO flight plan	33%
Failure to update ACID after flights delay or cancellation, or before commencing the next sector of a flight	11%
Others	10%

- a) The following measures are commonplace to lessen the repeating trend of human errors:
  - De-briefing and additional training with the crews directly involved in the occurrences;

- Issuance of internal safety bulletins, circulars or notice to all staff members for educational purpose and enhancing safety awareness;
  - Revisit and review the standard operating procedures, emphasising on cross-check by flight operations supervisors and/or captain-in-flight;
  - Automating flight data handling process through software or system upgrade.
- b) Database errors and aircraft defects should be tackled by a timely maintenance of the defective part(s) and software upgrade.
