**Sixth Meeting of the Surveillance Implementation
Coordination Group (SURICG/7)**

RECENT ADS-B AVIONICS ISSUES OBSERVED IN THE UNITED STATES

(Presented by United States/Federal Aviation Administration)

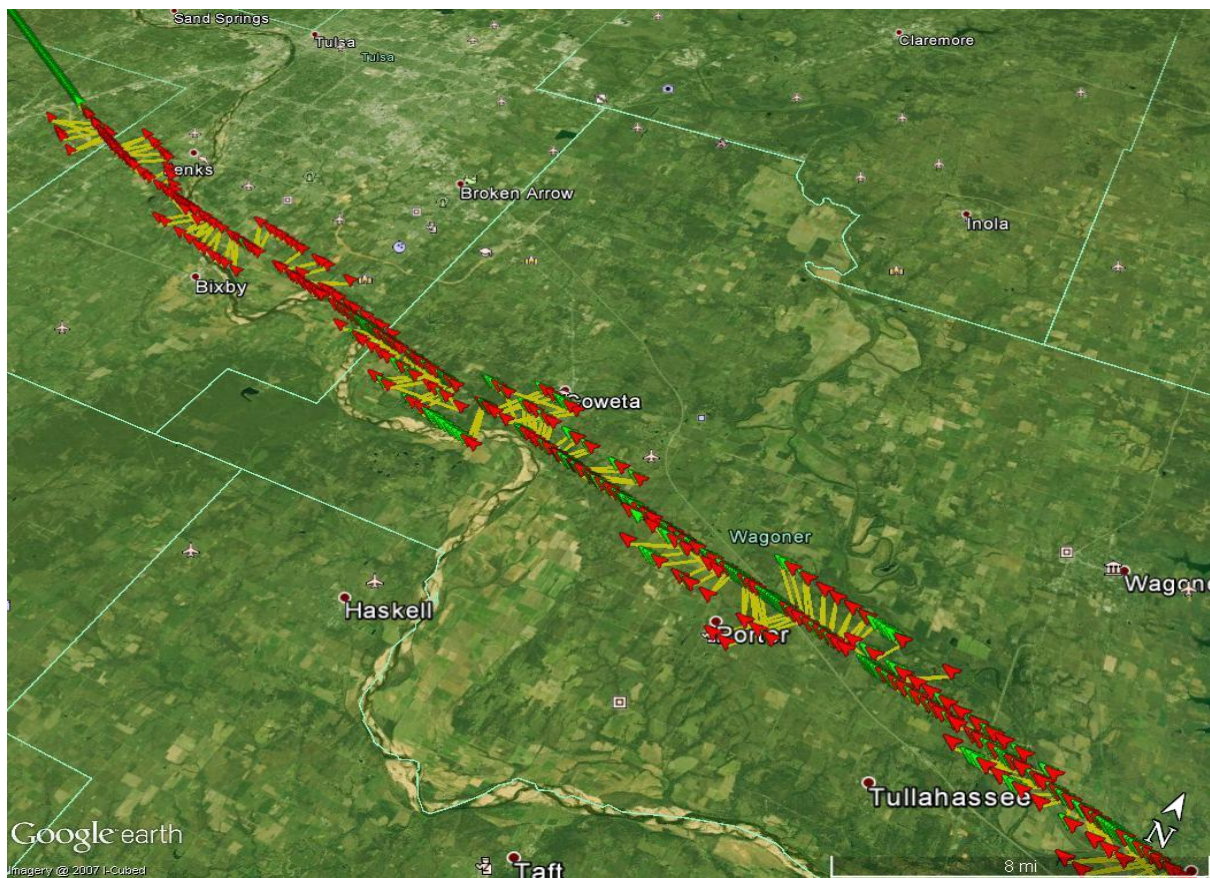
2.1.1 In early 2018, FAA monitoring observed ADS-B “track” jumping by an Embraer 175 regional jet equipped with Honeywell Version 2 transponders. As illustrated in the below graphic, the APM will designate green for compliant ADS-B data and red for noncompliant ADS-B Data. The graphic is from a flight on 17 January 2018; the track depicts the aircraft flying from the right side of the graphic to the left. The transponders were removed from this aircraft, and provided to Honeywell engineering for bench testing.

2.1.3 In all but one of the observed cases, the issue has never recurred on the same aircraft after the transponders were removed. Bench testing of the removed transponders has revealed no faults or anomalies to date.

2.1.4 The FAA learned from communications with Embraer that the most recent events detected by FAA generated an “ADS-B NOT AVAIL” Crew Alerting System (CAS) message. When flight crews report this message, airline maintenance replaces the transponder(s), which resolves the problem. To date, this has consistently occurred before FAA monitoring detected the problem and FAA personnel could engage with the airline. Occurrence of this issue is rare, as FAA has only observed one recent occurrence of this issue since March 2020. This is the second occurrence in which swapping the transponders has not resolved the issue. Prior to that occurrence, there were no events identified between November 2018 and March 2020, even though over 500 E17x aircraft were operated daily in the U.S. during this period. The root cause for this issue remains unknown.
