Agenda Item 2: Central Reporting Agency Reports

FIT-ASIA CENTRAL REPORTING AGENCY (CRA) PROBLEM REPORT BRIEFING

(Presented by the FIT-Asia CRA)

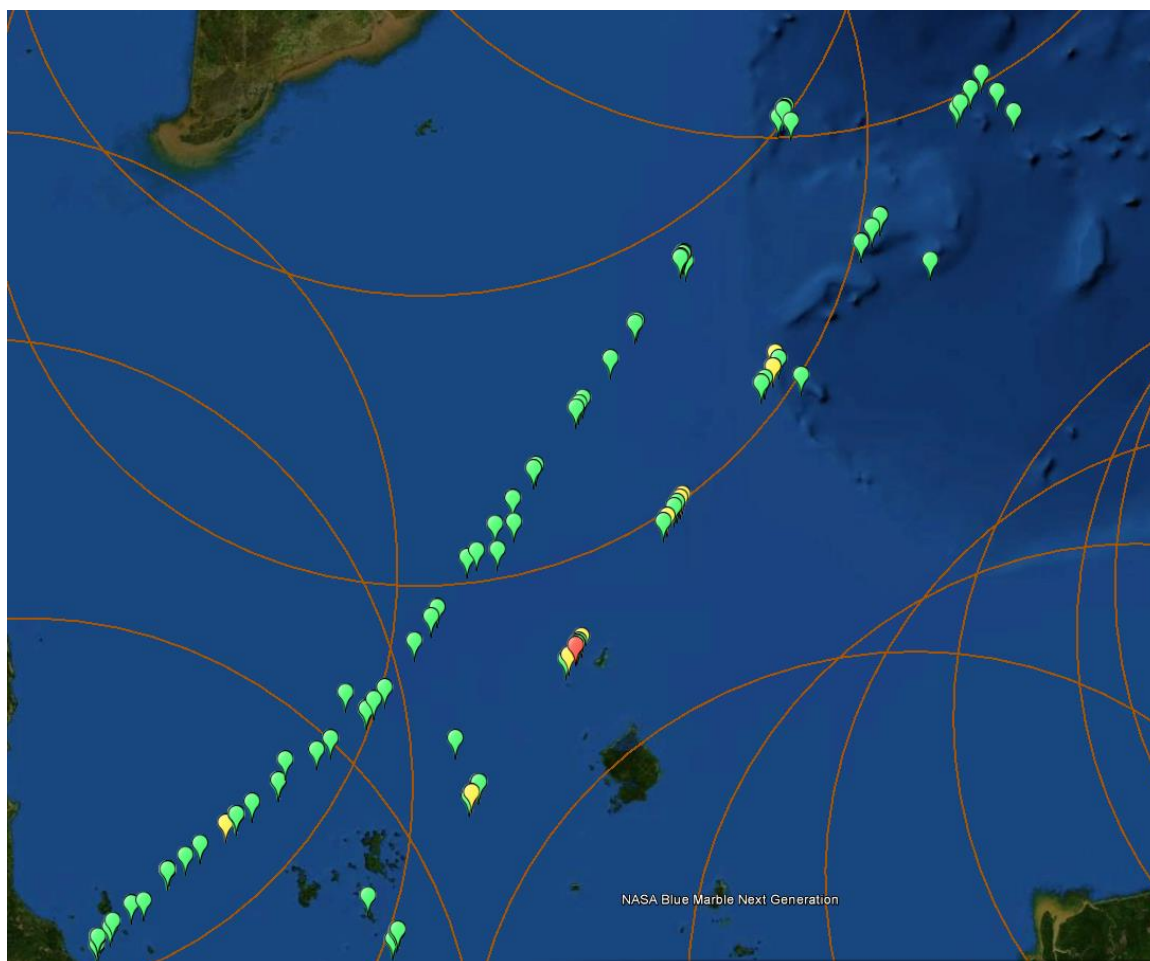
Figure 2: PR 3419-MM ADS-C Reports

b) 3419-MM, Active / Multiple. CAA Singapore reported that a Boeing 777 did not meet the RSP180 95% delivery time requirement during the period from April to June 2022.

i) PBCS data and CSP log analysis indicates that the poor ADS-C report delivery time performance occurred due to limited VHF datalink coverage in the South China Sea area (including in the area between West Malaysia and East Malaysia where the NTX ground stations on Natuna Island previously provided coverage), specifically due to the time necessary for the avionics to transition from using VHF to using SATCOM when the aircraft was operating on the edge of VHF datalink coverage to the northeast of Singapore. The CRA also notes that the ADS-C report delivery time performance by this aircraft in the Oakland Oceanic and Anchorage Oceanic FIRs during the period from July to December 2021 was excellent and further that 777 AIMS-2 BPV18 software will implement the ACARS RAT1 function which is specifically designed to ensure that aircraft meet RCP240 and RSP180 time requirements during transitions from VHF to SATCOM.

ii) Nevertheless, PBCS data and CSP log analysis also indicates apparent delays to ADS-C reports that the VCS ground station operated by AEROTHAI received, specifically that on 15 May 2022 the ground station did not send ACARS acknowledgement uplinks to the aircraft in response to ADS-C report downlinks that it received and also that ADS-C report downlinks that the ground station received were not sent to CAA Singapore. The CRA assigned ARINC (which is affiliated with AEROTHAI) to investigate this aspect of the PR.

iii) Thanks to assistance from Airways New Zealand, Figure 2 below depicts the ADS-C report positions and associated delivery times (green for times less than 90 seconds, yellow for times from 90 seconds to 180 seconds, and red for times greater than 180 seconds) along with nominal VHF datalink coverage. As the figure shows, the delayed ADS-C reports occurred on the edges or outside of VHF datalink coverage, including where the NTX ground stations previously provided coverage.

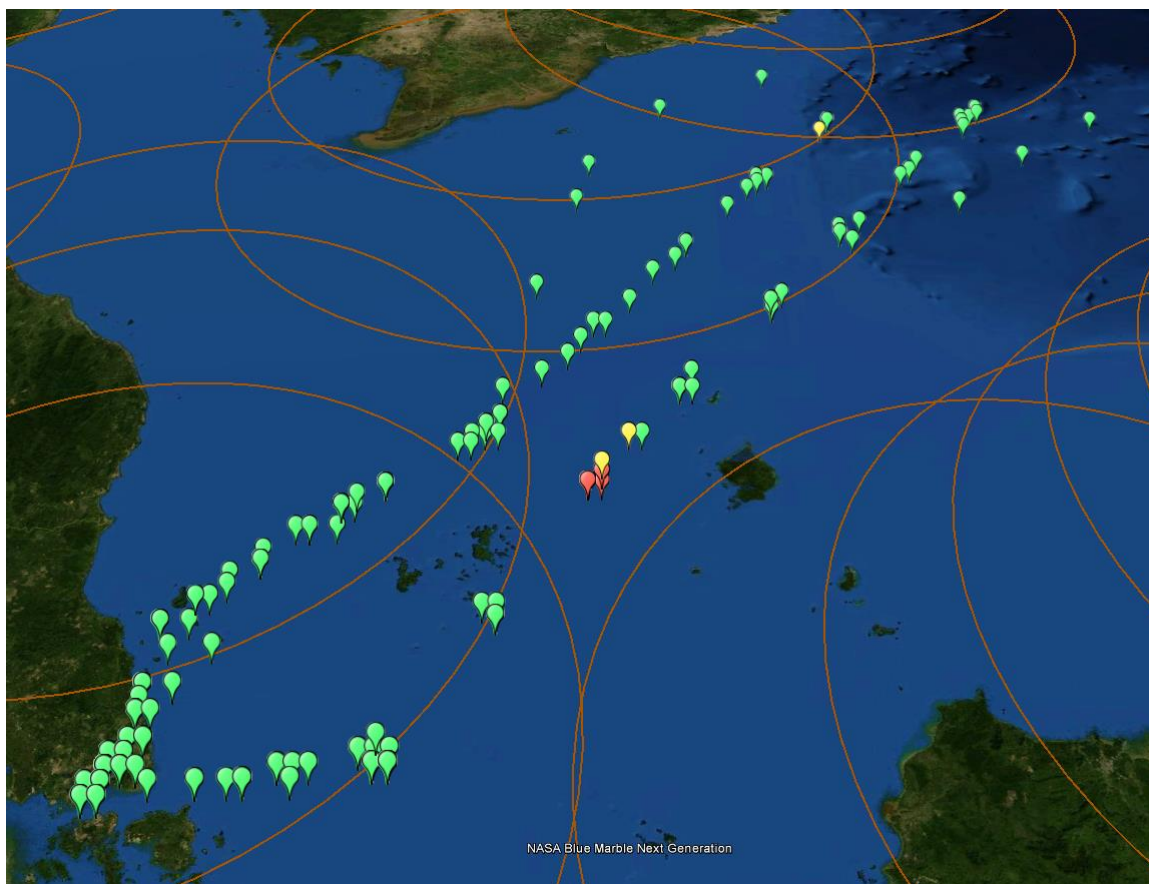
Figure 3: PR 3421-MM ADS-C Reports

d) 3421-MM, Closed as Duplicate / Multiple. CAA Singapore reported that a Boeing 777 did not meet the RSP180 95% delivery time requirement during the period from April to June 2022.

i) The CRA could not fully investigate this PR because the dates of poor performance occurred too long before the PR was submitted for relevant CSP and avionics logs to be available. The PBCS data that CAA Singapore provided did indicate, however, that the poor performance occurred due to the time necessary for the avionics to transition from using VHF to using SATCOM when the airplane was operating on the edge of VHF datalink coverage to the northeast of Singapore where the NTX ground stations previously provided coverage. The CRA accordingly closed this PR as a duplicate of PR 3074-MM.

ii) The CRA also notes that the ADS-C report delivery time performance by this aircraft in the Oakland Oceanic and Anchorage Oceanic FIRs during the period from July to December 2021 was excellent and further that 777 AIMS-2 BPV18 software will implement the ACARS RAT1 function which is specifically designed to ensure that aircraft meet RCP240 and RSP180 time requirements during transitions from VHF to SATCOM.

iii) Thanks to assistance from Airways New Zealand, Figure 3 below depicts the ADS-C report positions and associated delivery times (green for times less than 90 seconds, yellow for times from 90 seconds to 180 seconds, and red for times greater than 180 seconds) along with nominal VHF datalink coverage. As the figure shows, the delayed ADS-C reports occurred on the edges or outside of VHF datalink coverage, including where the NTX ground stations previously provided coverage.
