Audit Findings & Follow-Up Exercise

Findings

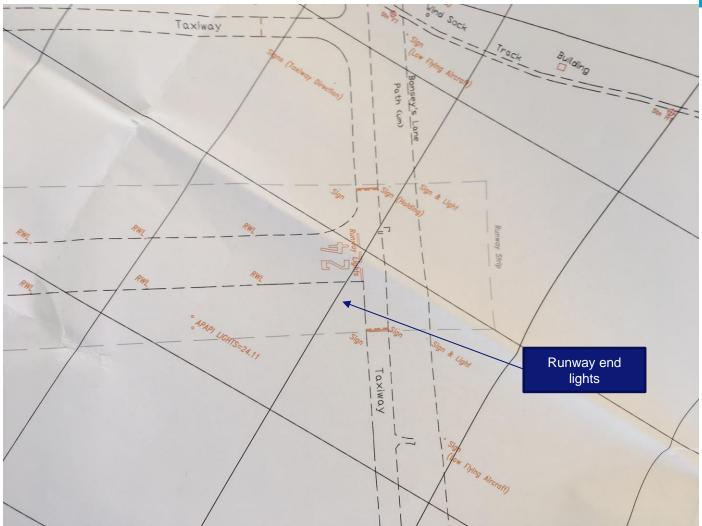
Aerodrome survey Plan

- You are on audit and find the following:
- 1. The AIP chart shows the runway 06 stop end lights at the end of pavement
- 2. The aerodrome survey shows the runway 06 stop end lights at the intersection of the runway and the taxiway across the runway end
- A photograph onsite confirms that 2 is correct.
- The agreed declared distances state that the TORA and ASDA end at the end of pavement
- Actions
- 1. Is this a finding or an observation?
- 2. If yes, is it a Level 1 or Level 2?
- 3. Draft your audit report item covering this.

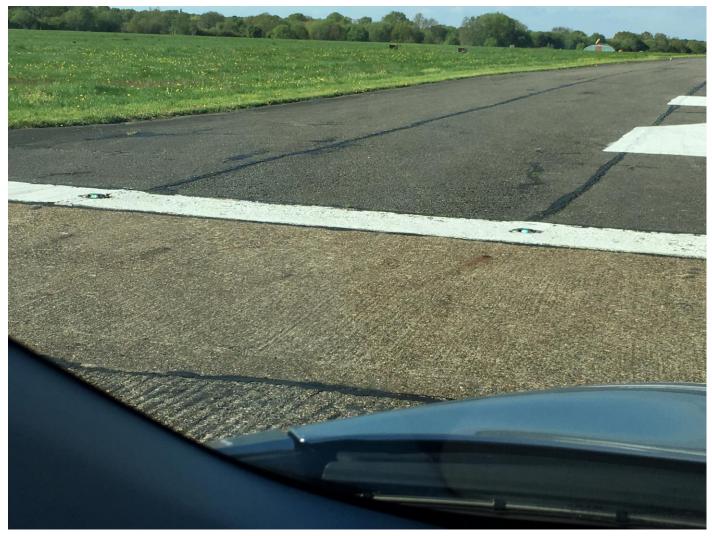
The declared distances for runway 06 LDA were found to be incorrect. For runway 06 LDA they are declared to the runway end lights, but these are not at the end of pavement which is where LDA is measured to. The airport should either reduce LDA to 747m or move the runway end lights.

- Amending CA1560C to show that the LDA ends at the end of the paved surface, thus retaining an LDA of 760M.
- b) Inserting into the AIP, EGTF AD 2.20 Local Traffic Regulations, a warning to the effect "Caution, the LDA and paved surface for runway 06 ends 13 metres beyond the runway end lights".

c) Submitting an AIP change to update the Aerodrome Chart at AD 2-EGTF-2-1 to correctly depict the location of the runway end lights.
