*International Civil Aviation Organization***Tenth Meeting of the Surveillance Implementation  
Coordination Group (SURICG/10)***Bangkok, Thailand, 21 - 23 April 2025*

**ANALYSIS OF ABNORMAL TRACKS CAUSED BY  
ELECTROMAGNETIC ENVIRONMENT**

(Presented by China)

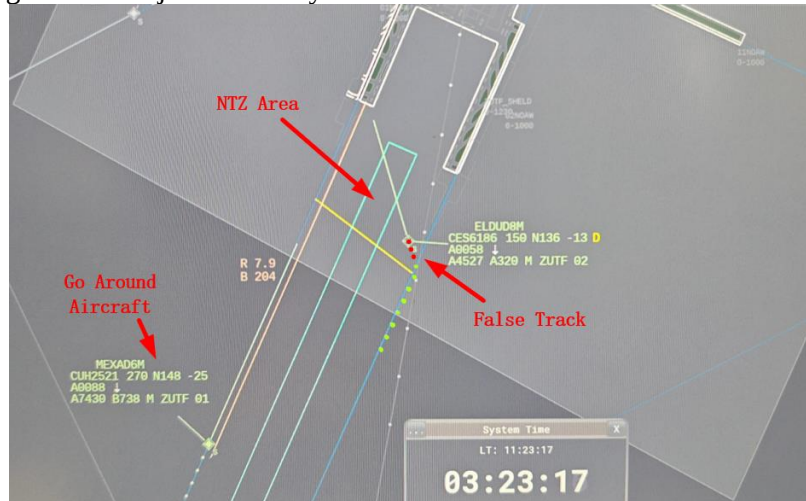
2.1 In February 2024, during the independent parallel instrument approach, a radar generated erratic tracks due to the occlusion of trees, which mismatched the turning mechanism of the automated system, and generated a false target turn to the adjacent runway, resulted in the go-around of subsequent flight on the adjacent runway.

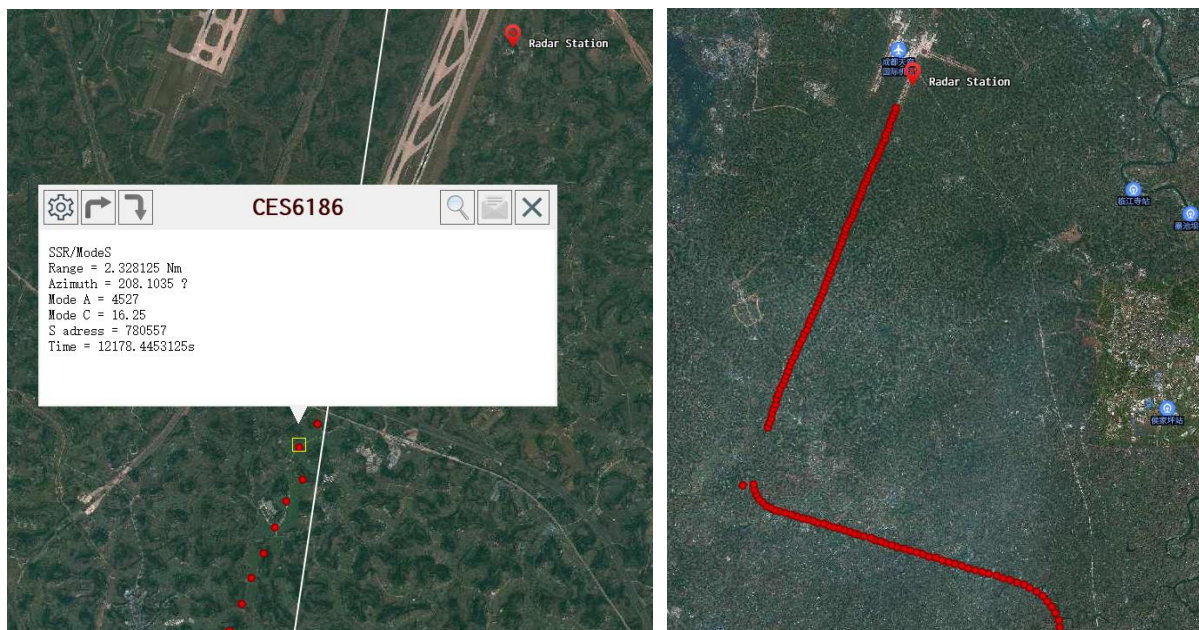
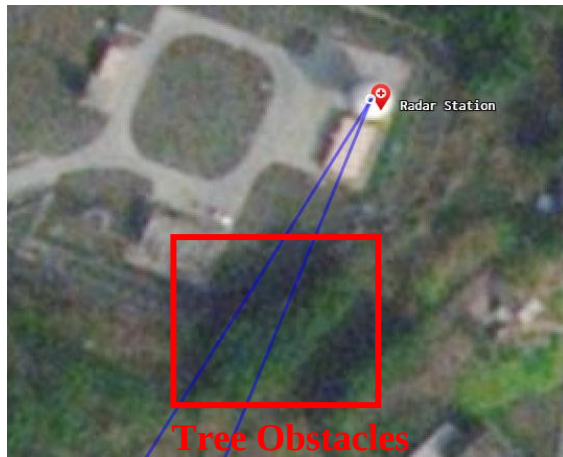
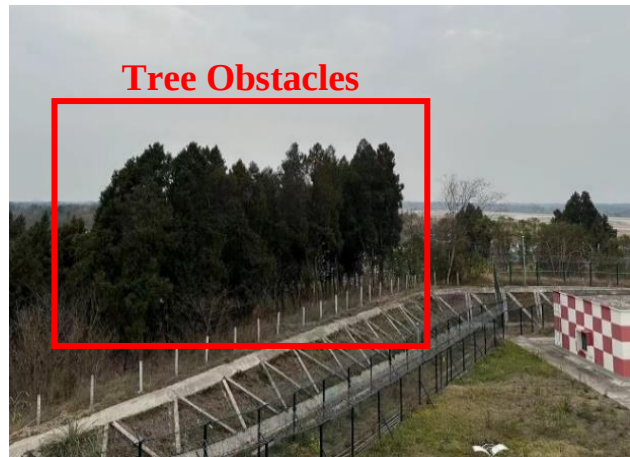
2.2 It was caused by the occlusion of trees. Further analysis found that targets missed in the direction of trees occlusion. The quality of track was greatly improved after clearing the trees.

Target missing and erratic track caused by Trees occlusion

2.5 In order to timely detect and deal with the illegal construction or trees occlusion, China has carried out electromagnetic environmental protection monitoring based on AI technology, by setting up cameras and laser rangefinders on the radar tower, automatically identify building construction, calculate the obstructing angle of trees, and provide early warning information.

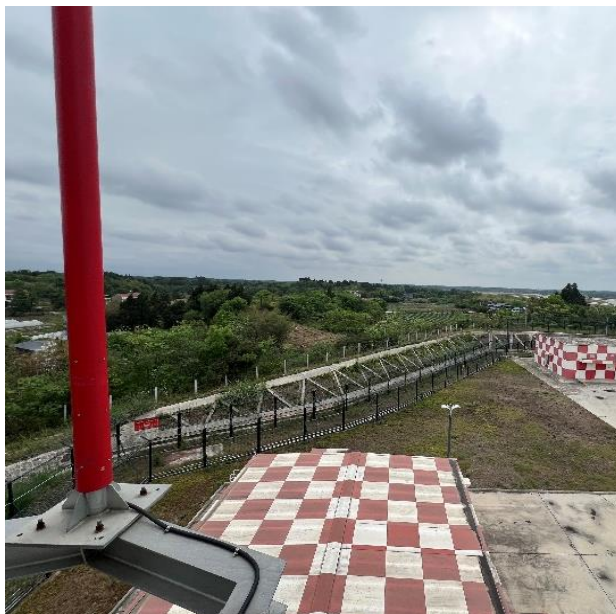
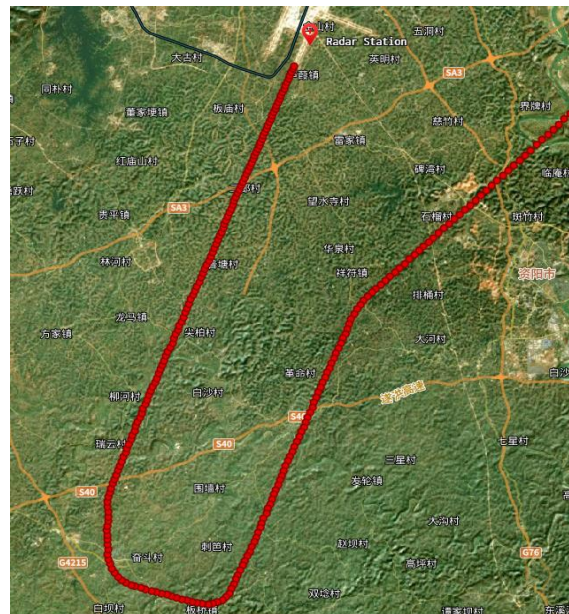
The quality of track was greatly improved after clearing the trees

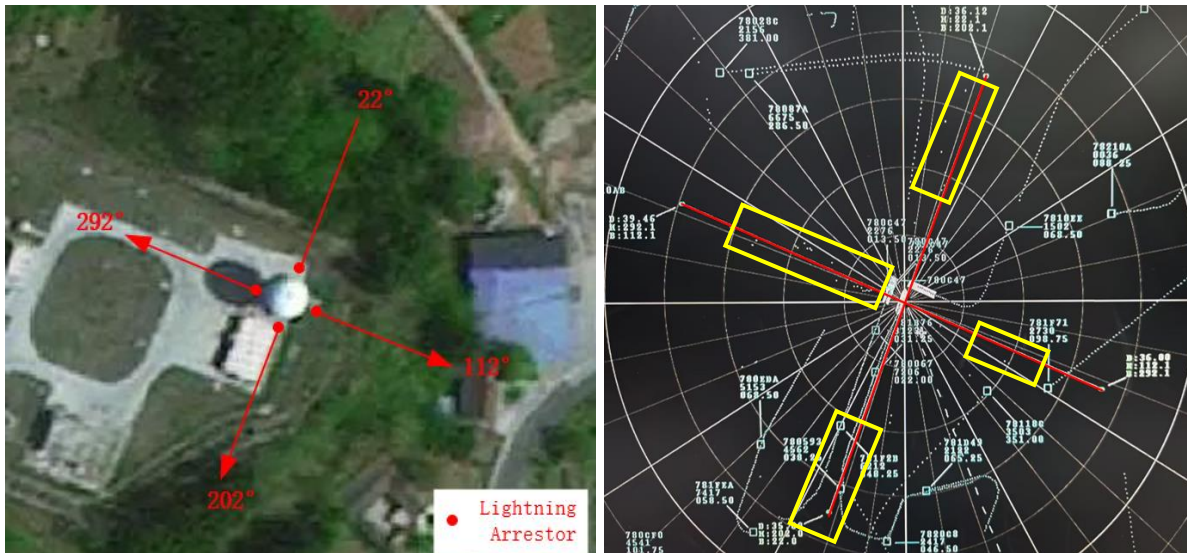
2.3 In the direction of lightning arrestor, the track is erratic, and some reflection plots can be observed. Once the tracks are generated, it will result in reflection targets.

2.4 There is a lack of research and guidance on the impact of lightning arrestors for ATC radar. According to data analysis, the impact of lightning arrestors on radar is larger than the actual obstructing angle, even up to  $\pm 5^\circ$ .

2.6 It is recommended that the installation of lightning arrestors should be carefully decided during the design period to reduce the influence:

- 1) The installation angle of the lightning arrestors for terminal radar should consider the direction of the runway to avoid obscuring the upwind or final of the runway;
- 2) The installation angle of the lightning arrestors for route radar should avoid along with the route as much as possible;
- 3) The installation position of the lightning arrestors should be as far away from the radar antenna as possible while meeting the requirements of lightning protection.

2.7 It is recommended to research the impact of lightning arrestors material, thickness, etc. on radar based on surveillance radar frequency and operating characteristics, develop relevant standards and specifications to guide the installation of lightning arrestors.
