**Tenth Meeting of the Surveillance Implementation  
Coordination Group (SURICG/10)**

## **UPDATE ON IP/18 SURICG/9 CHALLENGES FINDING THE CAUSE OF NON-COMPLIANT ADS-B DATA**

(Presented by New Zealand)

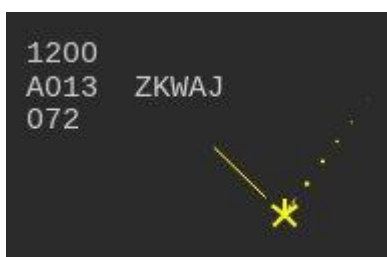
2.1 ADS-B transponder type “Y” is being detected outputting NACp, NIC and NACv ZERO with a SIL of THREE. This is non-compliant ADSB data under NZCAA rule 91 and cannot be used for Surveillance Separation. When the non-compliant ADS-B data occurs, an ADS-B alert is generated to controllers – either a yellow starfish RPS for targets in ADSB-only airspace or a Degraded ADSB Data (DAD) alert for aircraft in airspace covered by both ADSB and either MLAT or MSSR.

Example of a degraded alert on ADS-B only target

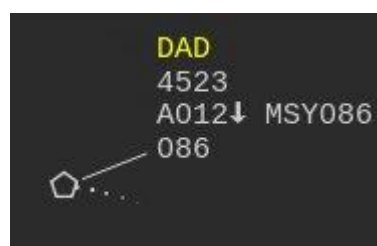
Example of a DAD alert on a non-correlated target
