The Tenth Meeting of the Aerodromes Operations and Planning Sub-Group (AOP/SG/10)

*Bangkok, Thailand, 10 to 14 August 2026***Agenda Item 5: State's/Aerodrome Operator's update and best practices****RUNWAY MISALIGNMENT DURING NIGHT AND LOW-VISIBILITY OPERATIONS:  
HUMAN FACTORS, AERODROME GEOMETRY AND VISUAL GUIDANCE  
MITIGATION**

(Presented by AIRPORTS AUTHORITY OF INDIA, INDIA)

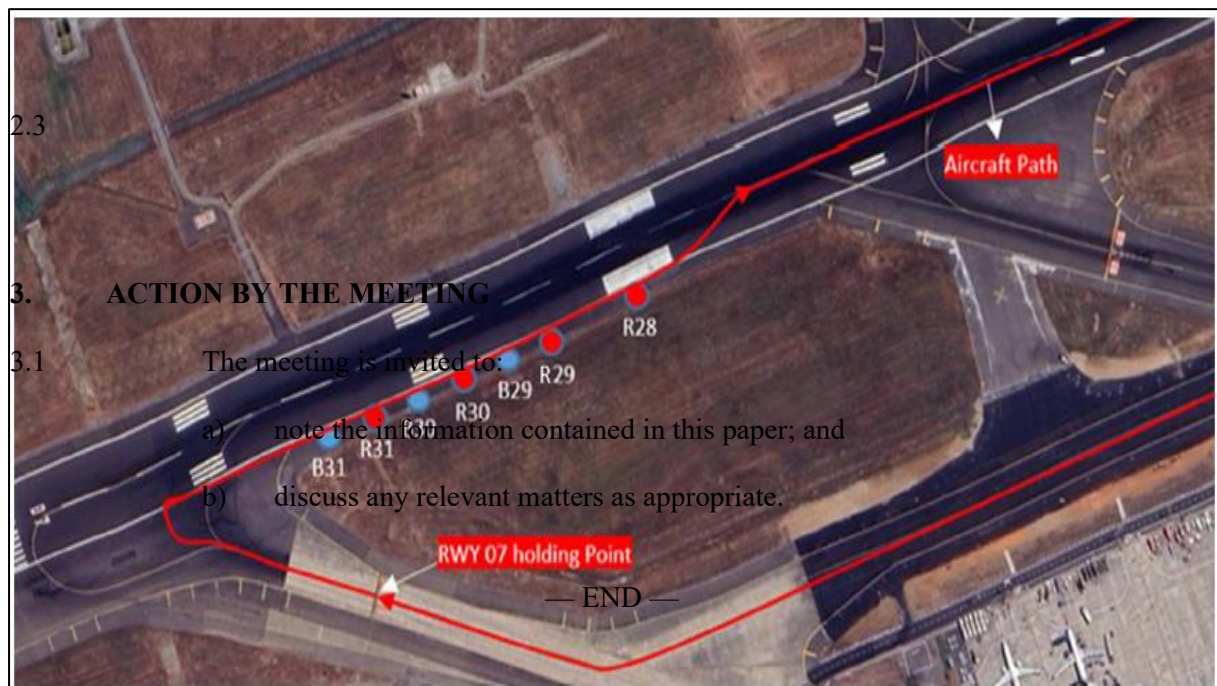
2.1 On 25 February 2025, during night operations, an Embraer EMB-170 entered Runway 07 at Chennai International Airport via Taxiway K. During line-up, the aircraft deviated from the designated lead-in guidance, aligned close to the right-hand runway edge and commenced the take-off roll while laterally displaced from the runway centreline. ASMGCS data, tyre marks and flight-recorder data showed that the aircraft travelled approximately 360 meters before its alignment was corrected towards the runway centreline. Seven runway edge lights were damaged. The aircraft continued the flight and landed safely at its destination, with no injuries and aircraft damage.

2.2 The investigation found that the runway lighting and markings complied with the applicable requirements and that weather was not a factor. The sequence nevertheless exposed several human performance vulnerabilities. The Pilot Monitoring was conducting the before-take-off checklist during line-up. The Pilot Flying was steering and handling the take-off clearance. The aircraft began rolling before the Pilot Monitoring had fully returned attention outside. He detected the edge lights through peripheral vision and called for a correction after the take-off roll had commenced. The commander was also operating to Chennai for the first time and had not received the airport familiarisation required by the operator. Crew feedback indicated that the before-take-off checklist was being completed during line-up and that the lateral displacement was detected only after the take-off roll had commenced.

Figure 1. A-SMGCS playback showing the aircraft path from Taxiway K to the right edge of Runway

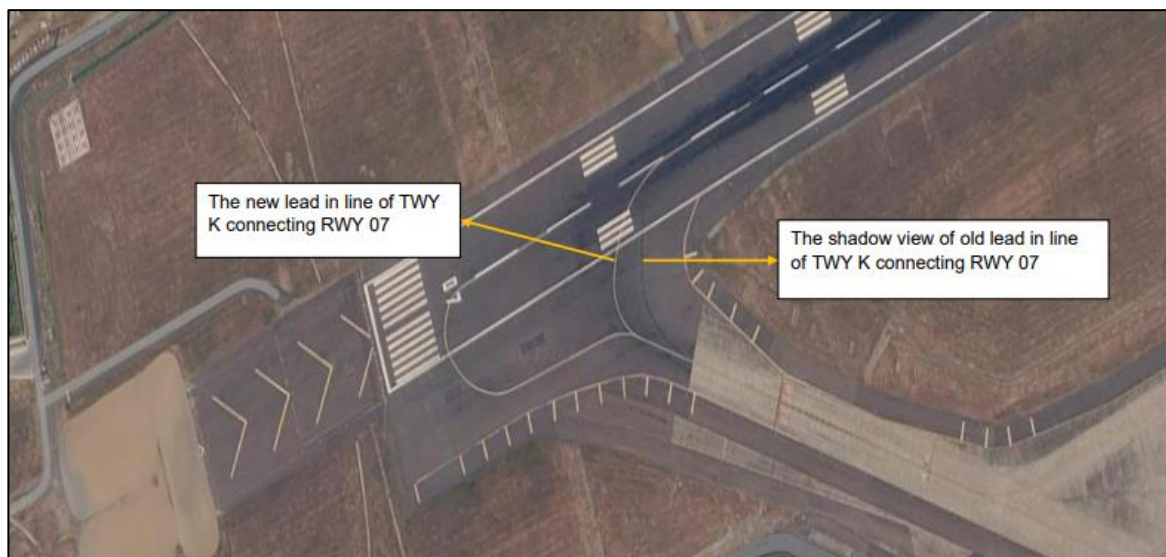
2.3 Airline operators had previously reported concerns about the conspicuity of the lead-in guidance at this entry. Following the occurrence, the aerodrome operator realigned the lead-in marking, used retro-reflective material and assessed additional centre line lighting. The before-and-after geometry shown in Figure 2 also illustrates a broader lesson. Erased or displaced lines, residual shadows, and adjacent guidance paths can continue to influence perception even after a marking has

been changed. The operational effect must be checked from the cockpit view, not only from an engineering plan or a vehicle inspection.

Figure 2. Previous and revised Taxiway K lead-in marking connecting to Runway 07.

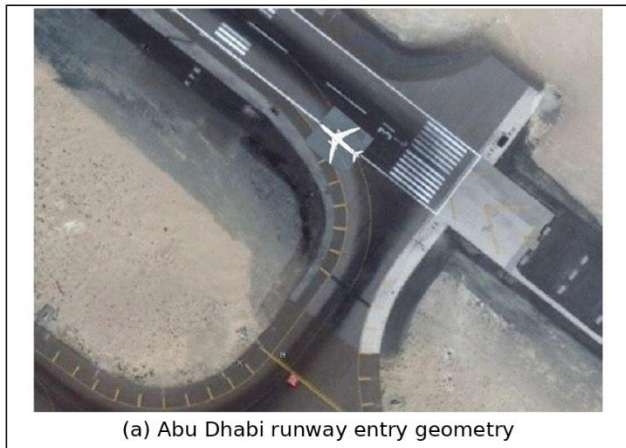
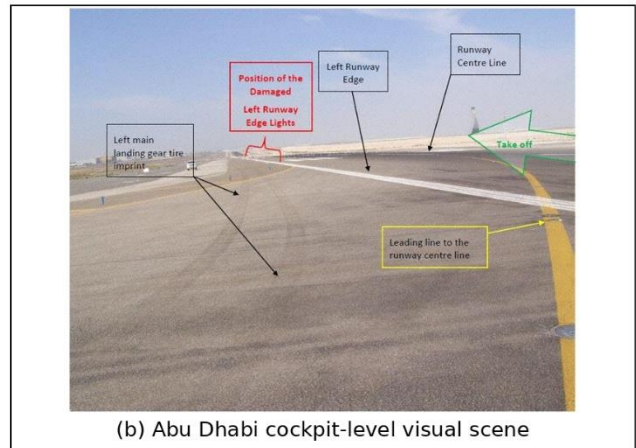
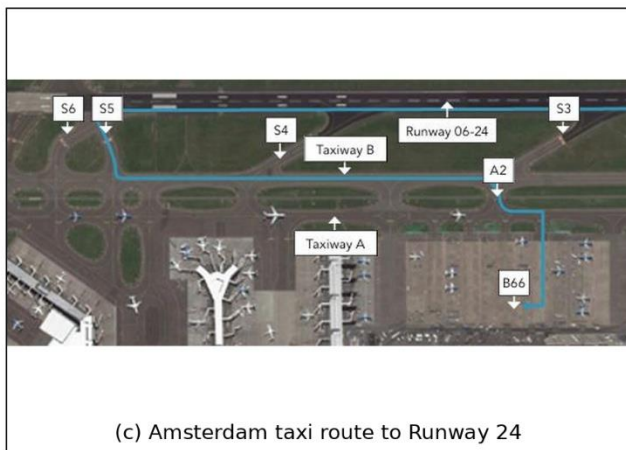
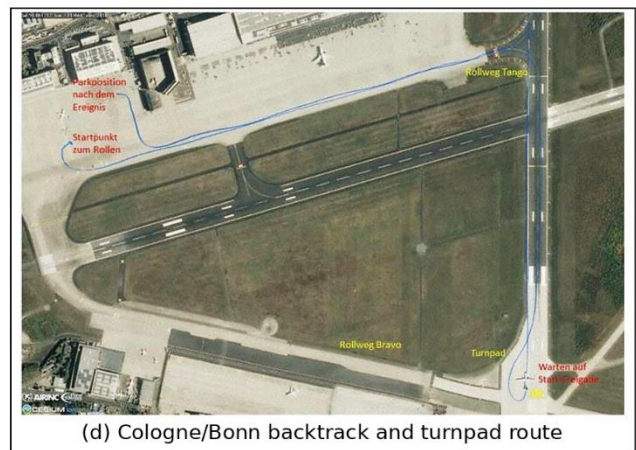
2.4 The Chennai occurrence is consistent with a recurring international pattern. The selected investigations in Table 1 involved different aircraft types, States and operating conditions. In each case, the crew followed a plausible but incorrect line of guidance. The events also show that the hazard can occur in low visibility or in otherwise good night weather, and during direct runway entry, a large-angle turn, backtrack or turn pad operations.

Figure 3. Selected runway entry geometries and visual scenes from international investigations.
