The Eighth Meeting of the Asia/Pacific
Aerodrome Assistance Working Group (AP-AA/WG/8)

SAFETY IMPLICATIONS OF RUNWAY MARKING OVERPAINTING ON RUBBER-CONTAMINATED SURFACES: RESULTANT FOREIGN OBJECT DEBRIS (FOD) RISKS AND MAINTENANCE CONSIDERATIONS

(Presented by AIRPORTS AUTHORITY OF INDIA, INDIA)

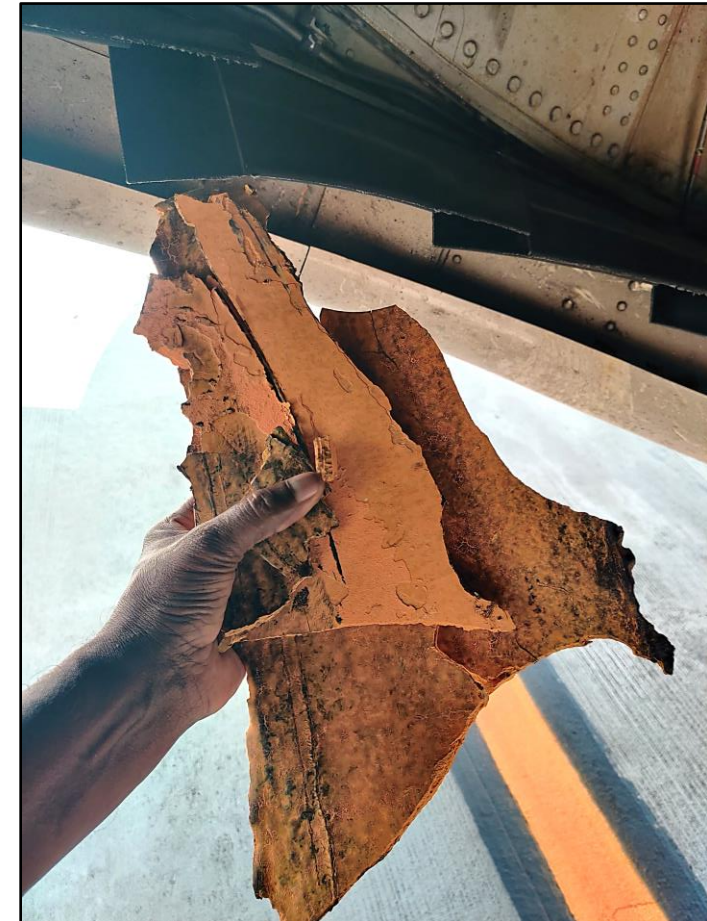
- I. At approximately 2220 hrs, information was received from a KLM engineer regarding the arrival aircraft SQ528 (9V-SCJ), which was parked at Stand 29. The aircraft was found to have puncture-like scratches/damage on its belly, specifically near the left air conditioning access panel (Panel No. 195C). Upon investigation, it was observed that the aircraft belly had punctures at four locations, with yellow paint chips present inside the affected areas. Subsequently, a detailed inspection of the runway and taxiway routing was carried out. While no FOD or loose paint chips were detected during the inspection, certain sections of the runway were found to have accumulated layers of paint. It was also noted that, at a few locations, the paint could potentially dislodge if subjected to manual force.

Operational Impact : High speed tape was applied at the punctured spots. Aircraft having STD:2325 hrs, departed at 0017 hrs.

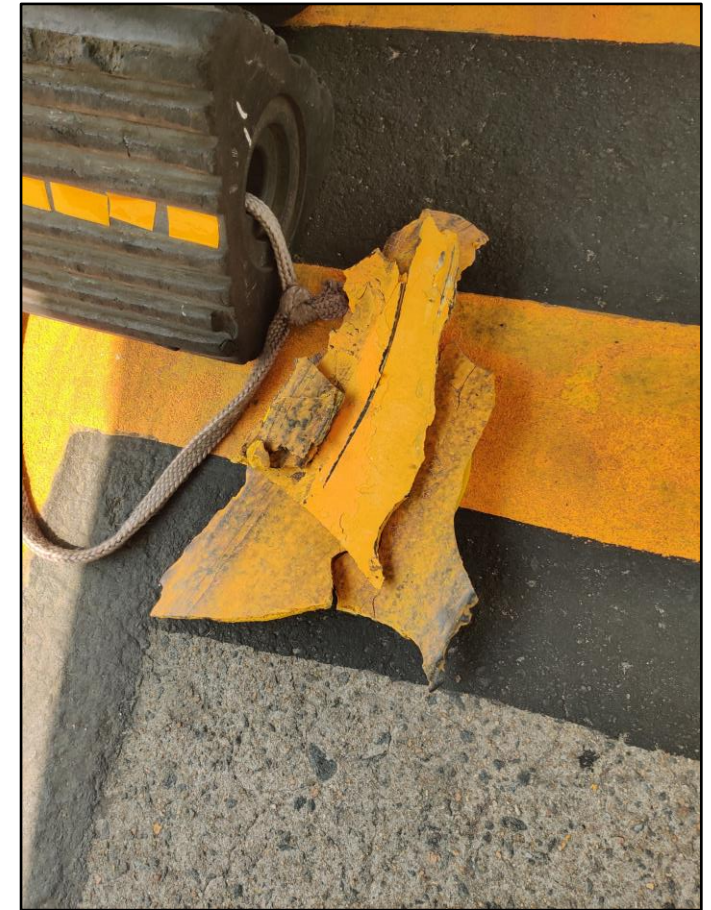
- II. A Foreign Object Debris (FOD) incident was reported involving aircraft VT-YBF operating flight QP-1305 (IXZ–MAA) on 12.11.2025. Upon arrival, paint flakes were observed in the aircraft's wheel well. Immediately after receiving this information, operational jeep carried out a detailed inspection of the aircraft's Runway–Taxiway movement route. No FOD was detected along the inspected route. However, an area between Taxiway P and Taxiway V was identified where the taxiway guideline marking had multiple layers of paint. Although no loose paint material was found at the time of inspection, the condition of the marking was noted. This location lies approximately 0.375 meters to the left of the centerline of Runway 07.

Operational Impact: The aircraft experienced a ground delay of approximately one hour for inspection.
