**ELEVENTH MEETING OF THE SURVEILLANCE  
IMPLEMENTATION COORDINATION GROUP  
(SURICG/11)**

**UPDATE ON IP/07 SURICG/10 CHALLENGES FINDING THE CAUSE OF  
NON-COMPLIANT ADS-B DATA AND GPS INTERFERENCE**

(Presented by New Zealand)

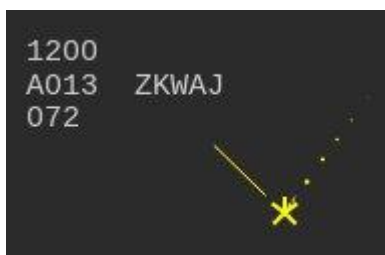
2.1. ADS-B transponder type “Y” has been detected outputting NACp, NIC and NACv ZERO with a SIL of THREE. This is non-compliant ADSB data under NZCAA rule 91 and cannot be used for a Surveillance Separation service. When the non-compliant ADS-B data occurs an A-DSB alert is generated to controllers as either a yellow starfish RPS (for targets in ADS-B only airspace), or a Degraded A-DSB Data (DAD) alert (for aircraft in airspace covered by both ADS-B and either MLAT, or MSSR).

Example of a degraded alert on ADS-B only target

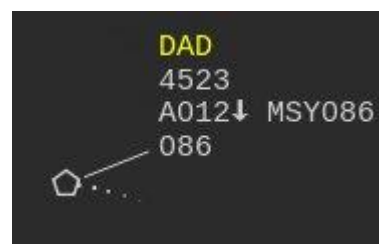
Example of a DAD alert on a non-correlated target.

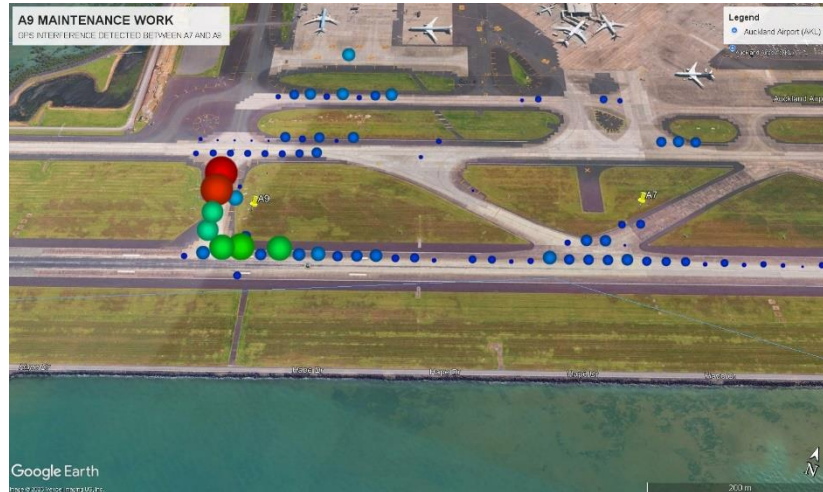
- 2.8. During this period Airways ran daily analysis of all ADS-B data for NZAA airport and plotted the data using Google Earth to show where the interference was detected. Analysis showed a wider issue than initially thought, with several different airlines and aircraft types subject to

2.9. Due to the summer holiday no maintenance work was conducted from Dec 20th, 2025, to Jan 13th, 2026, which saw the issue disappear. However, a resumption of airfield maintenance work on Jan 13th, 2026, around A3, saw the issue reappear between A2 and A4.

Example of where GPS interference occurred to airline traffic.

2.10. MBIE was called onsite again and found a contractor vehicle emitting a signal level likely to cause potential GPS interference. The vehicle was kept offsite while checks occurred around A3 to confirm no GPS interference was occurring. During this time, the vehicle left the airfield. It returned later and was checked again. No potential GPS interference was detected.

2.11. It was determined later that the vehicle’s company was using a GPS tracker to ensure they were always aware of the position and speed of its vehicles. The company was asked to disconnect the GPS tracker of any vehicles operating at NZAA and, since this has occurred, the issue has stabilized.
