ADT equipage in aircraft

ICAO EUR/APAC SAR WORKSHOP 2024
Export Control - Not technical
ADNS X3134PR2406502

COMMERCIAL AIRCRAFT

Peter Walther, Certification Manager RALS
03 September 2024

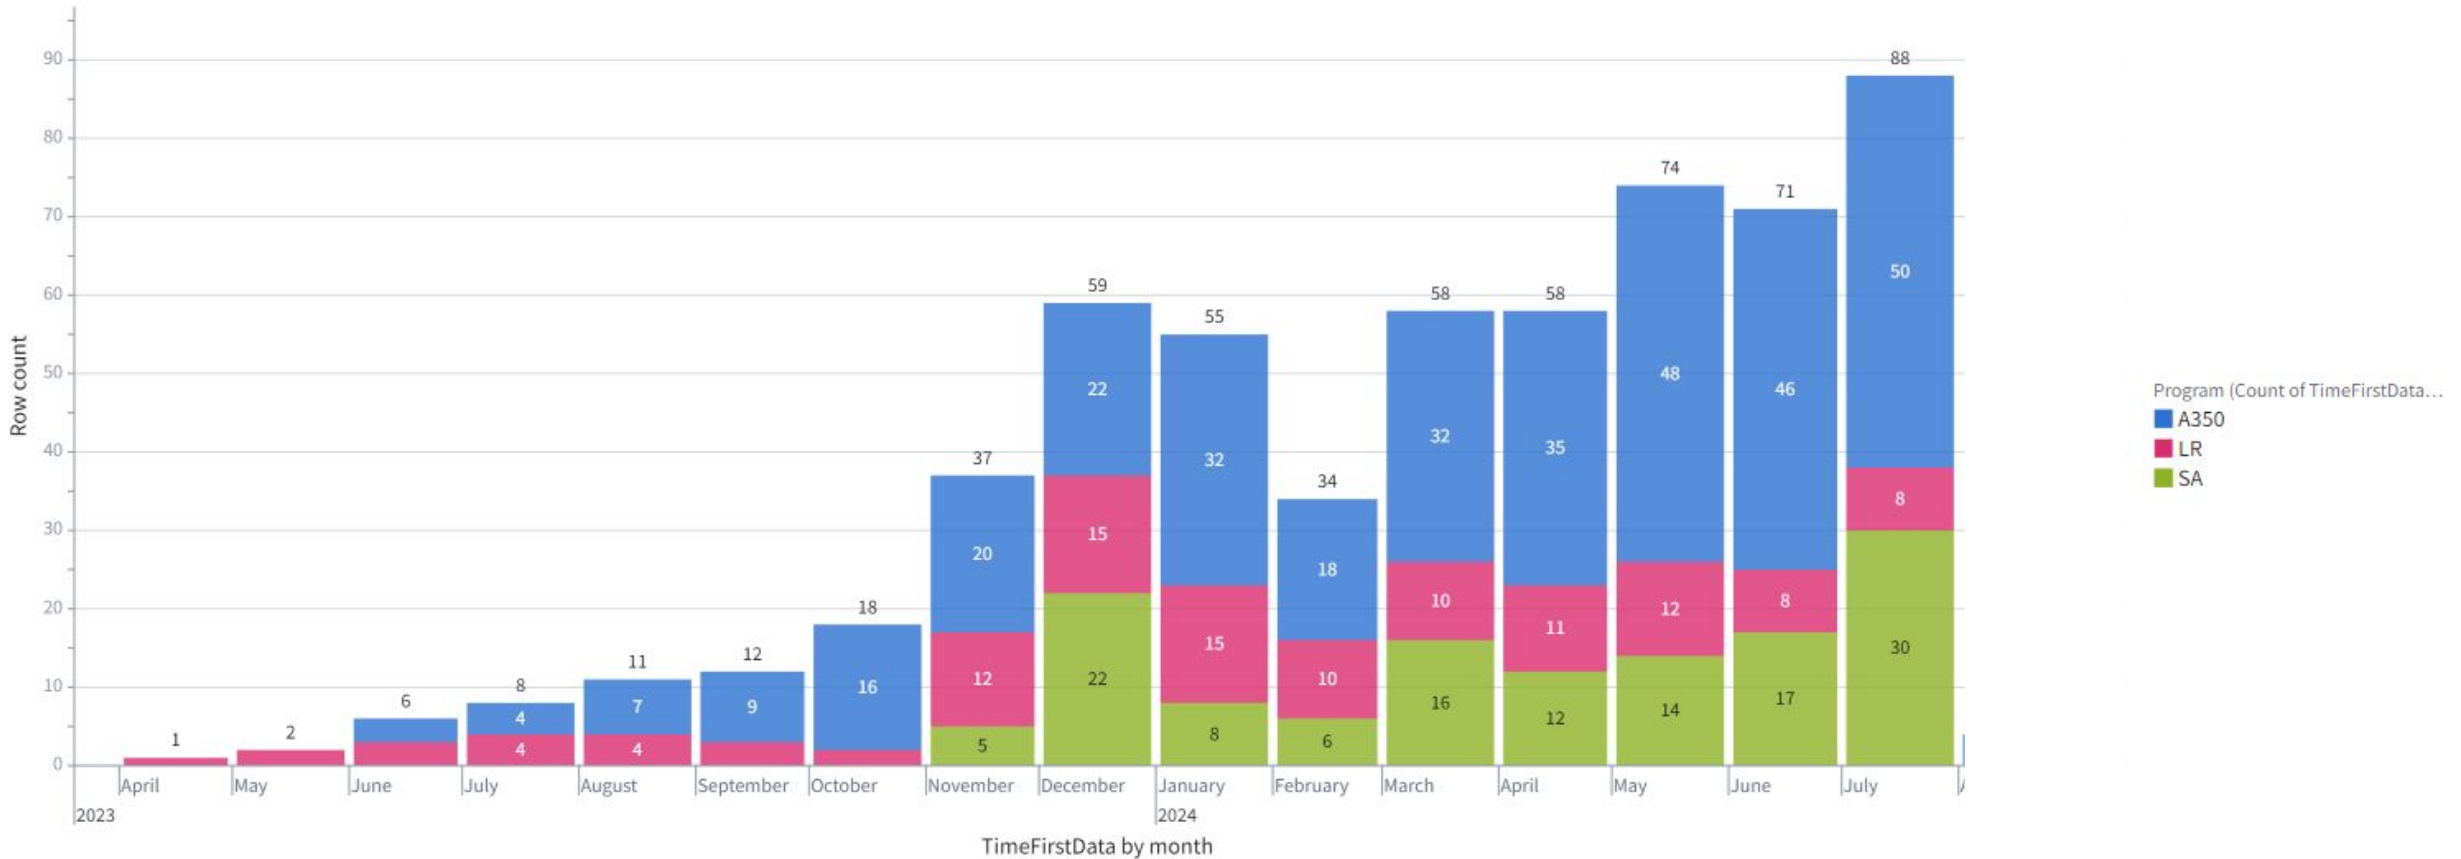
Inadvertent ELT-DT activations per month (autonomous activations only) (until 02.08.)

- **Based on COSPAS / SARSAT data as per 02.Aug.2024:**
 - **1161 transmission events from Airbus ELT-DTs were detected since 1st a/c delivery in April 23**
Remark: Until end of July 2024 Airbus delivered a total number of 437 aircraft equipped with ELT-DT
-> 588 new events since last status provide in April 2024
- All inadvertent transmissions (Manual / Automatic / Autonomous) started on ground
- One activation in flight linked to temporary loss of 28V emergency power during flight / considered as 1st autonomous activation started in flight as loss of ELT-DT emergency power supply is a defined trigger reason, hence it is considered as justified alert
- Some operators have several issues, while others less or even none

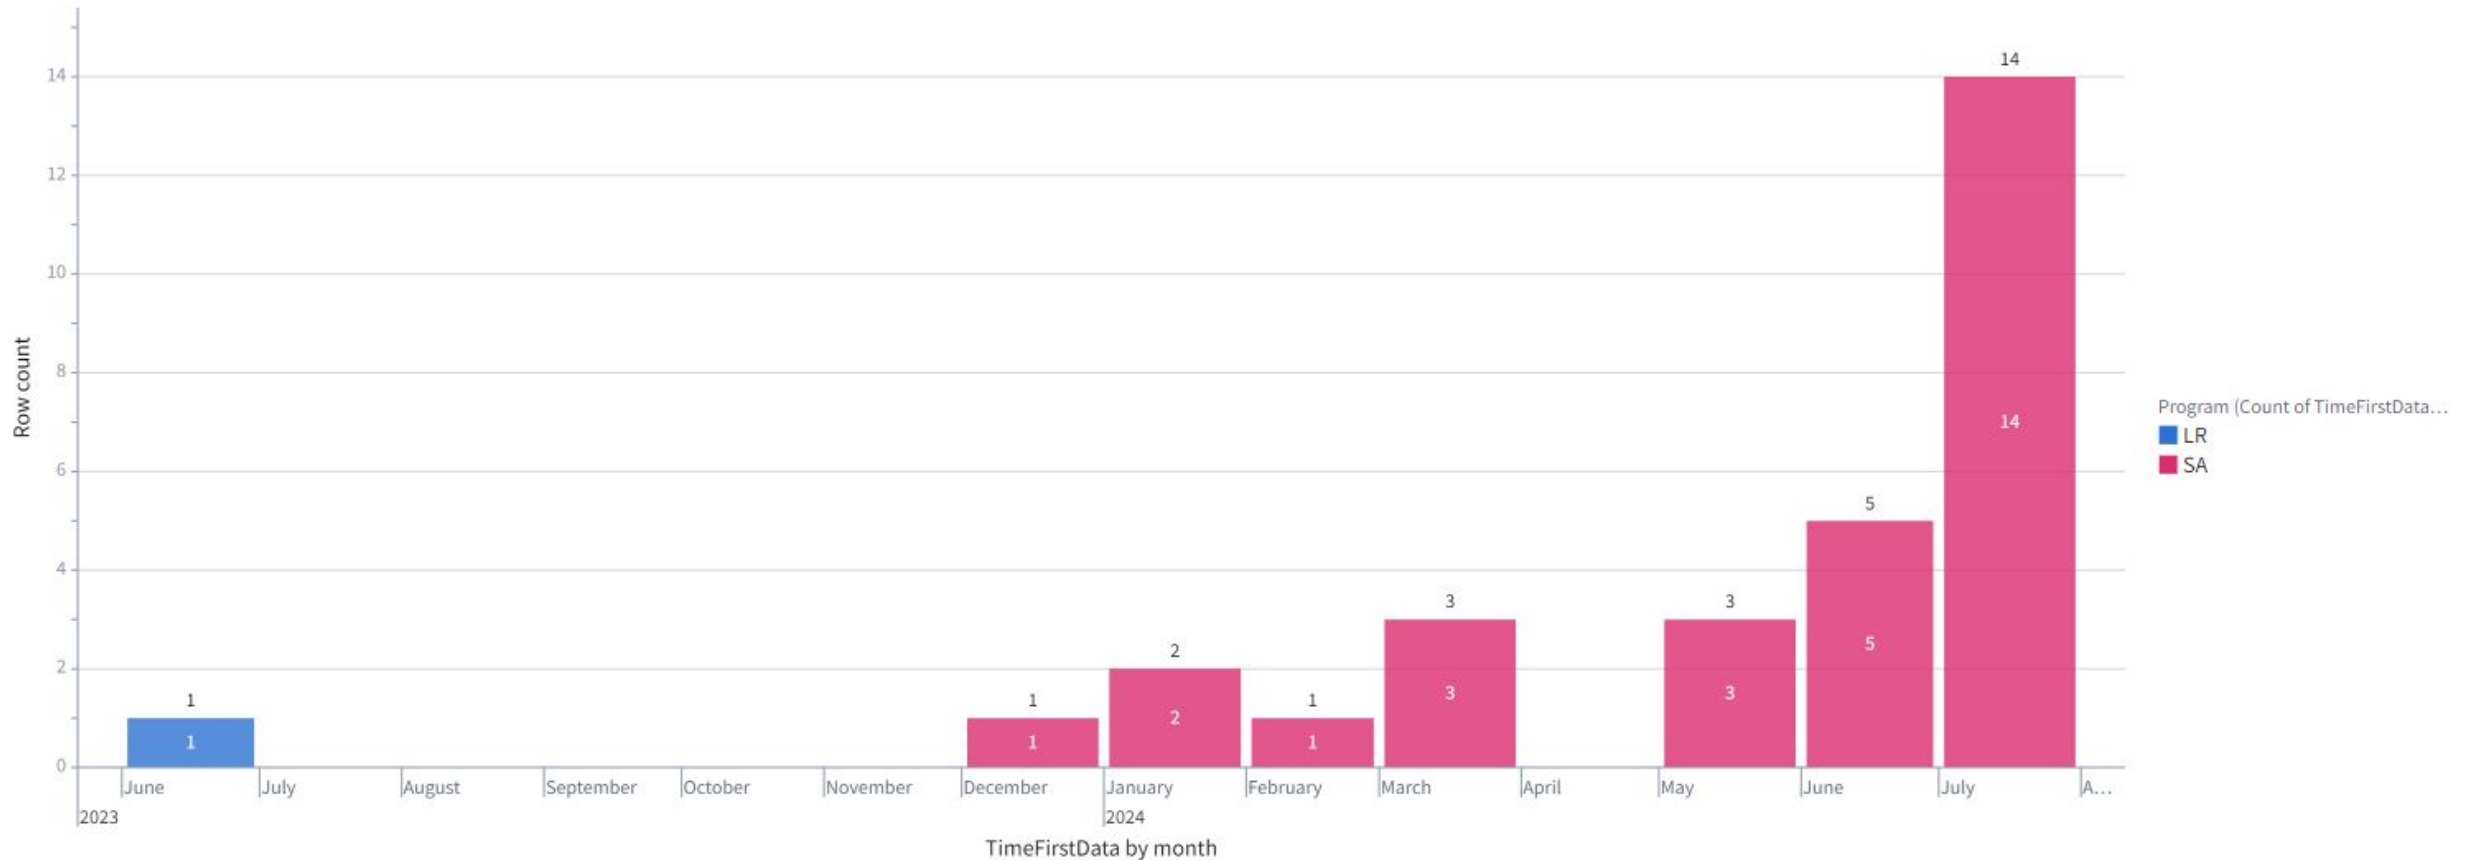
Inadvertent ELT-DT activations per month (automatic activations only) (until 02.08.)

(Note: In total 14 activations (May (1), June (2) and July (11)) could be traced down to a single unit installed on A320 MSN 11859. This ELT has been replaced and sent to Safran to be analyzed)
