# Runway Markings

Operational Safety

Captain Samir Ferreira

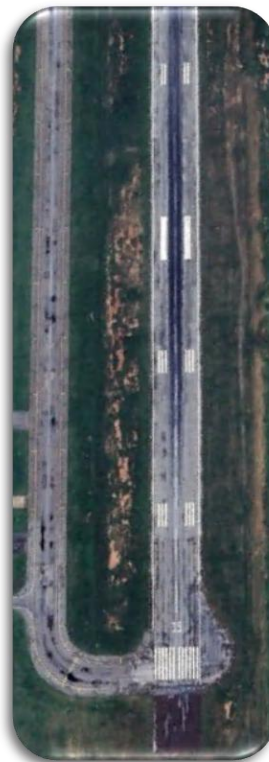
**CGB  
RWY 35  
2026**

## Find the Error!

Incorrect aiming point placement is a key contributing factor to Deep Landing occurrences.

Creation of a reduced Runway LDA in the Performance Softwares for SLZ 06 and CGB both runways.

Heads up for the pilots, letting them know about the wrong runway markings.
