# SAFETY ALERT

**Title: Lateral Deviations from ILS Track at SPJC.**

**Source: PCAST Misleading Task Force.**

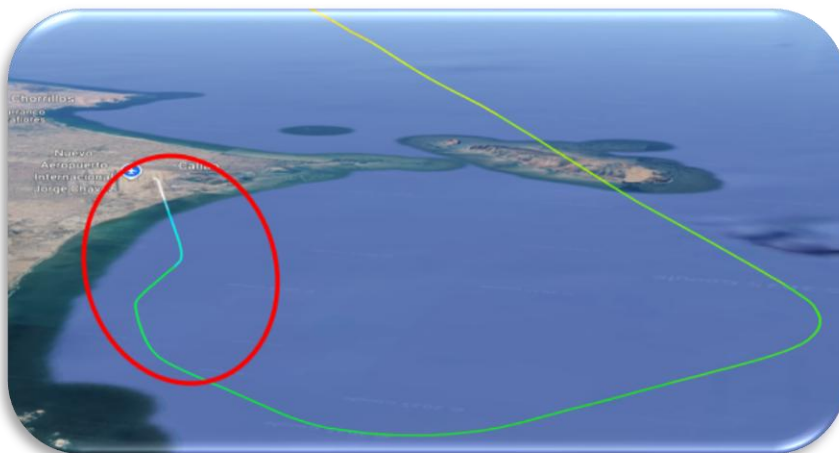
Reports have been received from flight crews and ATC describing events involving lateral deviations from the **ILS RWY 16R** track toward the **ILS RWY 16L** track during approach to **Lima Airport (SPJC)**..

In southbound approaches, when vectored to intercept the ILS RWY 16R and after pressing the APPROACH pushbutton, the FMGS entered LOC\* mode of ILS RWY 16L, despite the ILS RWY 16R being properly programmed in the MCDU.

*Ilustración 1. Flight trajectory recorded*

- **Strict adherence to current SOPs**, including verification of radio aids and frequencies programmed into the FMGS for the intended approach.
- **Maintain effective CRM** and continuous monitoring of automation and navigation system behavior throughout all phases of flight.
- **Review the "Temporary Abnormal Behaviors"** section in the aircraft manufacturer’s manuals, particularly regarding unexpected mode reversion or system behavior. Consider manual ILS frequency tuning ("hard tuning") as appropriate.
- **Foster a proactive safety culture**, recognizing and addressing the operational consequences of potential deviations.
- **Apply the Golden Rule: Take action if things do not go as expected.**
- **Immediately notify ATC** if an uncommand deviation from the cleared ILS approach path is suspected.
