COMANDO DA AERONÁUTICA
CENTRO DE INVESTIGAÇÃO E PREVENÇÃO DE
ACIDENTES AERONÁUTICOS

FINAL REPORT
A-091/CENIPA/2019

OCCURRENCE:	ACCIDENT
AIRCRAFT:	PR-MPN
MODEL:	ATR-42-320
DATE:	15JUN2019

This Final Report pertains to the 15 June 2019 accident involving the model ATR-42-320 aircraft of registration marks PR-MPN. The occurrence was typified as “[SCF-NP] System/Component Failure or Malfunction (Non-Powerplant).”

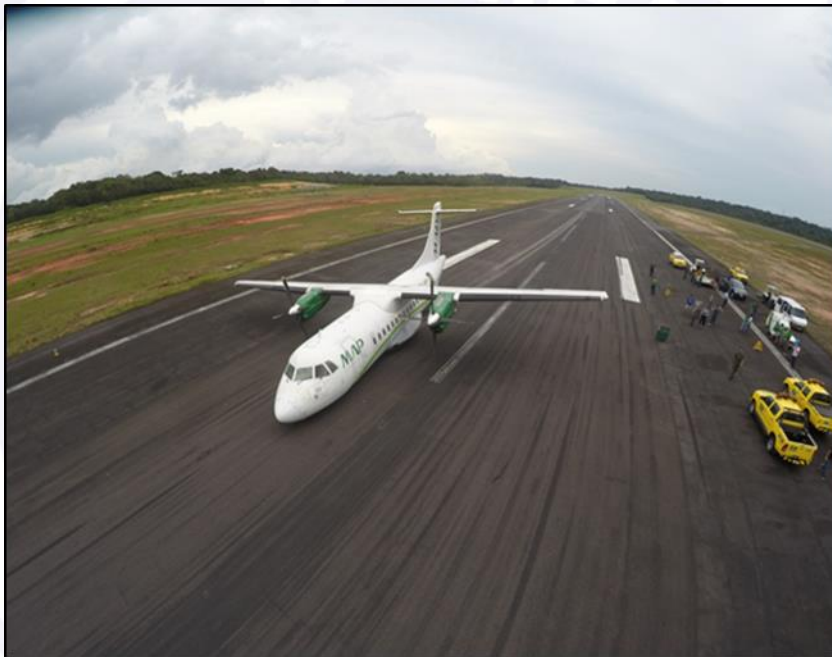
The aircraft landed with all three landing gear legs retracted.

Figure 1 - View of the aircraft after landing at SBEG with the landing gear retracted.

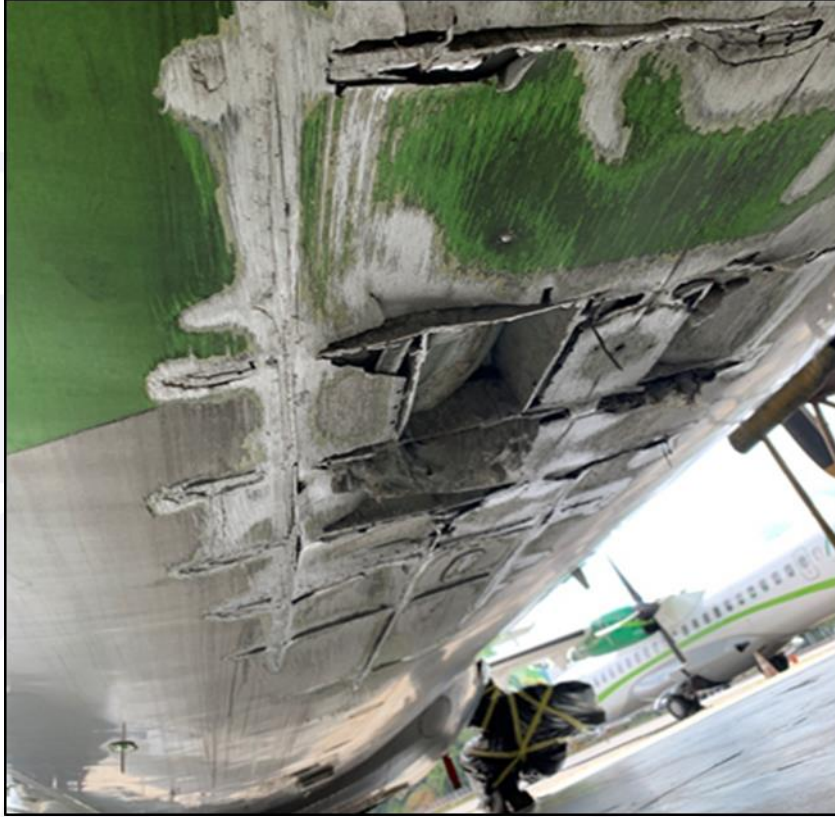
Due to ground friction during the landing with the landing gear retracted, there was substantial damage to the underside of the fuselage, as shown in Figures 2 and 3.

Figure 2 - Damage to the central underside of the fuselage.

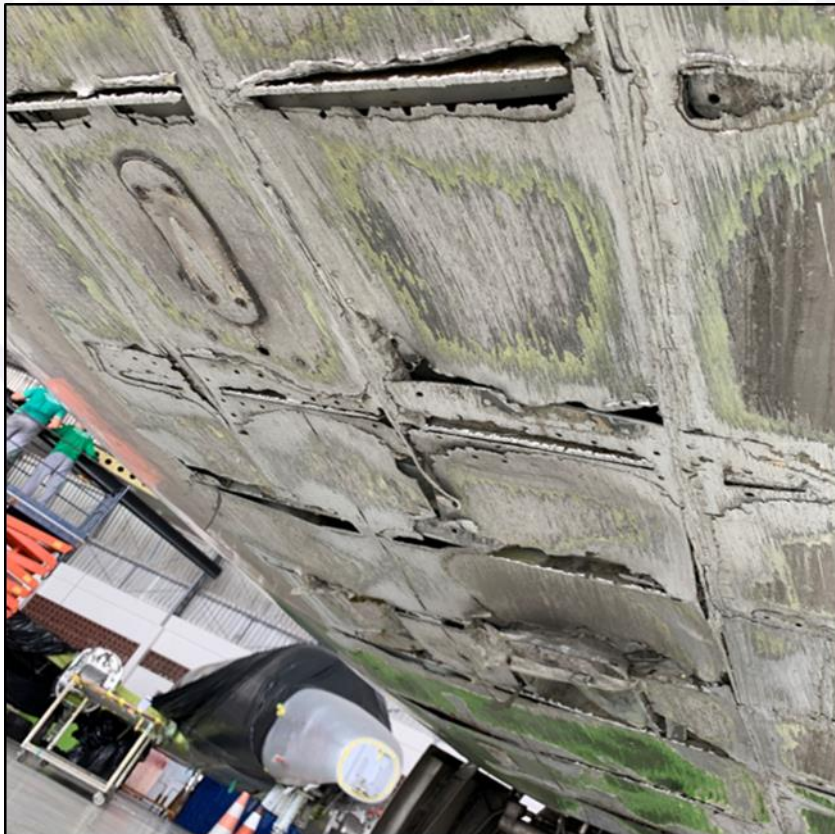
Figure 3 - Damage to the forward underside of the fuselage.

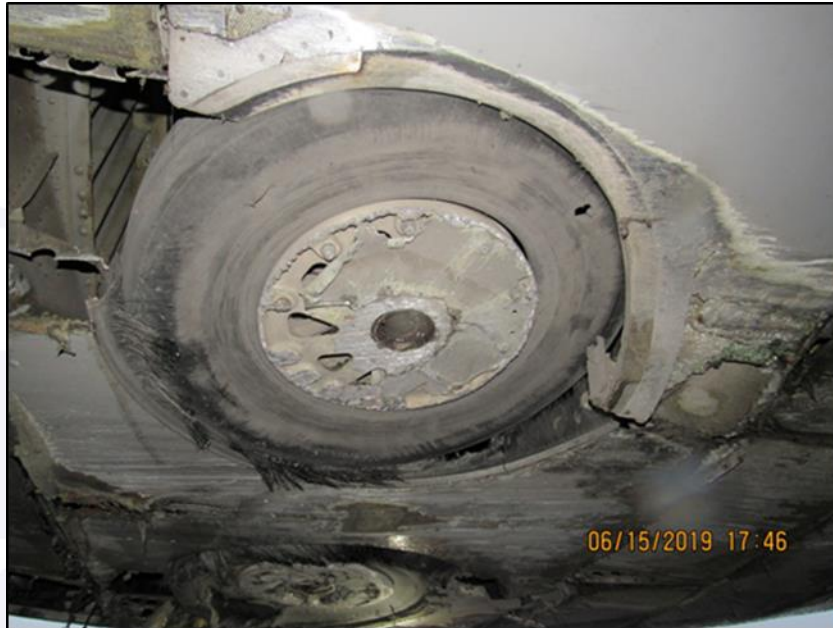
Damage was also observed on the landing gear doors, wheels, and tires of the aircraft (Figure 4).

Figure 4 - Damage to the wheels, tires, and landing gear doors.

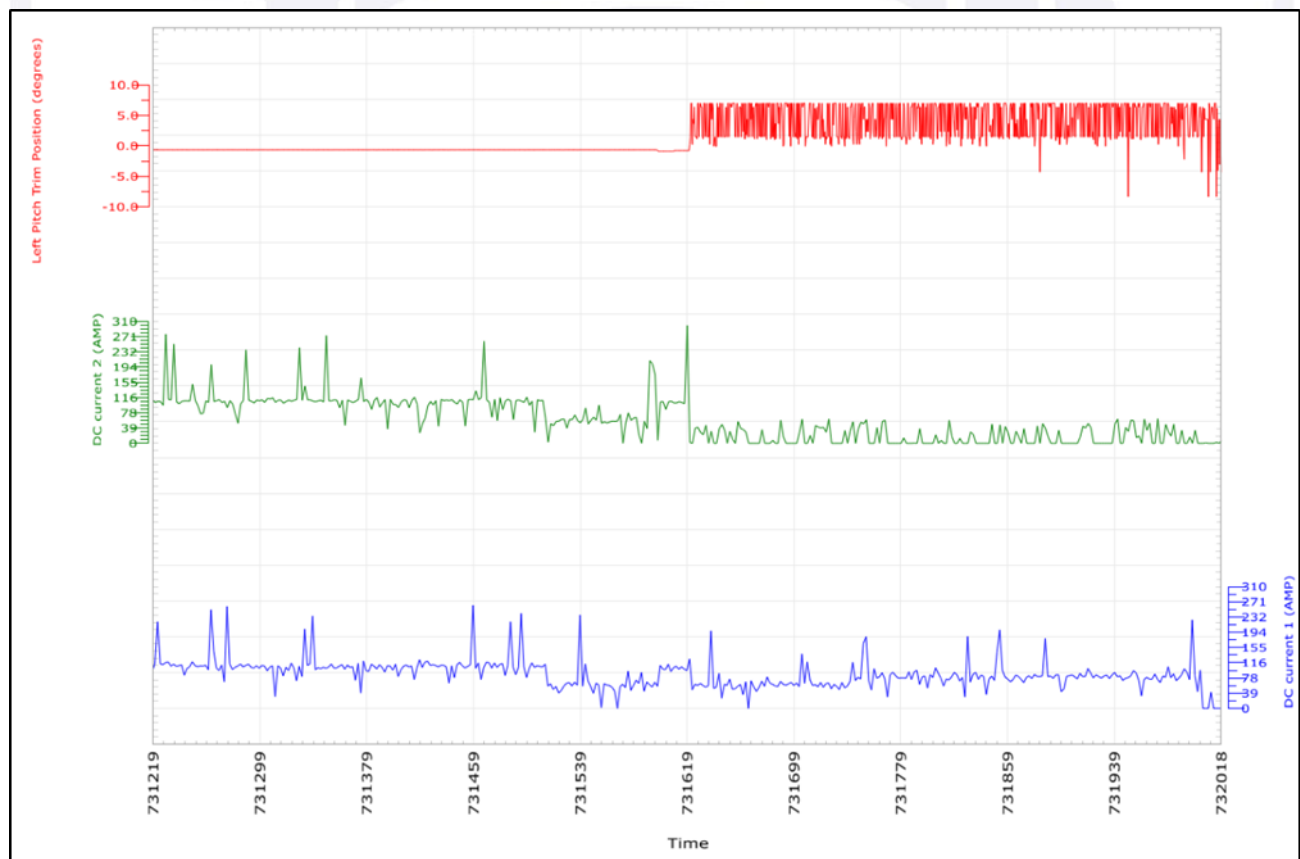
Lastly, it was observed that approximately six seconds after the onset of the electrical failure (16:39:43 UTC), multiple abrupt variations occurred in the parameters of the left elevator trim tab, which persisted until the end of the recordings.

Figure 14 – Extracted FDR data related to the left elevator trim tab indication.

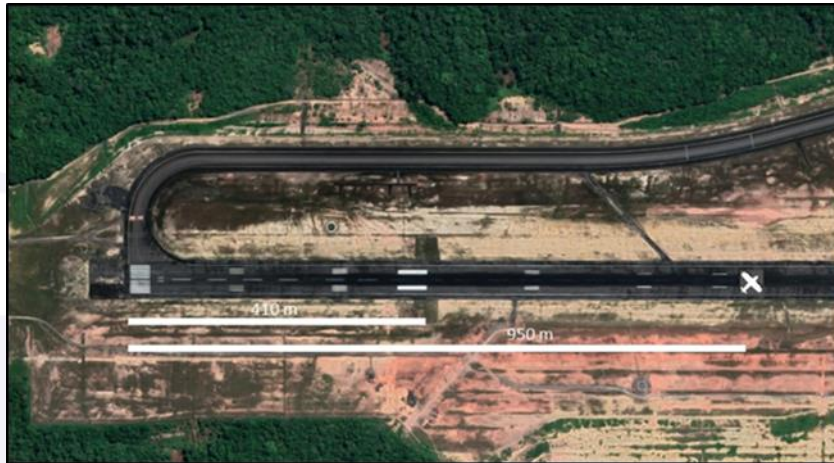
The friction marks resulting from the aircraft's contact with the ground extended approximately 540 meters from the initial point of impact until the full stop, which occurred at a distance of 950 meters past the threshold of runway 11 (Figure 15).

Figure 15 - Sketch of the touchdown point and aircraft movement on the runway at SBEG.

The level of damage to the fuselage, caused by abrasive friction against the asphalt surface, indicated that the aircraft had a high horizontal velocity and a low rate of descent at the moment of impact.

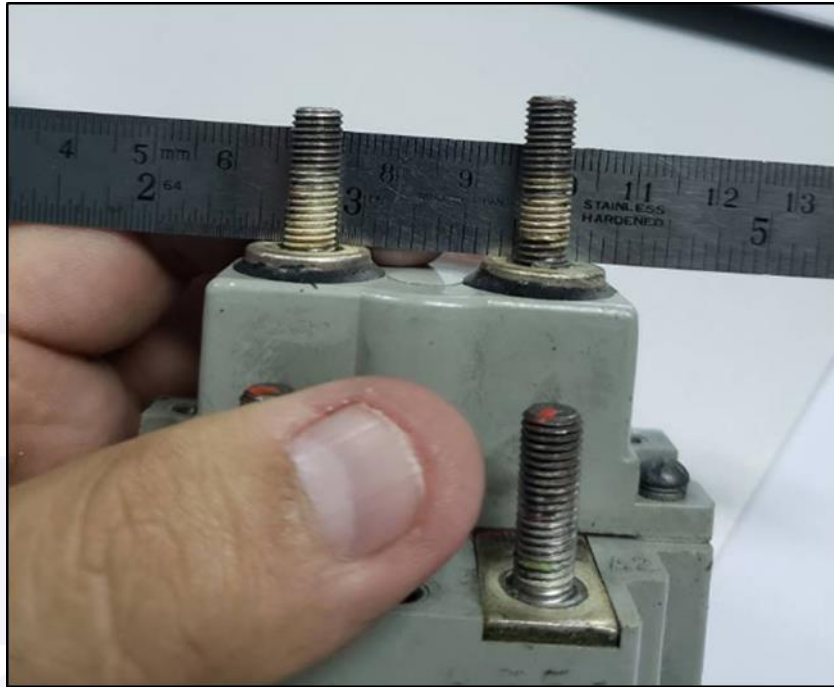
During the visual inspection of the 58PA relay, it was observed that one of its terminals was loose. It was approximately 5 mm longer than the other terminals (Figure 17).

Figure 17 - 58PA relay with height difference in one of the terminals.

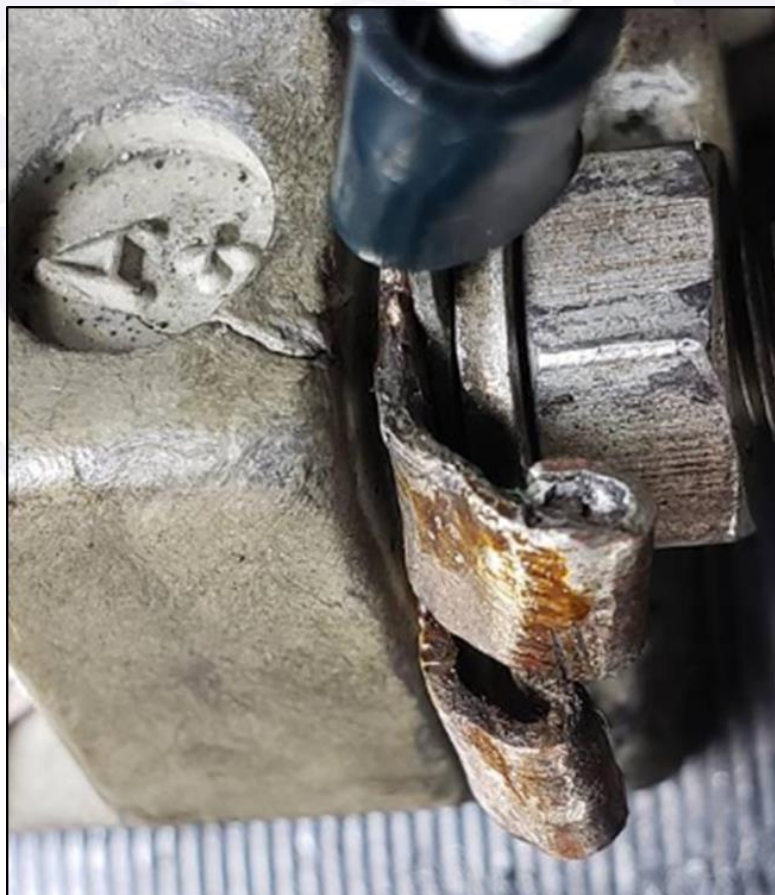
A visual inspection was also conducted on the *Starter-Generator No. 2*, revealing an improperly assembled terminal (A+). One of the contact washers securing the electrical wiring to the terminal exhibited plastic deformation and was out of position (Figure 18).

Figure 18 - Deformation of a contact washer on the terminal A+ of the *Starter-Generator No. 2*.

Due to this issue and considering the failure of the *DC BUS 2*, which was directly powered by the *Starter-Generator No. 2*, this component was also segregated and subjected to examinations and testing in the specialized facility of the component manufacturer.

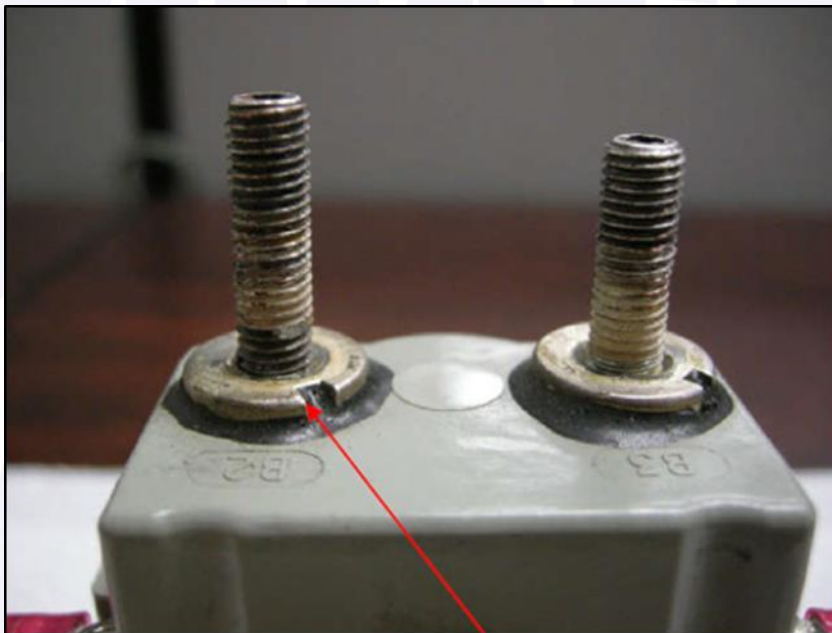
The 58PA relay (PN SM150D8, SN MFD 8551) was also received at the manufacturer's laboratory for compliance examinations and bench testing. During the visual compliance inspection of this component, it was confirmed that one of its contactor terminals was misaligned, with a height differing from the specified value. Analyses indicated that this discrepancy likely resulted from the application of excessive torque during maintenance servicing (Figure 19).

Figure 19 - Visual discrepancy in the 58PA relay:
B2 contact terminal longer than the B3 terminal.

The functional tests concluded that the relay had a non-acceptable condition, failing to meet the minimum operational requirements. The contact terminals B2 and B3, which are of the normally closed type, were also found to be non-functional.

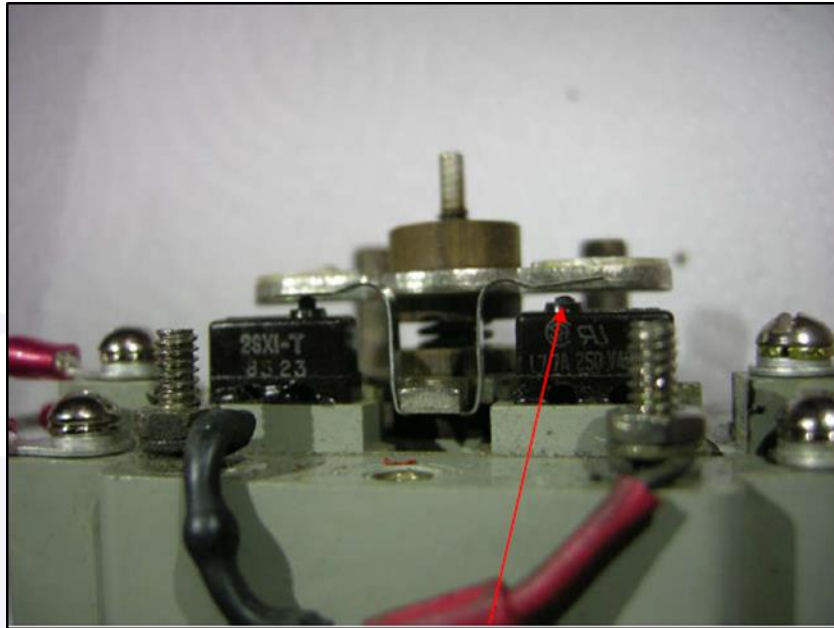
After the relay was disassembled and internally inspected, a discrepancy was identified in one of its actuation buttons, which was in a collapsed position (Figure 20). This condition likely contributed to the relay's intermittent operation. Such intermittent functioning of the relay could have impacted the proper operation of systems powered by it, including the intermittent activation of the Bus Tie Contactor (BTC).

Figure 20 - Collapsed position of the actuation button of the relay 58PA: button related to switch 11/12/13

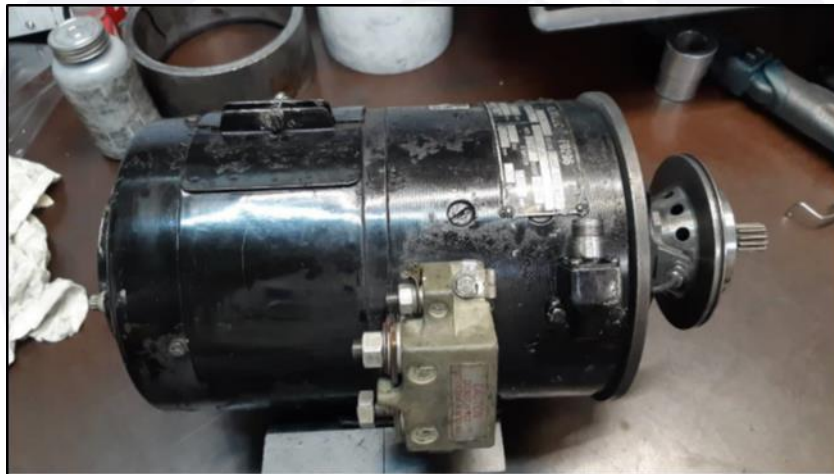
The *Starter-Generator* No. 2 (PN 8260-123, SN 2394) was received at the manufacturer's laboratory for examination. The compliance inspection revealed that the generator had a sticky surface resulting from an oil spill on its external casing and was in a poor condition of preservation (Figure 21).

Figure 21 - Overview of the *Starter-Generator* No. 2.

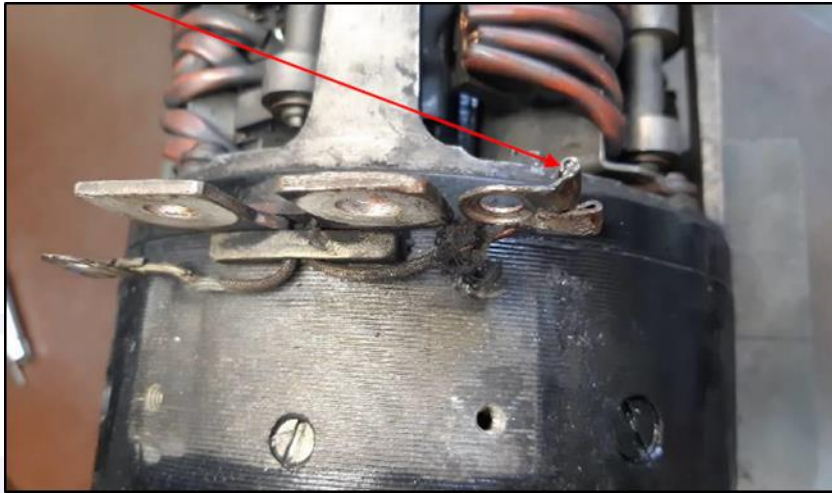
There was confirmation of the initial observation relative to the improper assembly at the "A+" terminal contact of this generator, with its insulation coating found to be damaged (Figure 22).

Figure 22 - Detail of the deformation at the fixation point of the wiring connected to the generator's "A+" terminal and damaged insulation coating.

The incorrect assembly and the plastic deformation induced by excessive tool force on one of the wire contact washers caused this washer (located between the locking nut and the terminal) to become loose and prone to movement. This movement, combined with the deformation, contributed to the development of an abrasive mechanical stress on the wiring insulation layer, wearing it down.

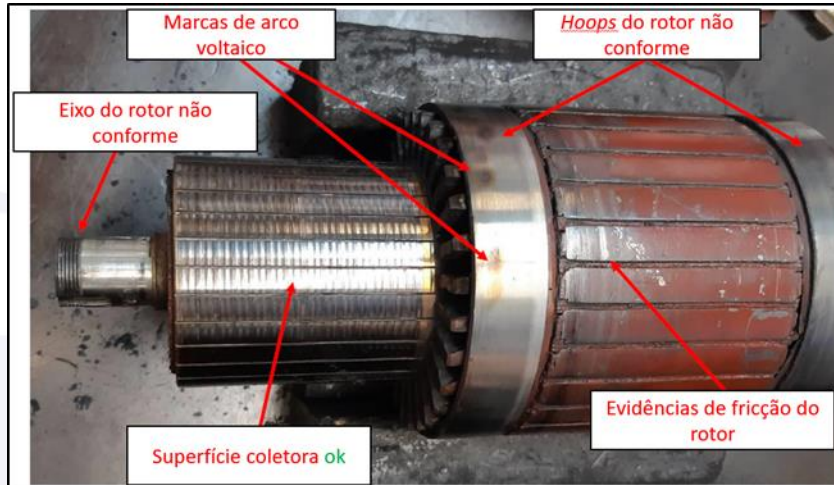
- rotor with physical characteristics differing from those specified by the manufacturer. The aforementioned discrepancies can be observed in Figures 23, 24, 25, and 26.

Figure 23 - Evident non-conformities in the rotor of the *Starter-Generator*.

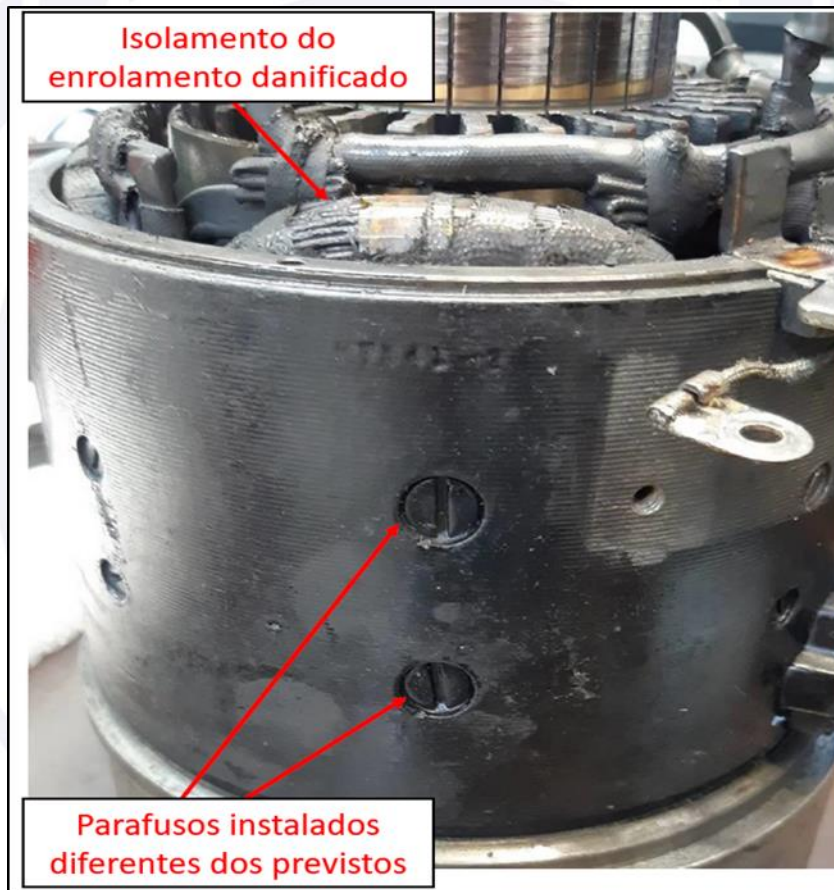
Figure 24 - Evident non-conformities in the casing and winding of the *Starter-Generator*.

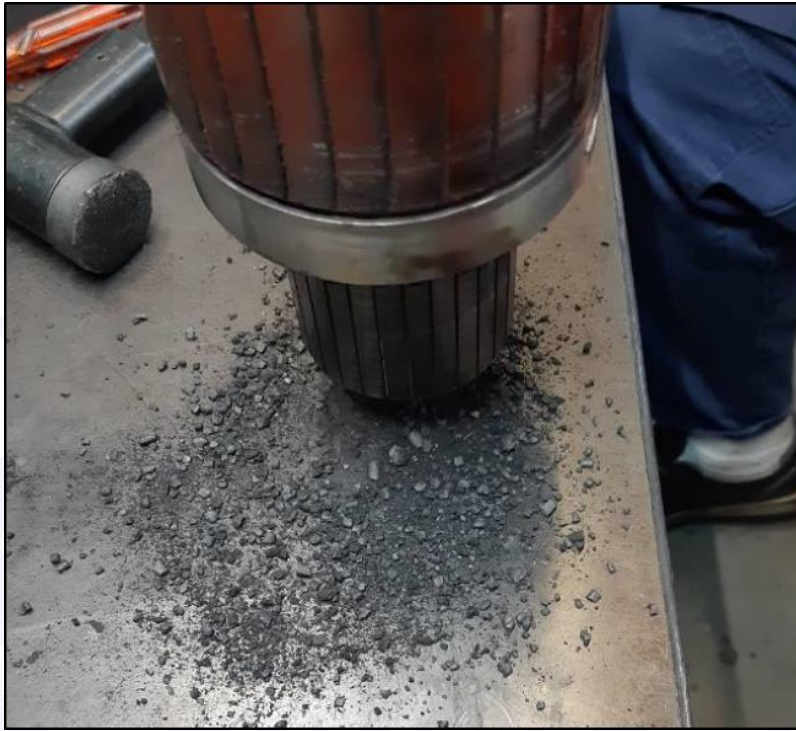
Figure 25 - High amount of metallic dust present on the rotor of the generator.

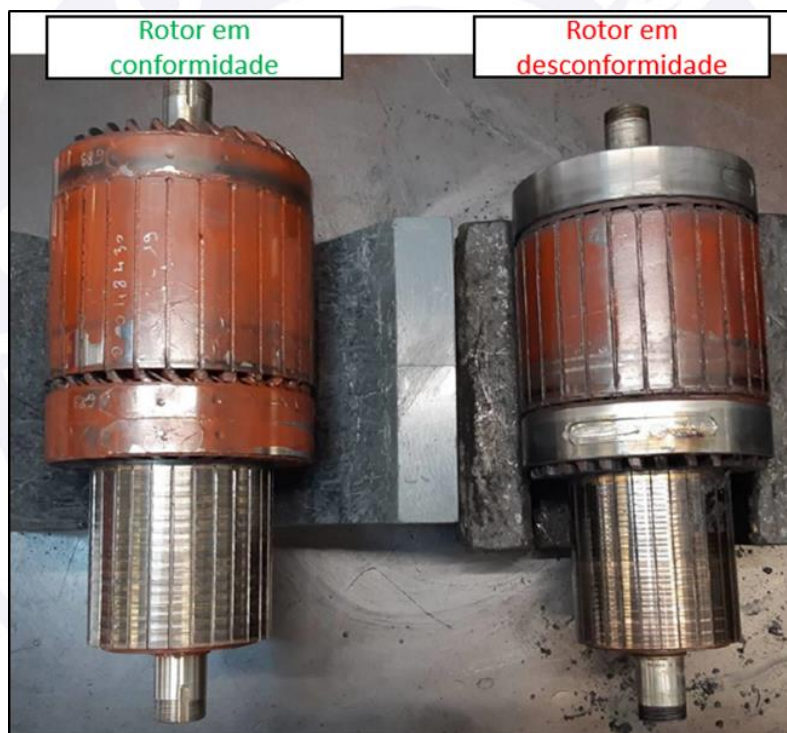
Figure 26 - Comparison between a compliant Starter-Generator rotor (on the left) and the rotor installed in the PR-MPN aircraft (on the right).

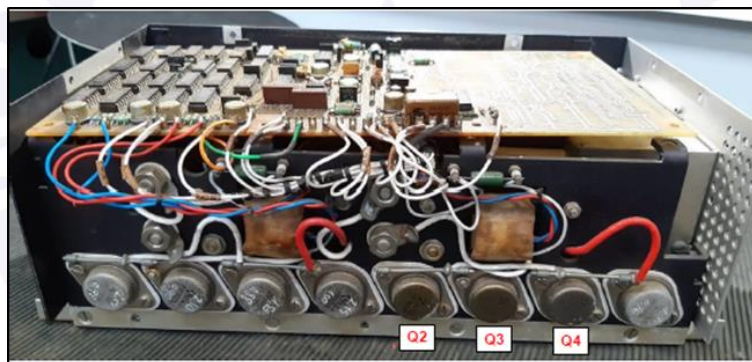
- power circuit: 3 transistors exhibiting signs of overheating.
- control and regulation circuit: two 1-Ohm resistors were used in series instead of a single 2-Ohm resistor, deviating from the manufacturer's specifications for achieving the required 2-Ohm resistance in one of the circuits.
- control and regulation circuit: signs of overheating due to rework, which did not comply with applicable standards; soldering on the circuit was also found to be non-compliant.
- one diode related to overvoltage protection was missing.
- one of the overvoltage protection diodes was in a short-circuit condition; and
- the overvoltage and undervoltage protection settings were incorrectly adjusted.

Figure 27 - Transistors Q2, Q3, and Q4 showing discoloration due to overheating.

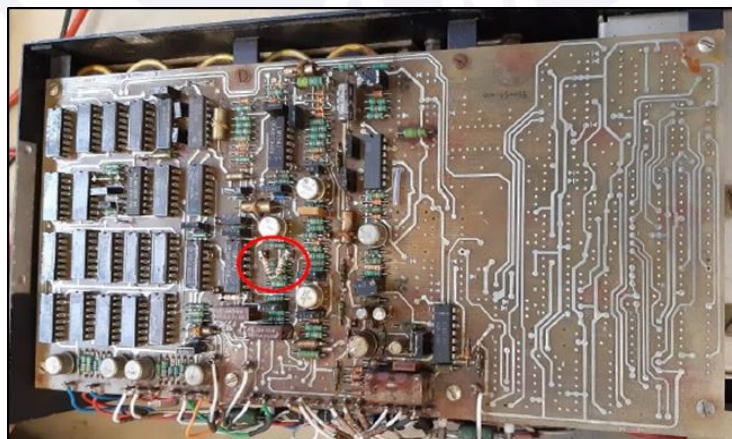
Figure 28 - Use of two 1-Ohm resistors in series instead of a single 2-Ohm resistor.

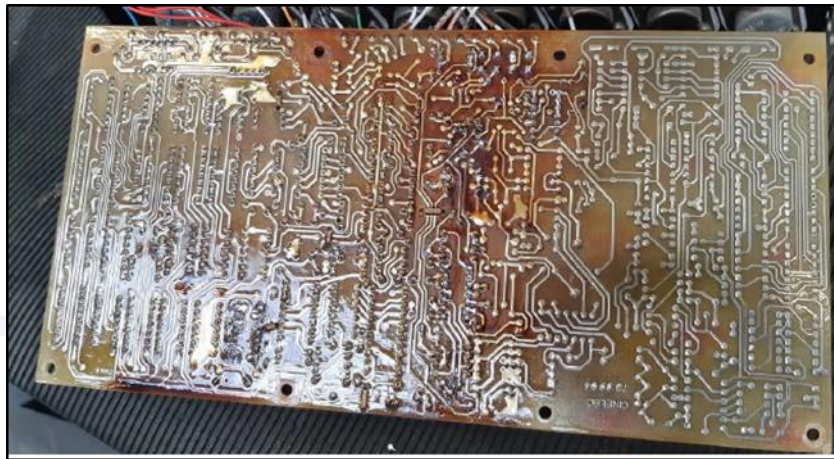
Figure 29 - Signs of overheating due to rework and soldering performed in non-compliance with standards.

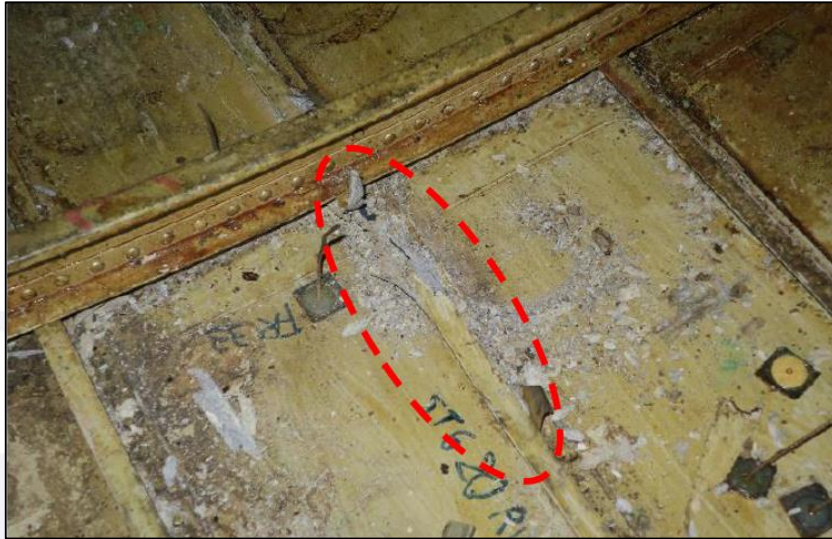
- The central section of the rear fuselage, inside the aircraft, near frame 33, where the stringer 20RH was found to be severely corroded, compromising its structural function at that location (Figures 35 and 36).

Figure 36 - Stringer 20RH, near frame 33, showing severe corrosion.

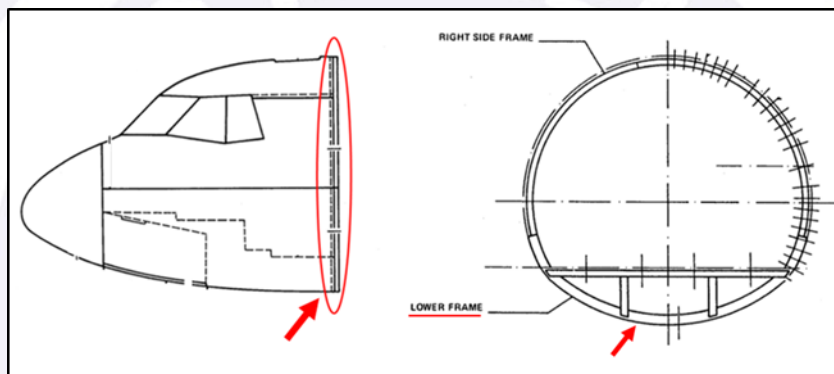
- In the lower part of frame 12, located in the nose section of the fuselage, corrosion was found extending across the entire face of the frame. Additionally, in the same area, a fracture was discovered, spanning over 50% of the frame's face (Figures 37 and 38).

Figure 37 - Location of frame 12 and the corroded/fractured area.

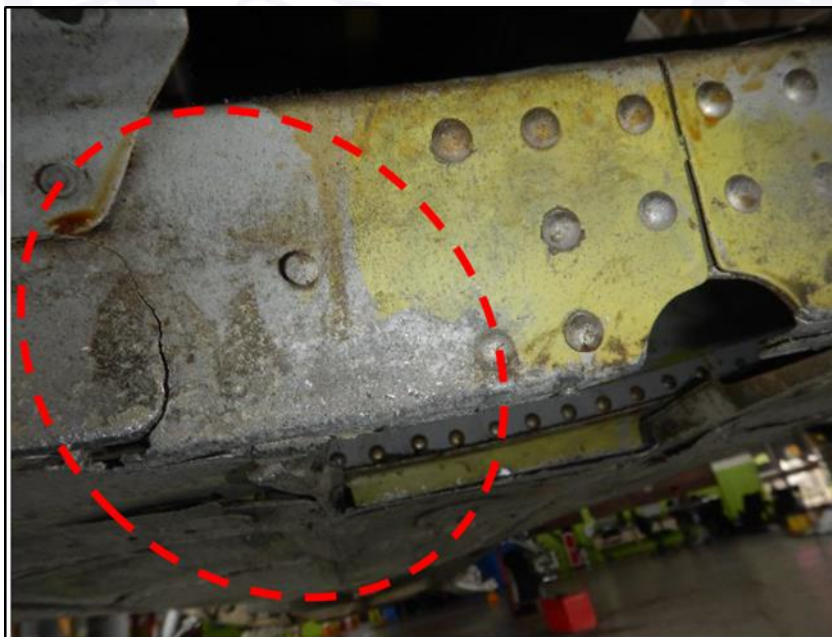
Figure 38 - Lower segment of frame 12, showing corrosion and fracture.

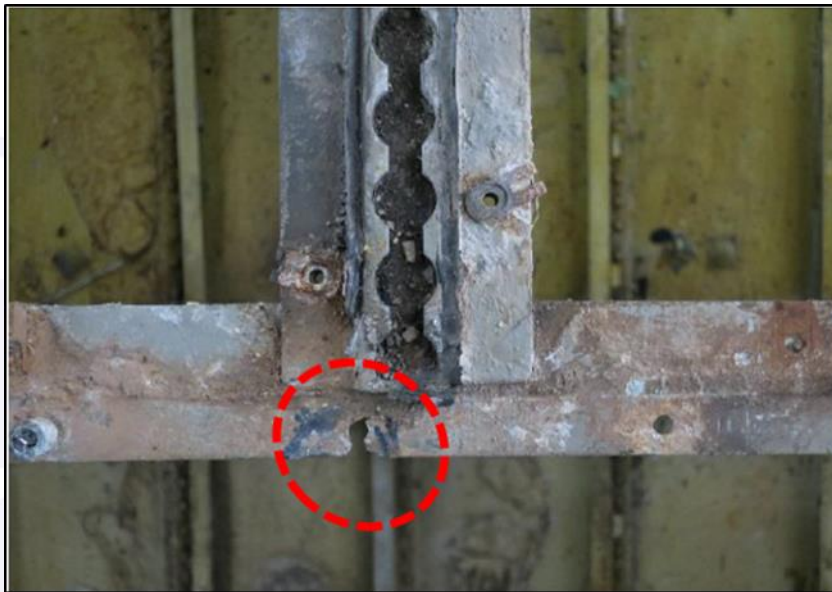
- In the area between frames 36 and 39, multiple instances of corrosion were identified, including passenger seat rails, thresholds of service and passenger doors, as well as floor panels. Specifically, on the structural element where the floor was secured, instances of penetrating corrosion were observed (Figure 39).

Figure 39 - Penetrating corrosion on the structural element securing the floor.
