**COMANDO DA AERONÁUTICA**  
**CENTRO DE INVESTIGAÇÃO E PREVENÇÃO DE**  
**ACIDENTES AERONÁUTICOS**

**FINAL REPORT**  
**A-116/CENIPA/2024**

**PS-VPB**

**ATR-72-212A (500)**

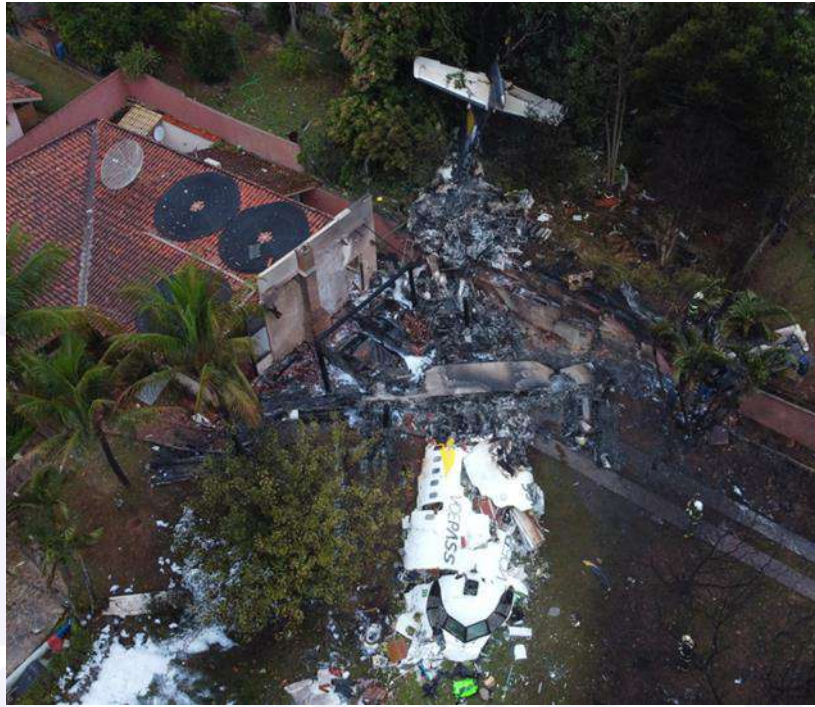
The aircraft was destroyed. In general, there were deformations and fractures throughout the fuselage due to the high-energy impact with the ground.

The aircraft had part of the right wing torn off, the tail cone was severed, both engines sustained substantial damage along their entire length, and the propellers were fractured as a result of the ground impact.

The forward fuselage section remained relatively preserved when compared to the rest of the aircraft, as it was not affected by the fire.

Figure 1 – General view of the aircraft after ground impact and post-impact fire.

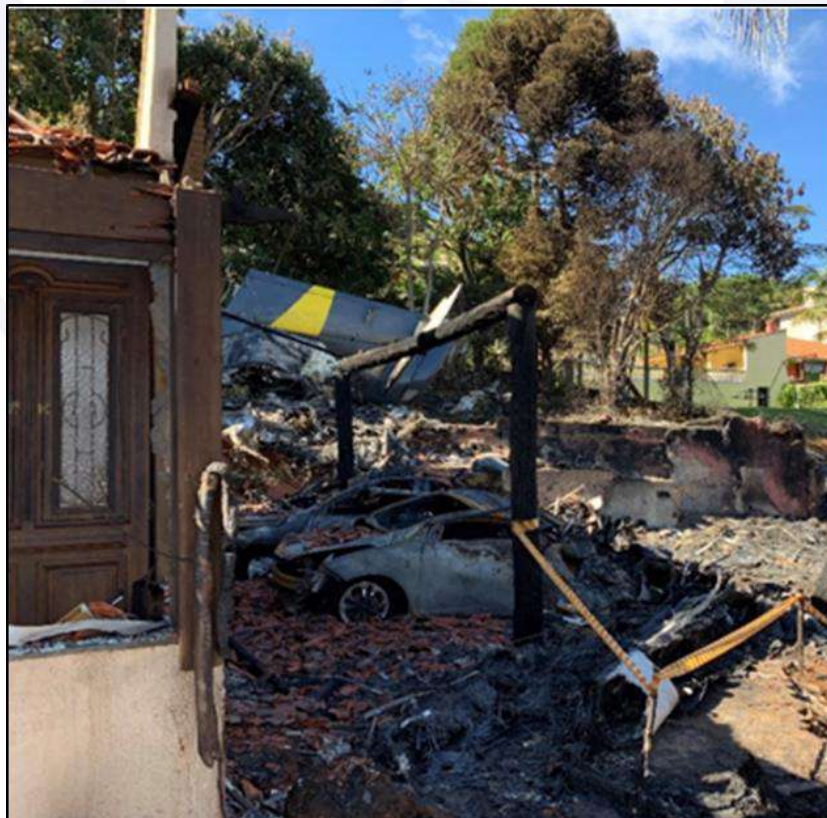
Additionally, two vehicles that were parked near the impact site, in the garage of the residence that contained most of the wreckage, were completely destroyed by the fire resulting from the accident (Figure 2).

Figure 2 – Vehicles destroyed in the vicinity of the wreckage.

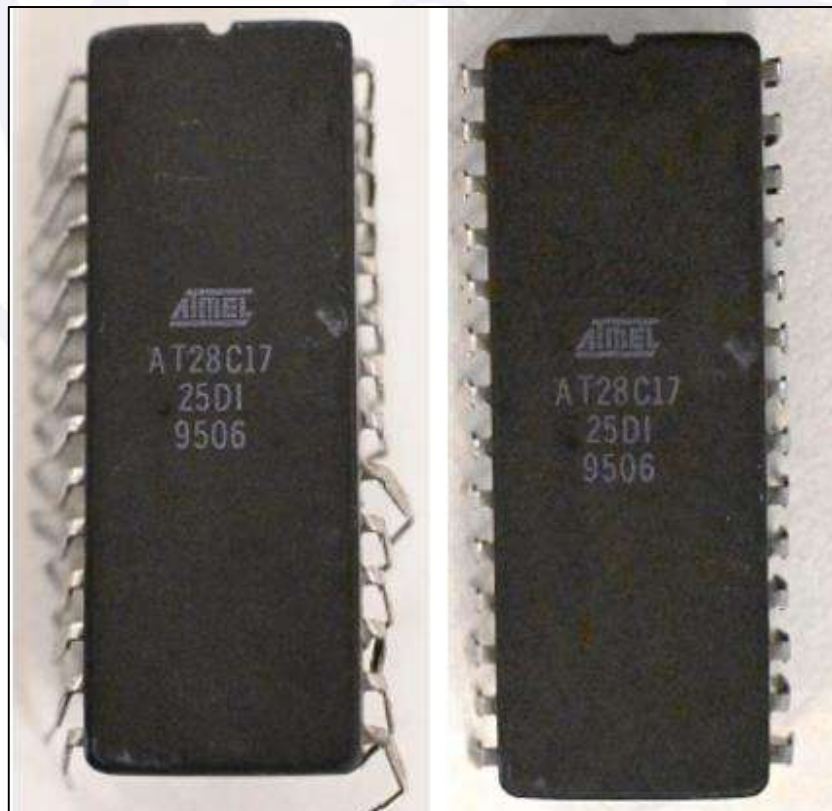
Figure 59 – On the left, MFC1B memory with damaged pins; on the right, the same component after pin repair for the execution of tests and data readout.

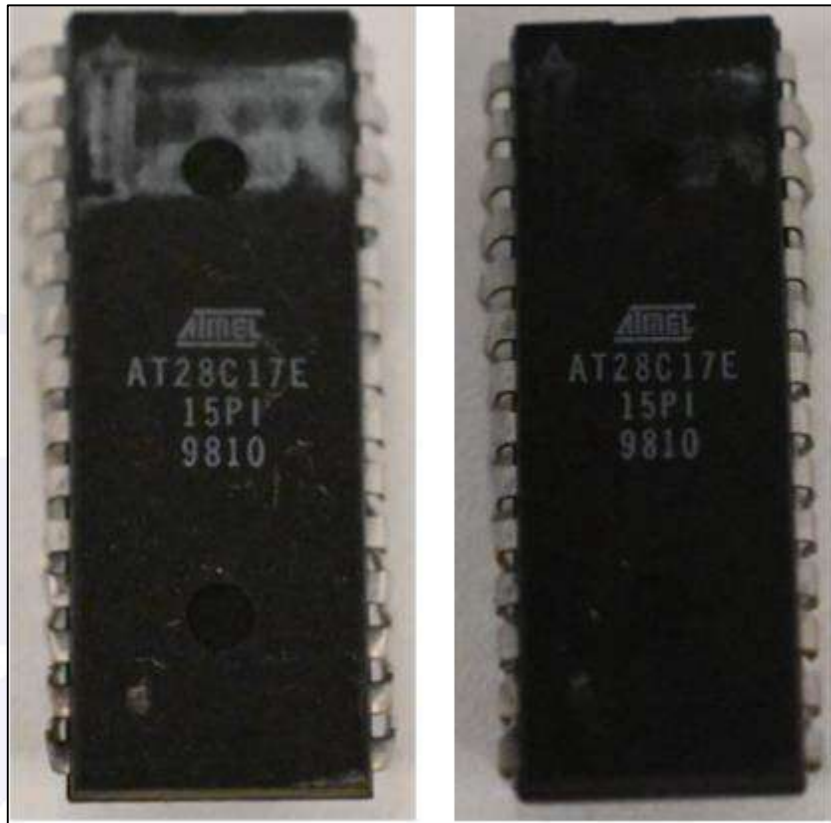
Figure 62 – On the left, MFC2A memory component with damaged pins; on the right, the same component after pin repair for testing and data readout.

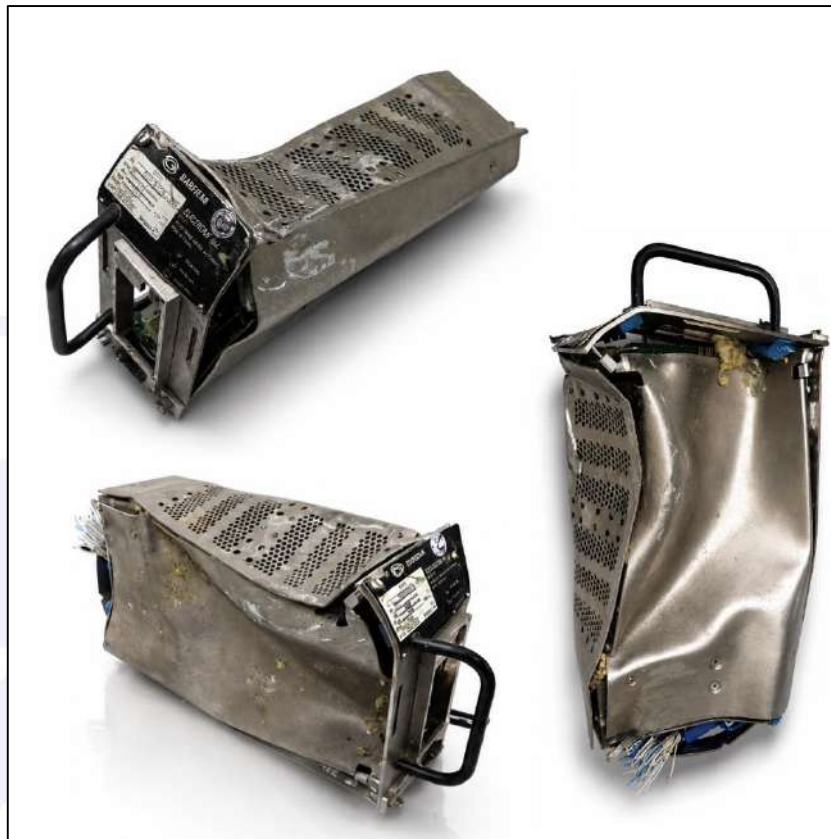
Figure 65 – Images of the MPC installed on aircraft PS-VPB, showing damage and deformation of its housing.

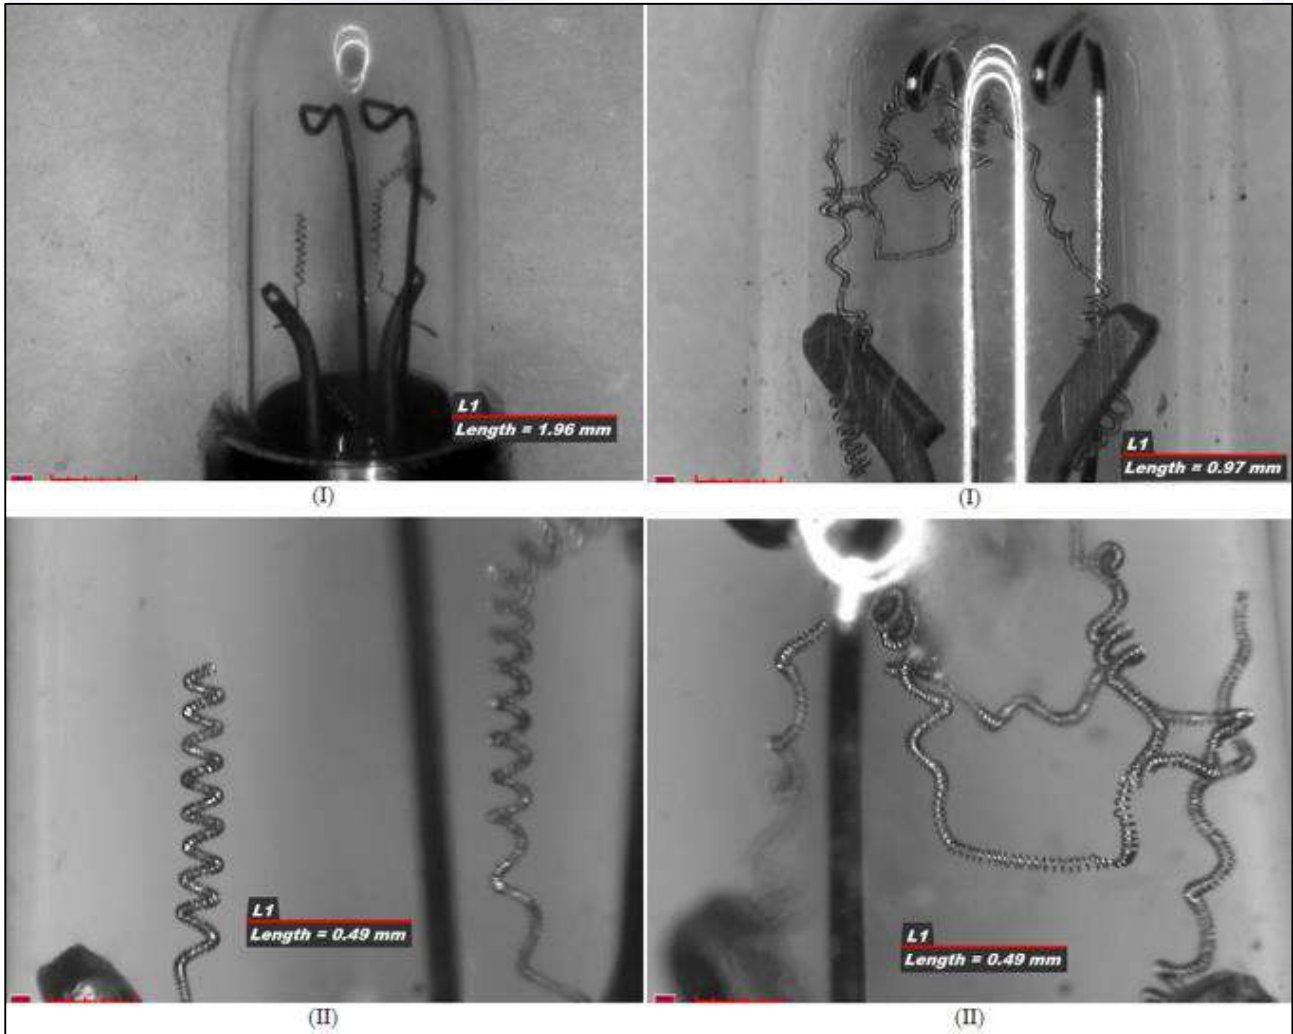
Figure 85 – On the left, (I and II), lamp 01 of the DC GEN 1 FAULT indication, with little deformation at the filament fracture. On the right (I and II), lamp 01 of the STICK PUSHER indication with high deformation at the filament fracture.

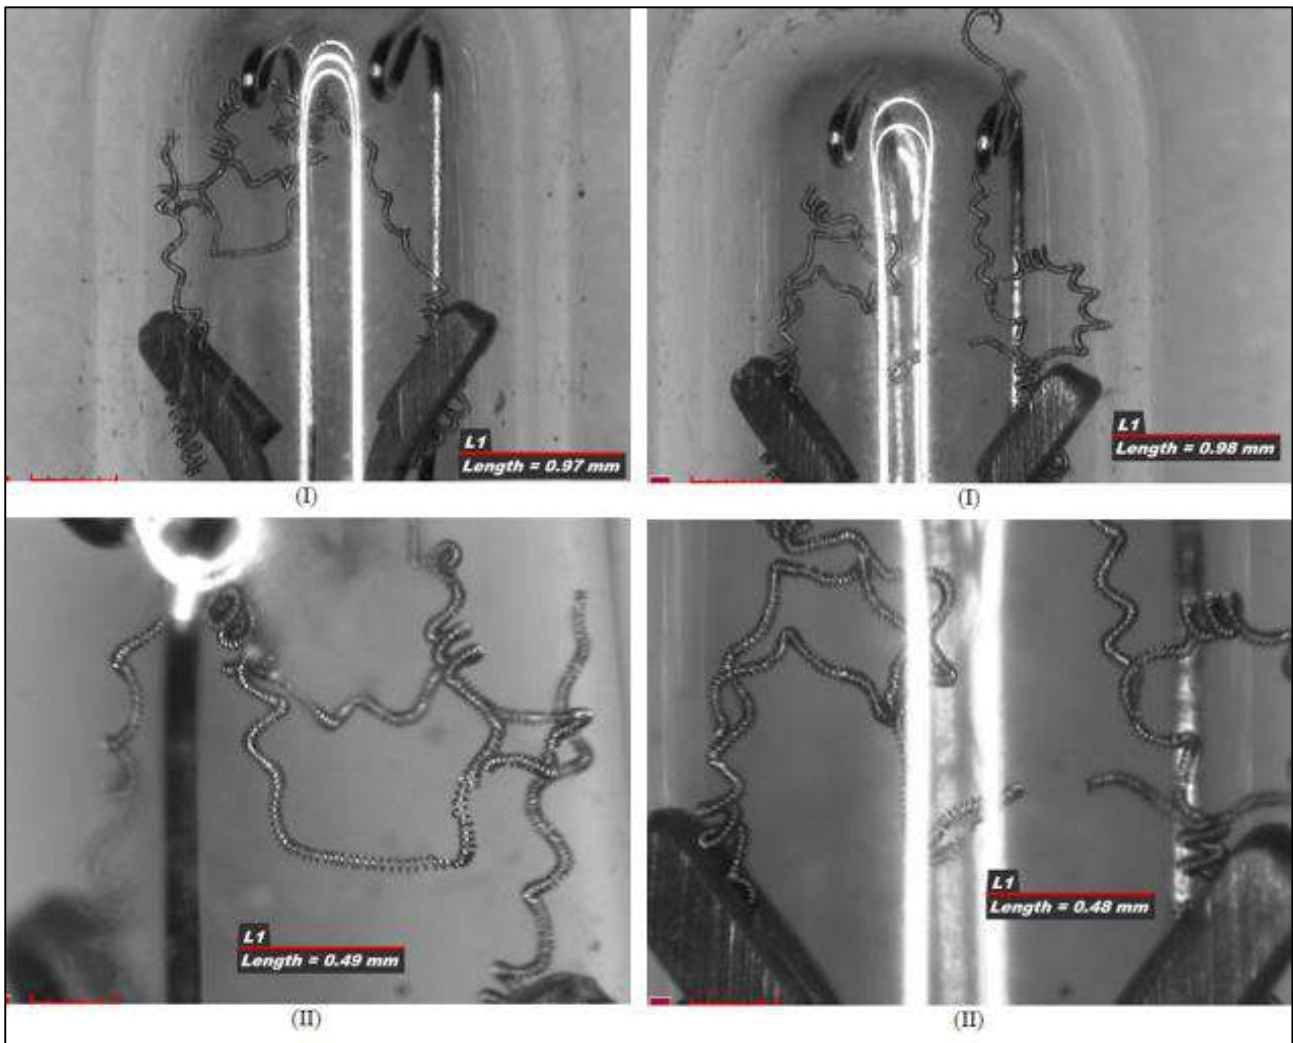
Figure 86 – Stereoscopic images of lamps 01 (left) and 02 (right) of the STICK PUSHER indication on the right panel.

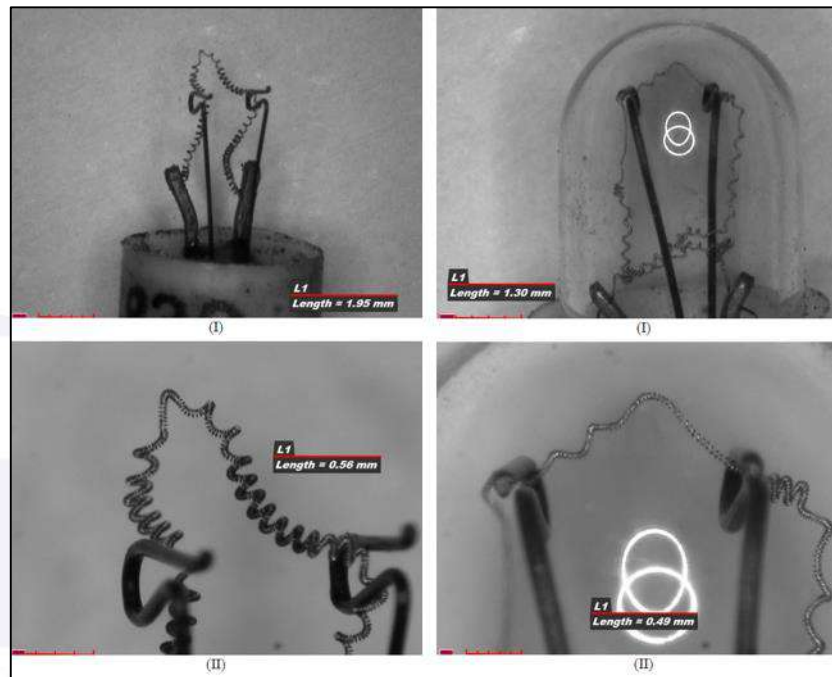
Figure 87 – Stereoscopic images of lamps 01 (left) and 02 (right) of the PITCH DISCONNECT indication on the CAP panel.

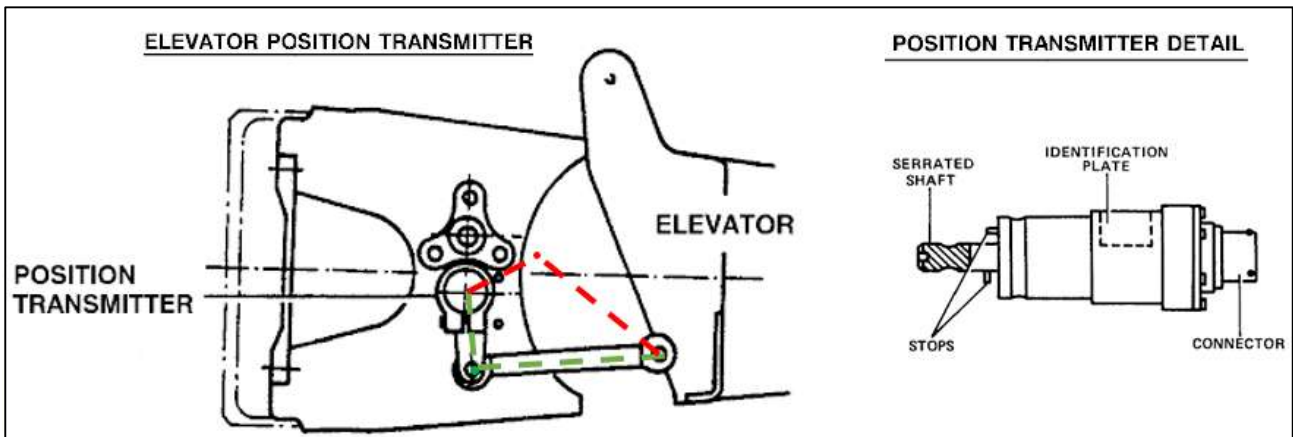
Figure 99 – On the left, front view. The green dashed line indicates the correct installation of the linkage rods between the elevator and the synchro transmitter. The red dashed line indicates the incorrect installation. On the right, side view of the component.

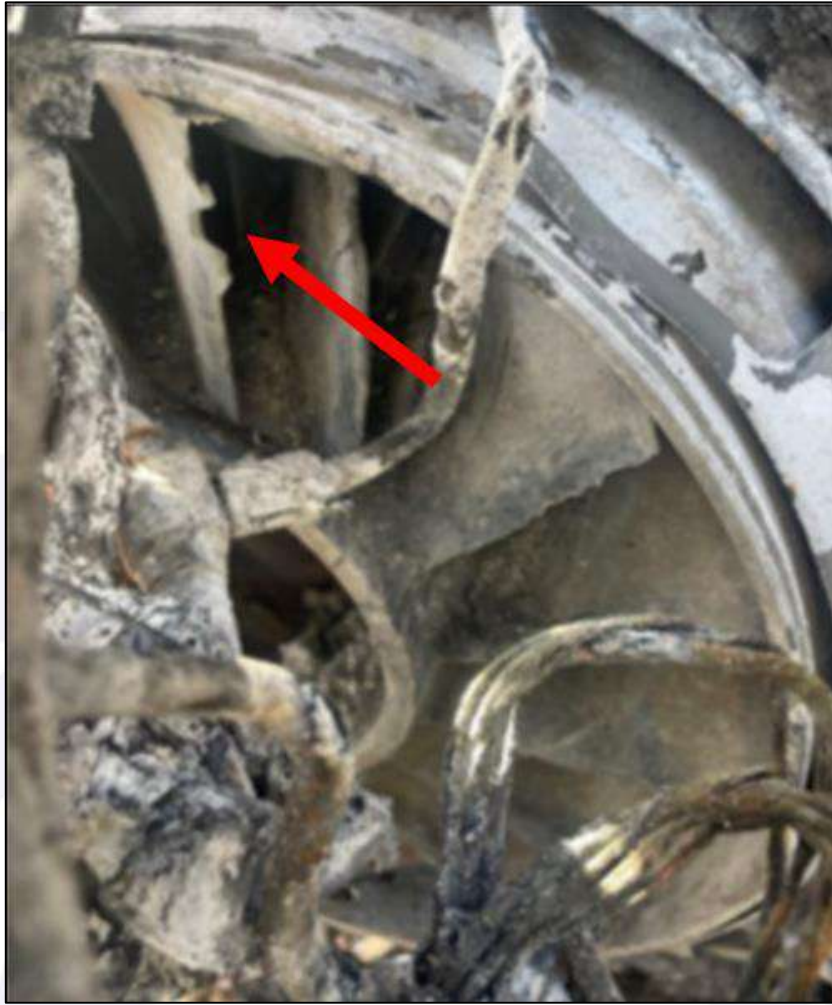
Figure 111 – Image of the LPC rotor of engine No. 1. Red arrow indicating blade deformations in the direction opposite to the rotation of the rotor shaft.

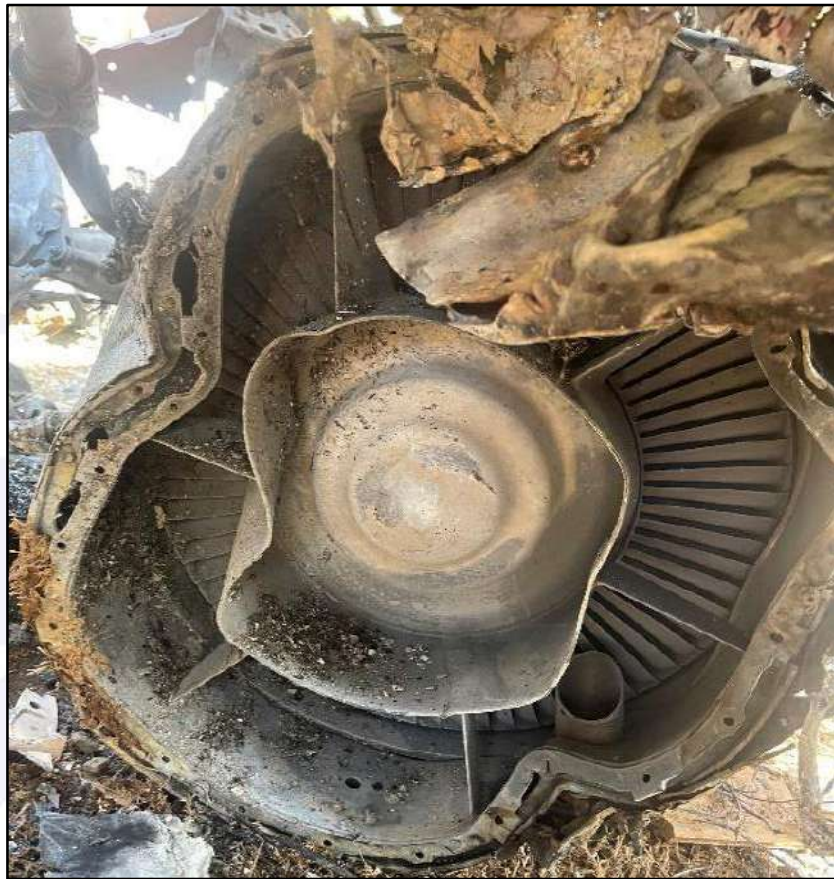
Figure 115 – Rear view of engine No. 1, showing deformations in the turbine support casing and the blades of the 2<sup>nd</sup> stage of the power turbine.
