Intermediate Report (Interim Statement)

Classification: ACCIDENT

Type of Occurrence: #ICE - FORMAÇÃO DE GELO

Date: 9 August 2024
Date (UTC): 9 August 2024
Time: 16:22
City: VINHEDO - SÃO PAULO - BRASIL
Aerodrome: OUTSIDE THE AERODROME
Local: RESIDENTIAL AREA OF THE CITY
Damage to third parties: YES

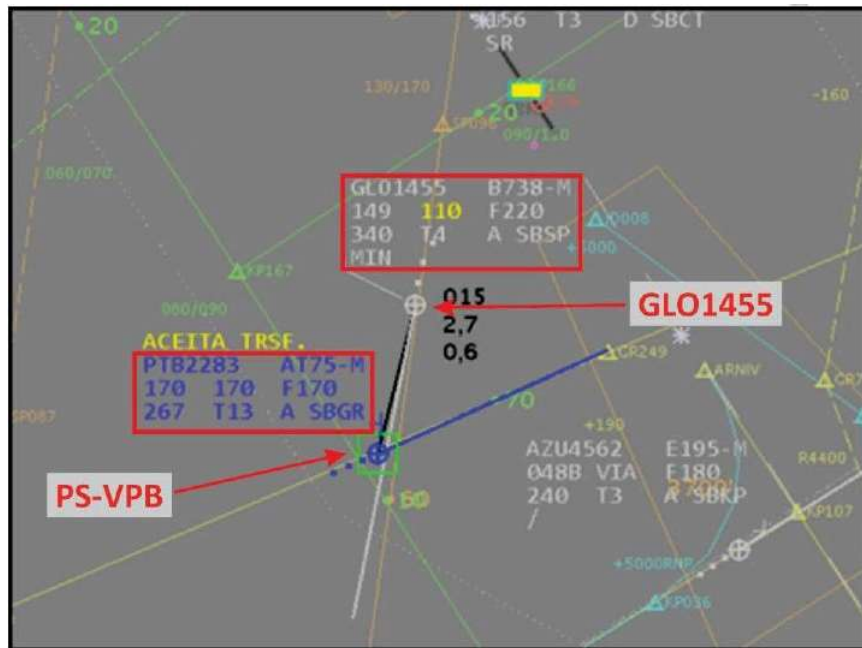
Figure 27 - RADAR rerun of the moment at which the PS-VPB had its traffic restricted by GLO 1455.

At that moment, *Passaredo 2283* was at FL170 at a distance of approximately 3 NM from the GR249 fix. There was traffic temporarily restricting their descent (GLO 1455, which was performing STAR DOSPI 1A, and was at a 10 o'clock position from *Passaredo 2283*, 2.7 NM away, heading south, and passing FL149, descending (Figure 27).

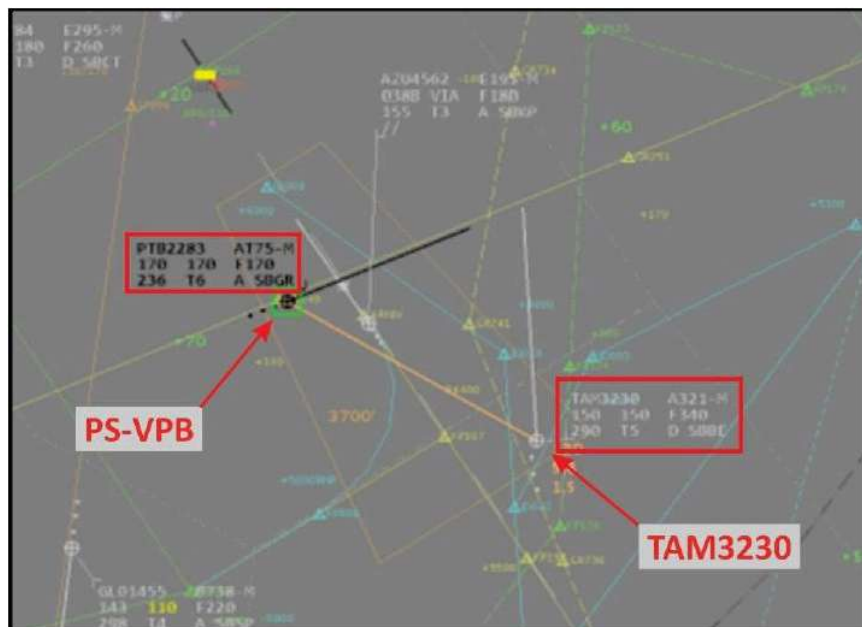
Figure 28 - RADAR rerun of the moment at which the PS-VPB had its traffic restricted by TAM 3230.

At that moment, *Passaredo 2283* was passing over the waypoint GR249, maintaining FL170, with the traffic of TAM3230 restricting its descent at the 2 o'clock relative position, distance 5.8 NM, leveled at FL150 and heading North (Figure 28).

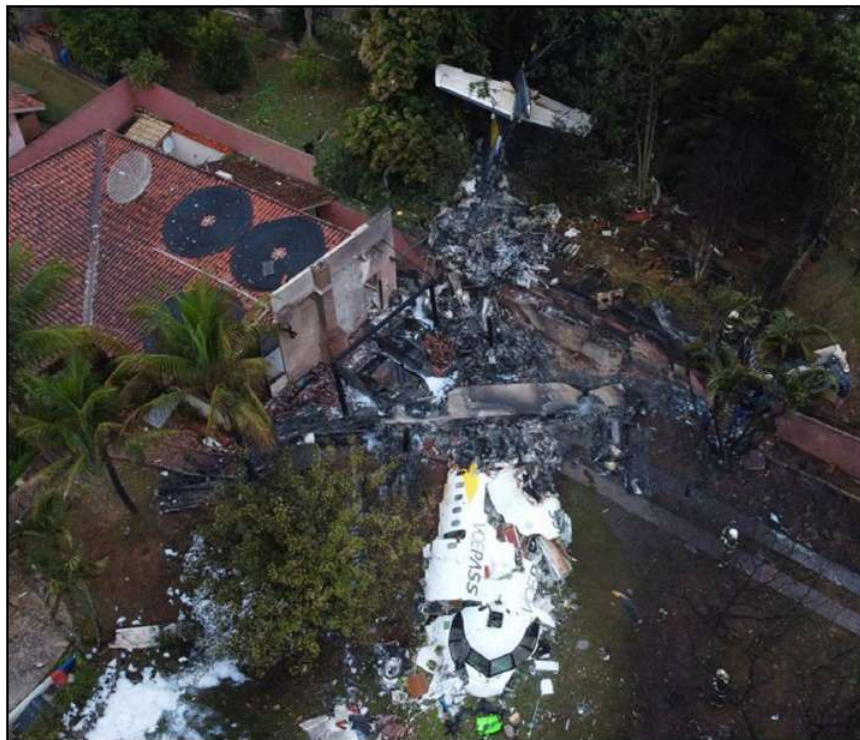
Figure 32 - Overview of the aircraft after colision with the ground and the post impact fire.

The engines remained attached to the wings, but were further affected by the post- impact fire. All the propellers were fractured due to impact with the ground. The aircraft's tail cone struck a wall and was not consumed by the fire.

The cockpit and flight instruments suffered substantial damage from the collision with the ground but were not affected by the fire.

There was no evidence of in-flight fire. The fire started immediately after impact with the ground. The burning material was the aircraft's fuel and the ignition source probably originated from the aircraft's strong friction with the
