**COMANDO DA AERONÁUTICA**  
**CENTRO DE INVESTIGAÇÃO E PREVENÇÃO DE**  
**ACIDENTES AERONÁUTICOS**

**FINAL REPORT**  
**A-135/CENIPA/2022**

| <b>OCCURRENCE:</b> | <b>ACCIDENT</b> |
| <b>MODEL:</b> | <b>A330-243</b> |

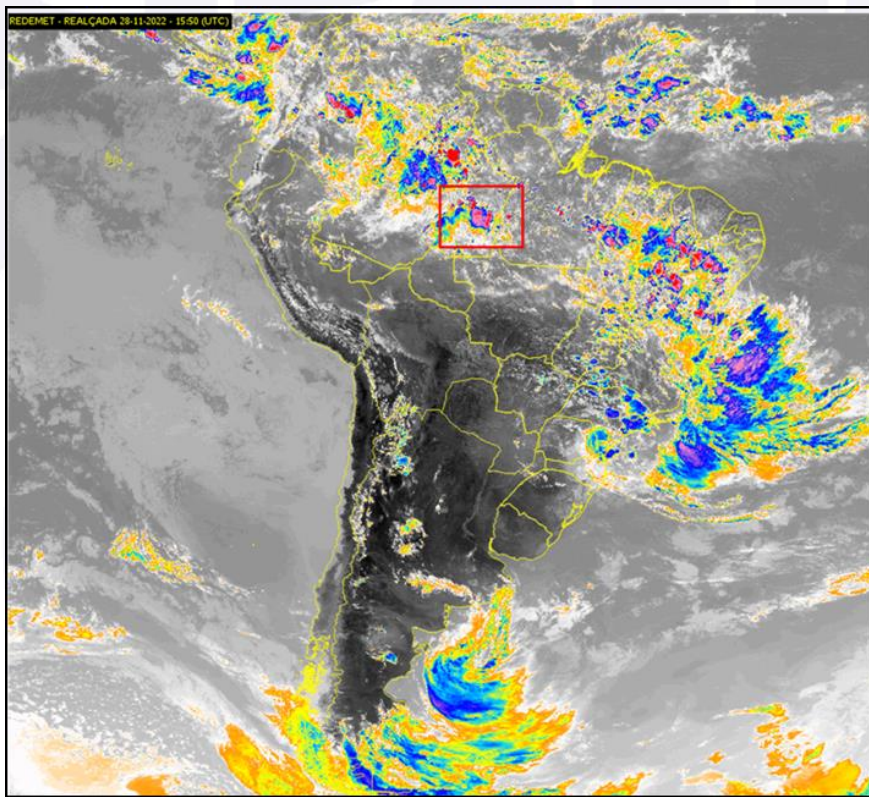
Figure 2 – Satellite image at 15:50 UTC on 28NOV2022, highlighting the location of the occurrence.

The areas highlighted by more intense colors indicated very cold cloud tops, consistent with well-developed cumulonimbus (CB) clouds, suggesting that those formations reached high levels of the troposphere, possibly near or above the tropical tropopause.

Some of these convective cells exhibited organized spatial structure and significant horizontal extent, a characteristic typical of Mesoscale Convective Systems (MCSs), with multiple embedded cells and intense convective activity, in a pattern consistent with the tropical convection of the region, favored by the high moisture content at low and middle levels, daytime heating, and convergence associated with the regional atmospheric circulation.

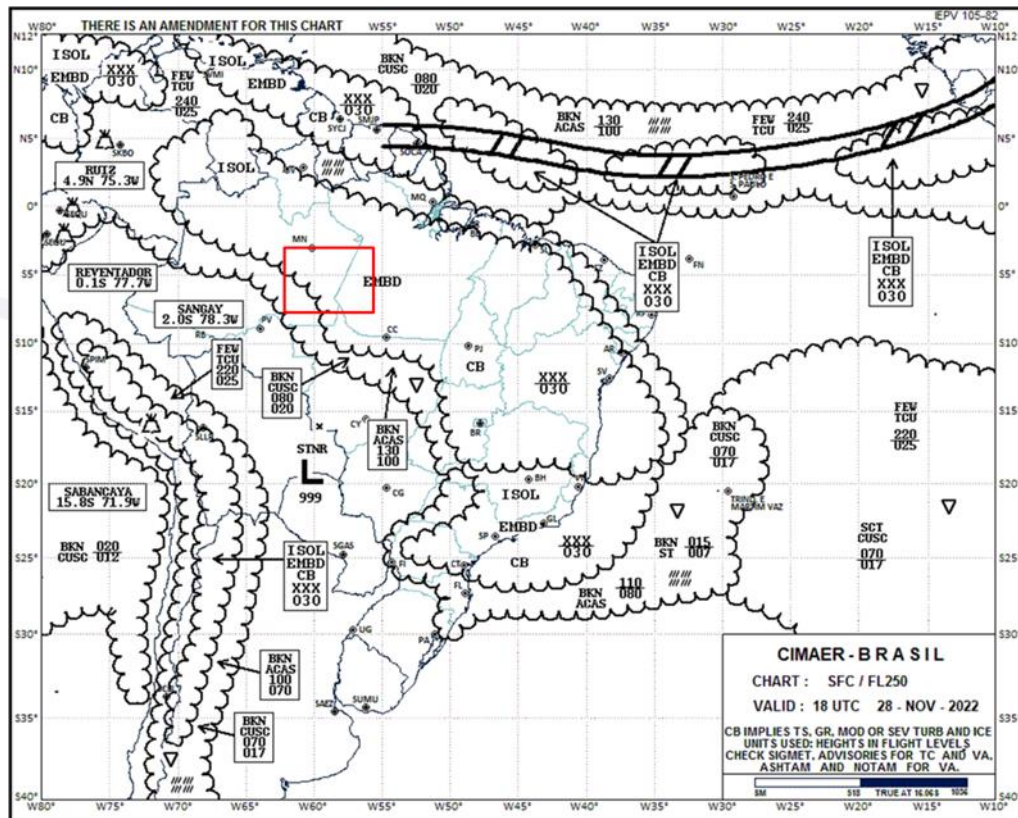
Figure 3 – SIGWX Chart valid until 18:00 UTC on 28NOV2022, highlighting the location of the occurrence  
Source: REDEMET.

The evaluation of the Significant Weather Chart (SIGWX), focusing on the corridor between SBCC and SBMN, revealed embedded convection distributed within an extensive layer of stratiform cloud, a configuration consistent with an environment of deep atmospheric instability that was difficult to detect tactically.

The convective cells were not isolated but rather embedded within the cloud mass, a condition that reduced both the ability to detect them visually and the effectiveness of the onboard weather radar. This scenario was consistent with the sequence of SIGMETs issued for the *Amazônica* FIR, which continuously reported the occurrence of embedded thunderstorms with high tops and stationary movement over the sector encompassing SBCC and SBMN, indicating the presence of a broad, persistent, and slow-moving convective system.

Along the specific segment between these aerodromes, the SIGWX chart already indicated the presence of towering cumulus (TCU) clouds and CB cells associated with convective development at multiple levels, which was subsequently confirmed by the SIGMETs.

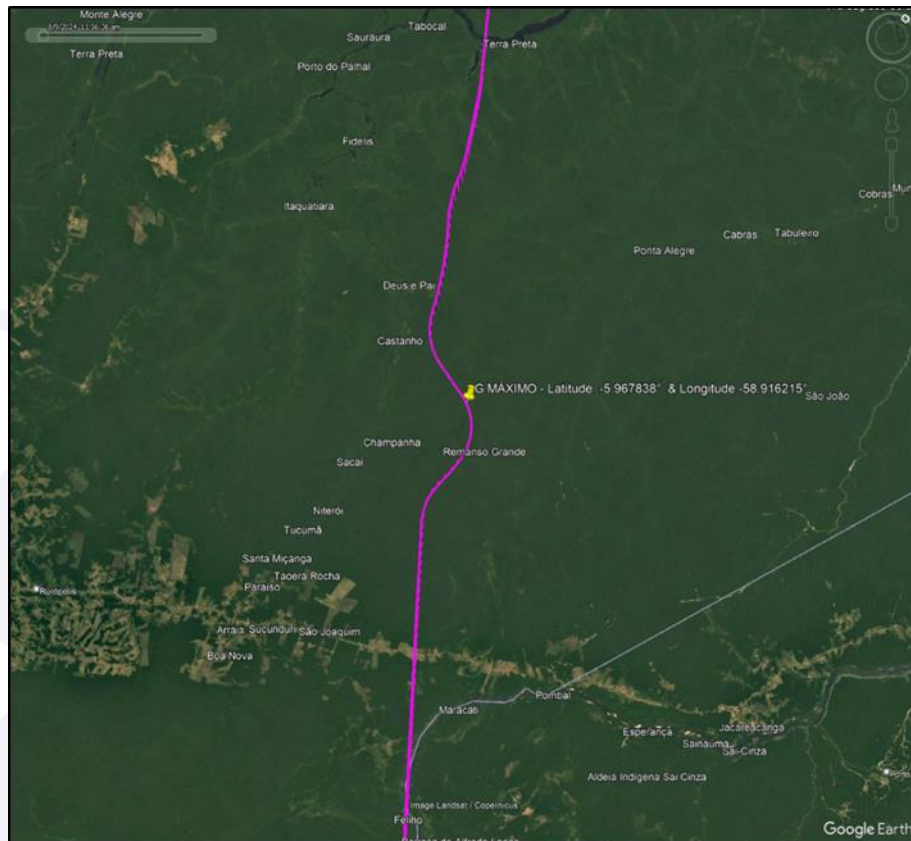
Figure 4 – Aircraft trajectory recorded by the FDR. Highlighted is the point at which the maximum vertical acceleration (maximum G) occurred.

During the cruise phase at FL380, within the *Amazônica* FIR, after approximately 2 hours and 45 minutes of flight, the aircraft encountered heavy weather formations consisting of cumulonimbus (CB) and cumulus congestus (TCU) clouds, displayed in magenta on the onboard weather radar.

As a result, the pilots stabilized the aircraft at the recommended turbulence penetration speed (Mach 0.80) and coordinated a right lateral deviation with the *Amazônica* Area Control Center (ACC). The deviation began while the aircraft was on airway UM417, approximately 215 nautical miles from the vertical of the city of *Manaus*, state of *Amazonas*, and reached a maximum displacement of 10 nautical miles from the original track (Figure 4).

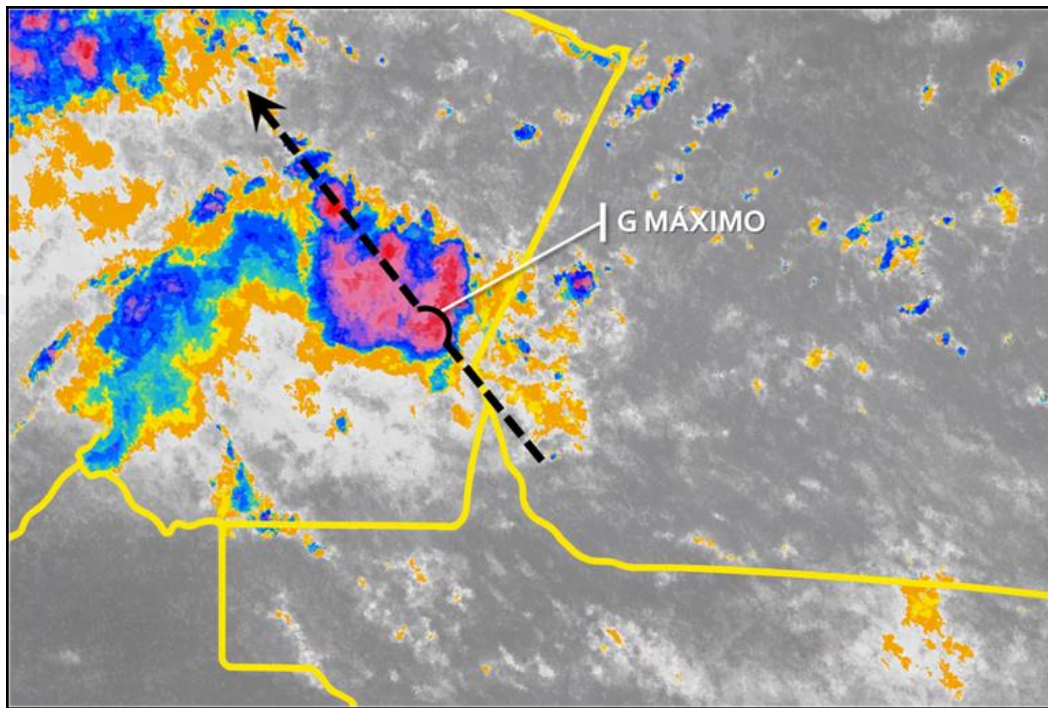
Figure 5 – Aircraft trajectory recorded by the FDR overlaid on the satellite image of the occurrence area. Highlighted is the point at which the maximum vertical acceleration occurred.  
Source: FDR/REDEMET.

The aircraft trajectory, shown in Figure 5 and overlaid on the satellite image provided by the Aeronautics Command Meteorological Network (REDEMET), was found to be consistent with the prescribed operational procedures.

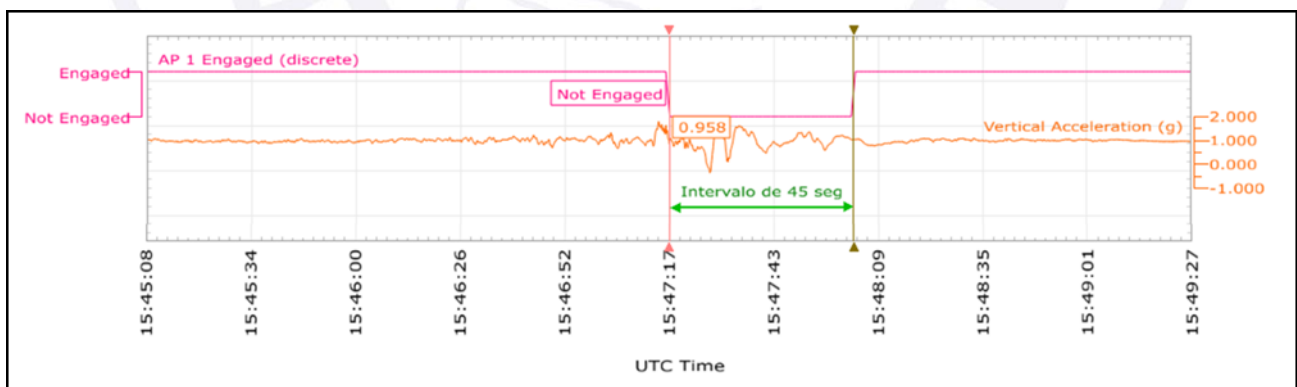
Figure 6 – Vertical acceleration (G) profile and autopilot status during the encounter with turbulence in cruise flight.  
Source: FDR.

In the sequence of events related to the encounter with the turbulence, 2 seconds after the peak load factor, the Autopilot (AP) disengaged, and the indication "AP OFF INVOLUNTARY" was recorded, characterizing an involuntary disengagement of the system. The AP disengagement indicated that the atmospheric disturbances had exceeded the automatic system's operational limits, resulting in its disconnection as a protective measure provided for in the aircraft design.

The AP remained disengaged for approximately 45 seconds and was re-engaged by the PF shortly after the aircraft had passed through the most critical phase of the turbulence. During this period, significant variations in vertical acceleration were recorded (Figure 6).

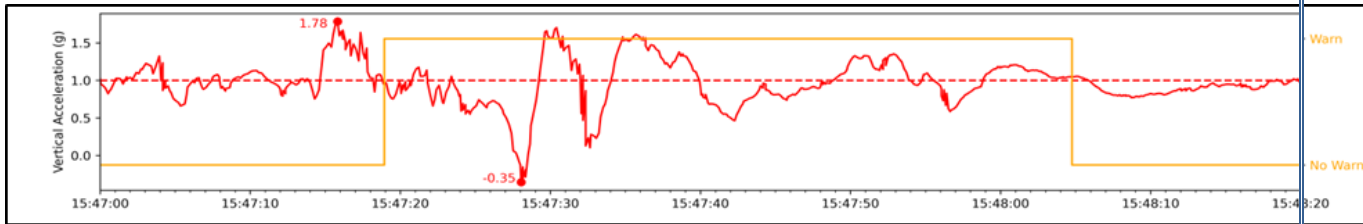
Figure 7 – Vertical acceleration (G) variation during the encounter with turbulence.

According to the FDR, the turbulence lasted approximately 55 seconds, with the peak intensity concentrated within a period of approximately 6 seconds.

During the initial period, the vertical acceleration remained predominantly close to the nominal value of 1 G, with moderate oscillations generally ranging between 0.8 G and 1.2 G. The observed variations were irregular and of small amplitude, consistent with the effects of light to moderate turbulence. No abrupt peaks or progressive increases in load factor were identified, indicating that the aircraft remained relatively stable, with no evidence of intentional pitch maneuvers or significant structural loading.

Subsequently, a marked intensification of the vertical acceleration oscillations was observed, characterized by rapid, large-amplitude variations. Notably, a maximum positive peak of approximately +1.78 G was recorded, followed shortly thereafter by an abrupt reduction to values significantly below 1 G, reaching a maximum negative peak of -0.35 G. This sequence evidenced the action of severe vertical currents, with a rapid alternation between strong updrafts and pronounced downdrafts, typical of strong to severe turbulence. The temporal pattern indicated an abrupt atmospheric variation, a condition that is particularly critical for occupants who are not adequately restrained.

Following the critical period, the vertical acceleration gradually returned to values closer to 1 G, although smaller irregular oscillations were still observed. The variations remained greater than those recorded during the initial phase, indicating the persistence of an unstable atmospheric environment, but without the recurrence of extreme vertical load peaks. This behavior suggested that the aircraft had exited the most intense core of the turbulence, with a progressive attenuation of the severe vertical currents.

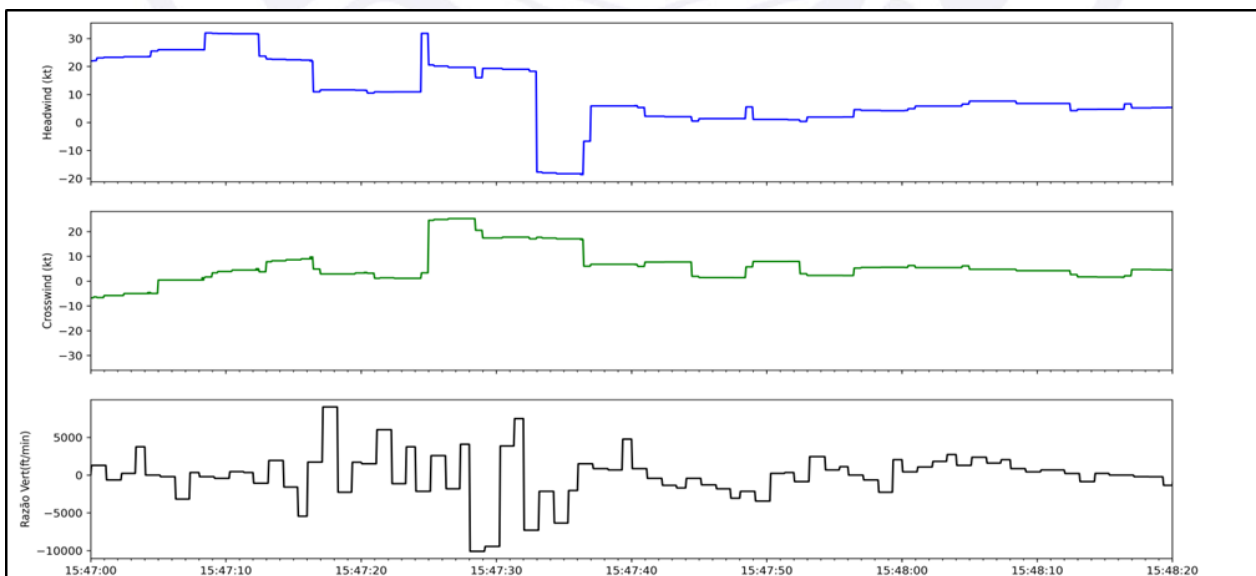
Figure 8 – Temporal evolution of the flight parameters during the turbulence.

Additionally, Figure 8 presents three graphs illustrating the temporal evolution of three other aerodynamic parameters during the aircraft's penetration into the turbulence, demonstrating the effects of the unstable atmospheric environment on the flight.

The first graph shows significant variations in the headwind component, with rapid oscillations and abrupt changes in intensity. Marked reductions were observed, followed by sudden increases, with peaks ranging from approximately 11 kt to values exceeding 30 kt over short periods of time. This behavior is consistent with the presence of wind gradients associated with turbulent cells, resulting in instantaneous variations in the available aerodynamic energy and directly affecting the aircraft's lift and indicated airspeed.

Taken together, the parameters analyzed indicated that the aircraft was subjected to an environment of strong turbulence, with simultaneous effects on its longitudinal, lateral, and vertical stability. These effects resulted in a significant increase in structural loads, a temporary degradation of flight quality, an increased flight crew workload, and a potential risk to occupants who were not adequately restrained.
