INTERNATIONAL CIVIL AVIATION ORGANIZATION

**EIGHTH TECHNICAL-
OPERATIONAL MEETING OF THE
REDDIG DIGITAL NETWORK**

FINAL REPORT

(Santiago de Chile, Chile 14 to 18 October 2019)

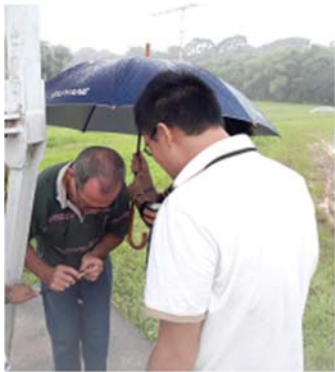
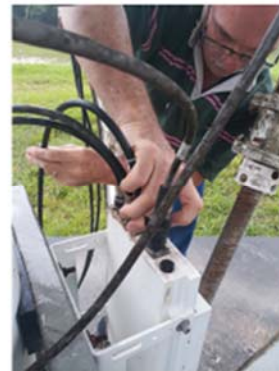
Durante la revisión se observaron novedades en el cableado y la funcionalidad de los equipos de la estación, tanto en la parte indoor como outdoor. Se verificó el funcionamiento mecánico de las llaves de conmutación del switch de los amplificadores y del switch de la guía de onda. Se reestablecieron las conexiones del cableado que estaba alternado por trabajos anteriores con el NCC.

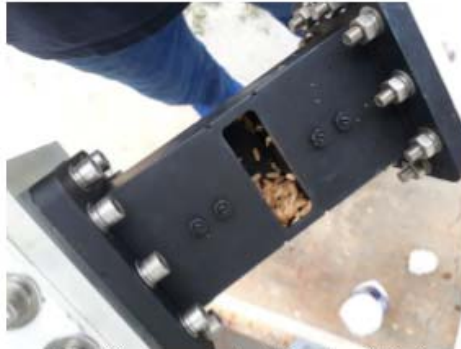
Mantenimiento componentes interior antenna (outdoor) – presencia de insectos

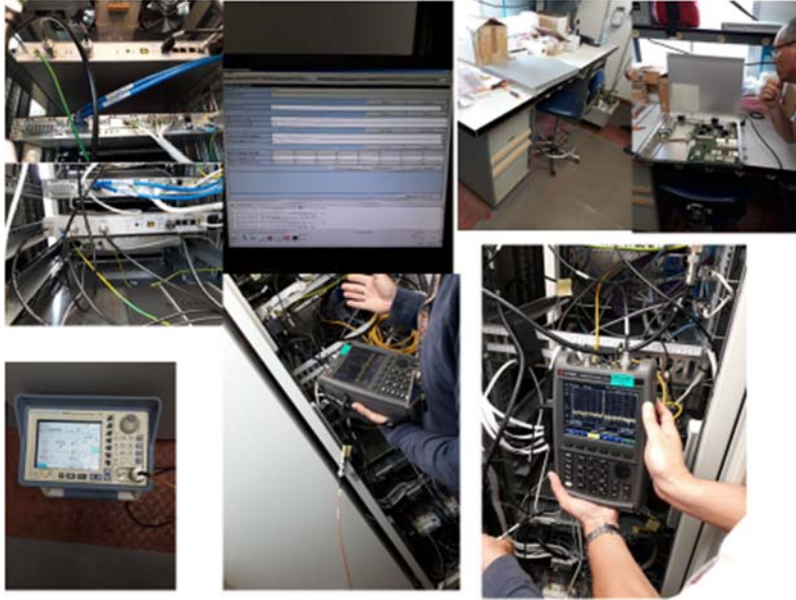
A efecto de poder verificar si la estación sufrió degradaciones por atenuaciones, se procedió a simular la inyección de una frecuencia tanto en recepción como en transmisión y la posterior lectura en las salidas de las etapas comentadas. Se registraron valores aceptables. Se hizo lo propio con los cables de transmisión y recepción que van del rack hasta la antena. Se obtuvieron resultados aceptables.

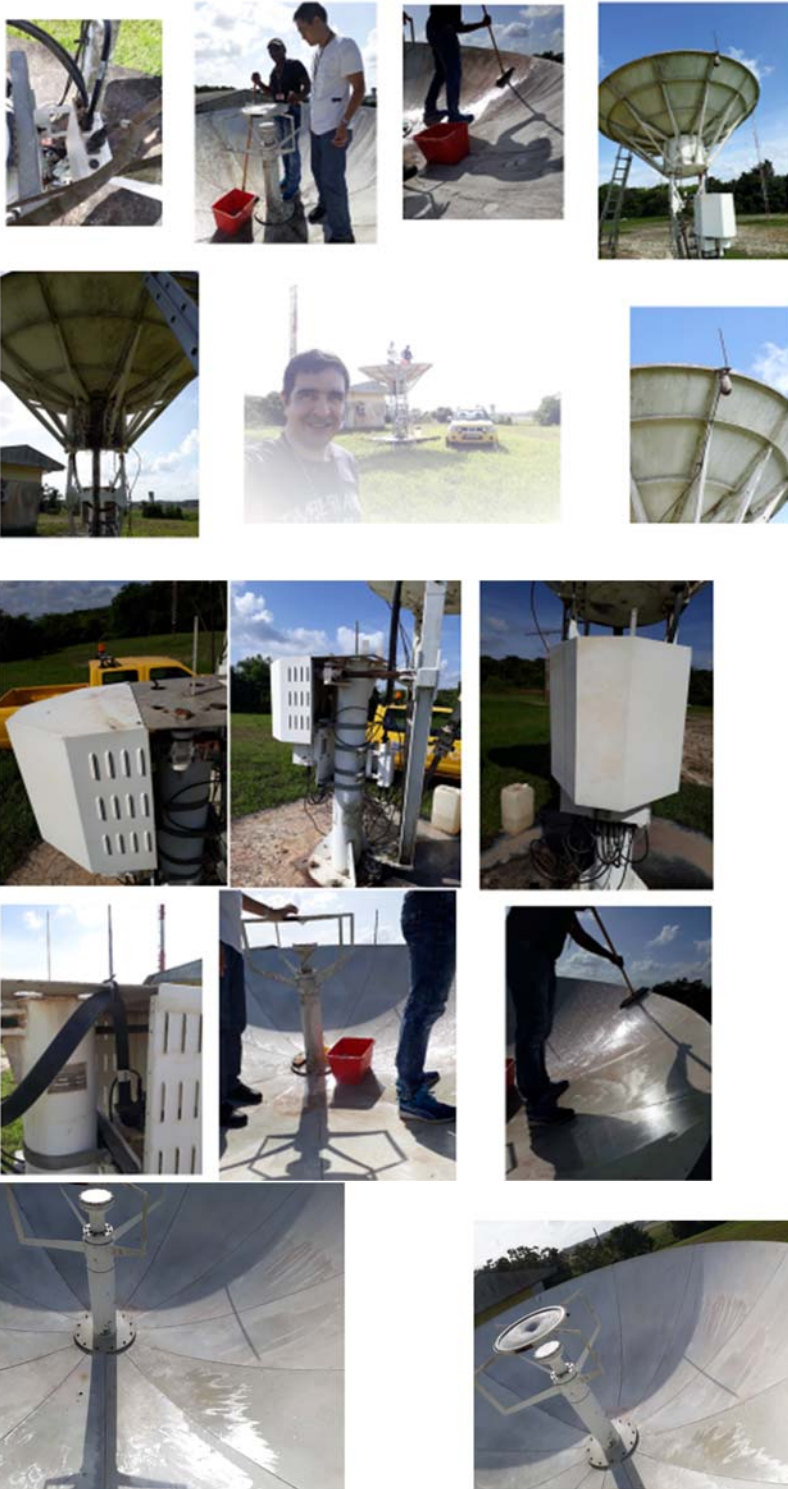
Conectores con novedades

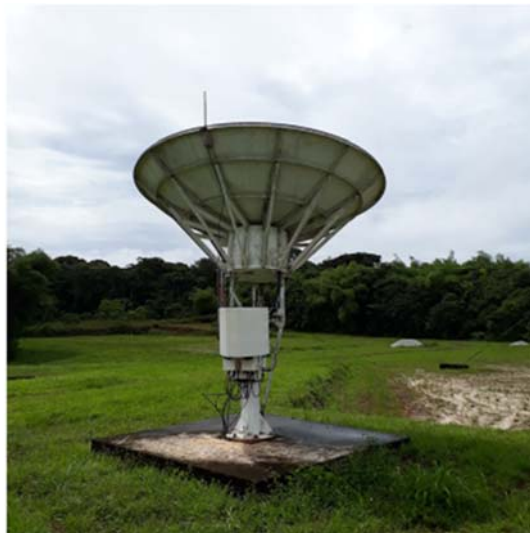
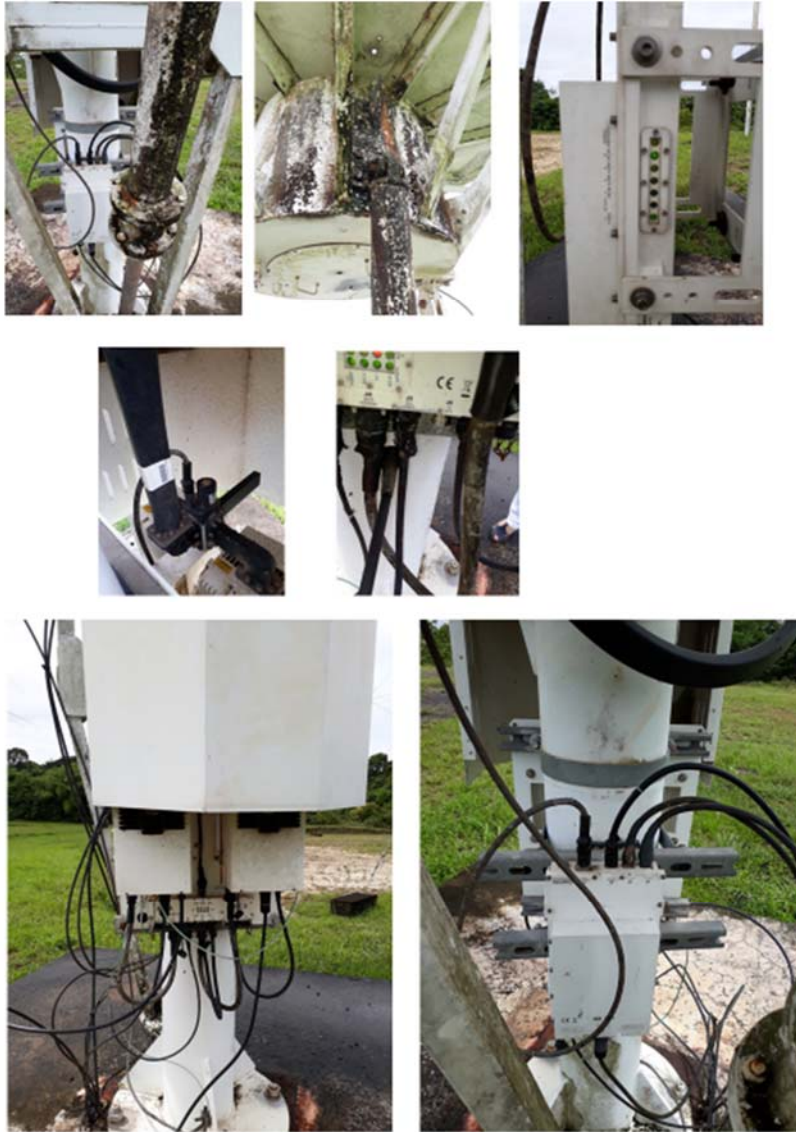
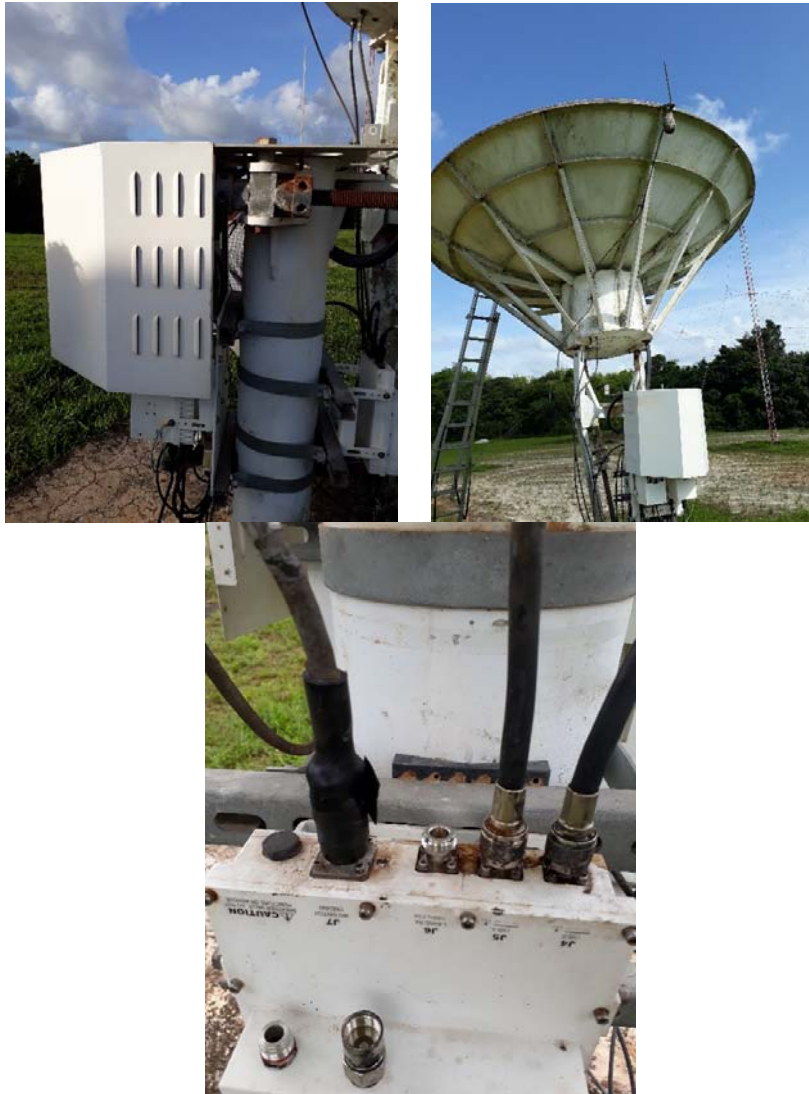
También se verificó que la infraestructura de la antena se encuentra en un estado que amerita una revitalización. En tal sentido, se adjunta un presupuesto para tener una referencia sobre los costos. Y se presentan a continuación fotografías que ilustran la situación.

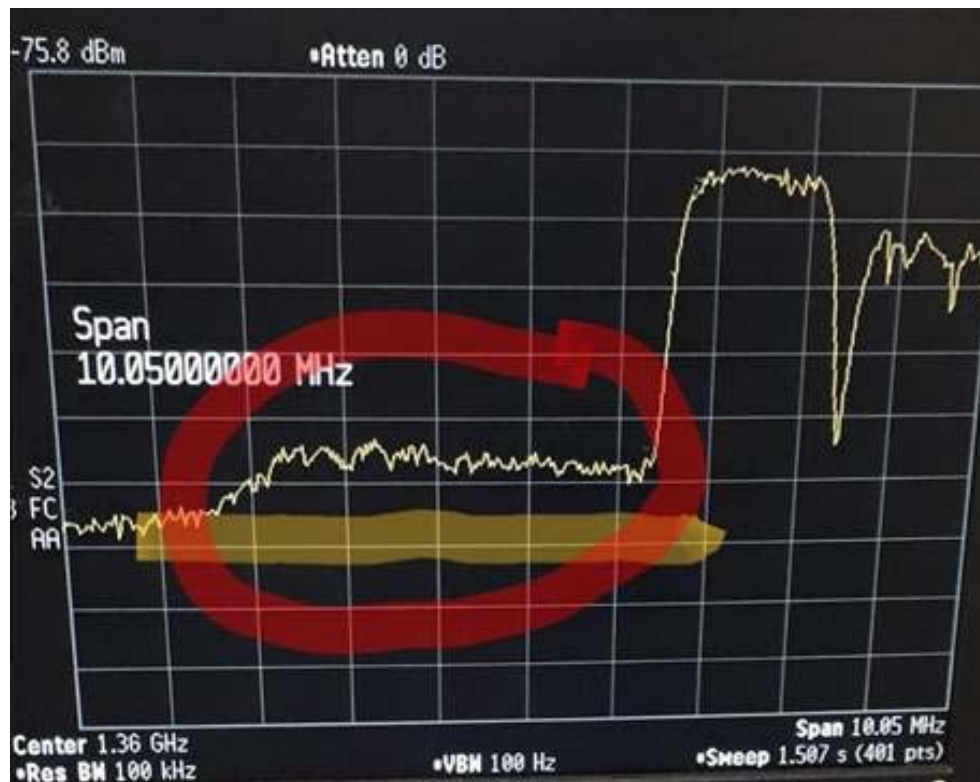
Cuando se apaga la transmisión de la red se observa la interferencia con 2 dB de incidencia

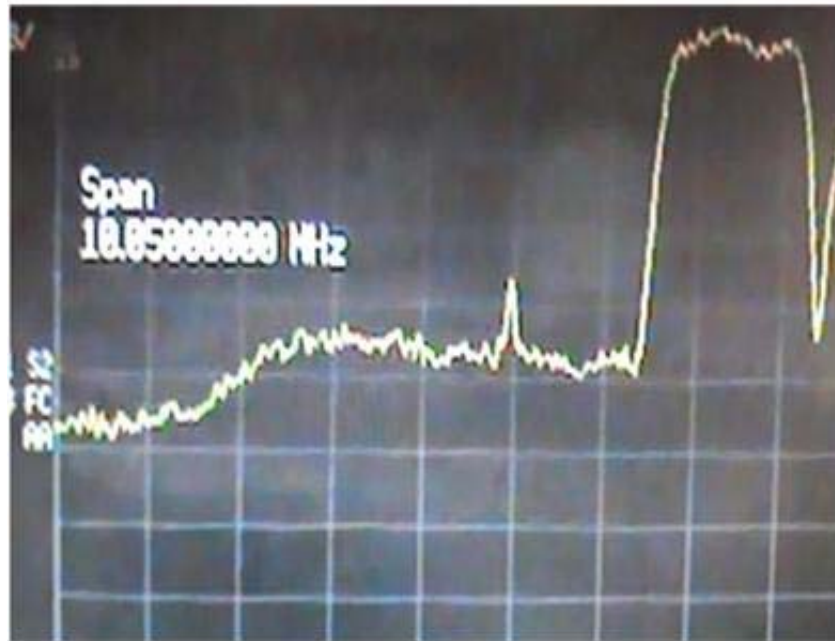
Picos que presenta la interferencia

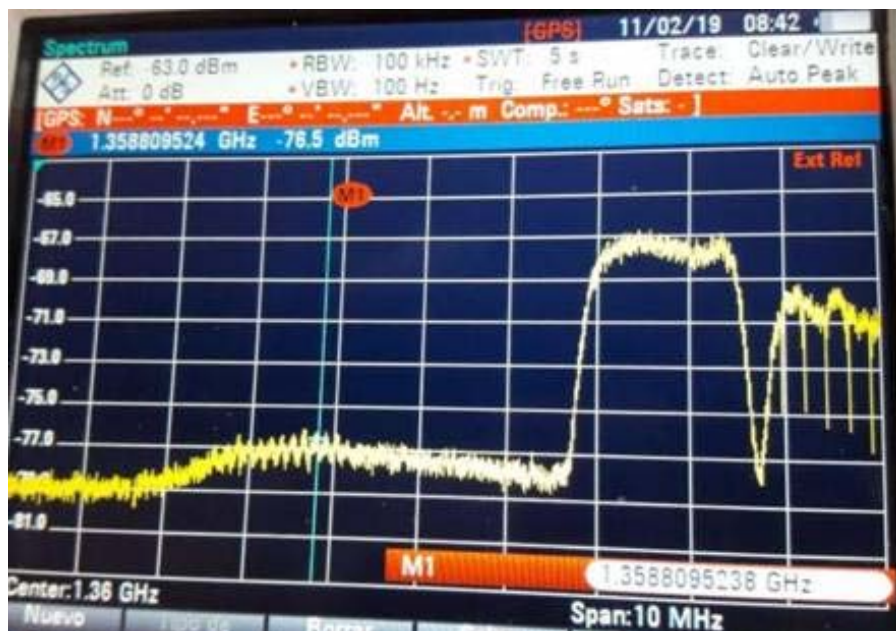
Misma incidencia observada desde Bogotá
