# Implementation of Measures to Prevent Objects Falling off Airplanes

January 2018

Civil Aviation Bureau of Japan,  
Ministry of Land, Infrastructure, Transport and Tourism  
Association of Air Transport Engineering and Research

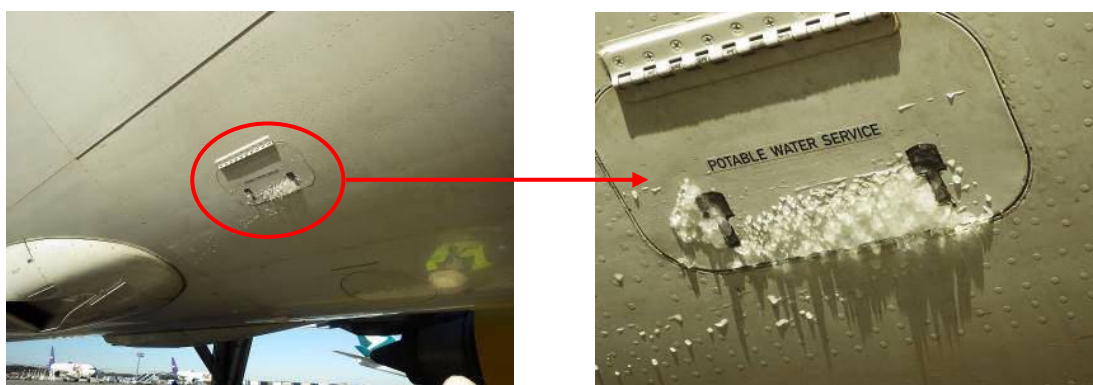
If the panel is not closed correctly or draining is insufficient after potable water servicing, ice blocks may form on the service panel and around it due to water leaks during flight. It is important to ensure that excess water is discharged after servicing, and it is also important, in particular, to completely drain water from the fill fitting itself. (Figure 3-1: Example of ice accumulation on potable water service panel and Figure 3-2: Example of ice accumulation on fill fitting (Potable water service panel))

Figure 3-1: Example of ice accumulation on potable water service panel

If a regular inspection task includes cleaning of the drain valve to maintain its functions properly and even a little water leak is found in daily water service, it is important to suspect if there may be a valve failure and immediately report it or inform the mechanics in charge of the aircraft.

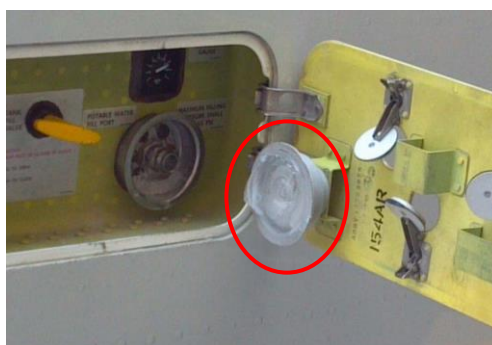
Figure 3-2: Example of ice accumulation on fill fitting (Potable water service panel)

A potable water drain is equipped to discharge water from the potable water system during maintenance work. However, improper switching of an internal valve or failure of an internal valve itself may cause a water leak into the drain line from the potable water system and may possibly result in ice accumulation.

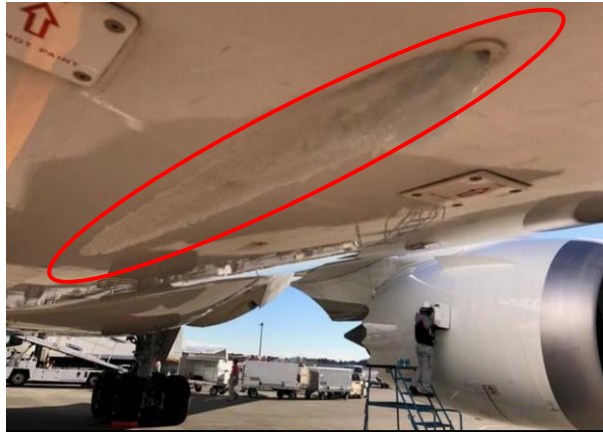
There are two conceivable mechanisms by which ice blocks form: One is that a drain valve has not been closed properly due to a temporary failure or dust clogging and this results in a water leak during flight; the other is that, when the difference in pressure between the inside and outside of the aircraft declines below certain altitude, the drain valve opens and the leaking water is exposed to the outside cold air. (Figure 3-3: Example of ice accumulation on fuselage drain)

Figure 3-3: Example of ice accumulation on fuselage drain

The drain valves of all models are required to be inspected and cleaned in periodical maintenance. Therefore, it is imperative that the function of these valves be maintained properly in order to prevent water from leaking to the outside of an aircraft during flight so that ice accumulation can be reduced. In addition, it is necessary to follow basic standards such as ensuring the complete removal of accumulated snow on cargo in order to prevent moisture from entering the cargo compartment. Further, it is important to follow the recommendations about ice accumulation on the cargo door as described in the next section.

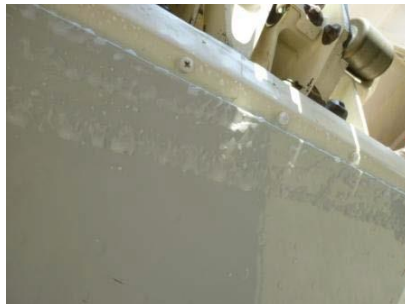
Ice accumulation on the cargo door may be caused by water leak or snow accumulation on cargo. It is important to remove moisture completely from the cargo and wrap it properly before loading. Take note of the following points:

Figure 3-4: Example of ice accumulation along the edge of the lower part of cargo door

- a. Make sure that cargo that has a potential for water leaks has been appropriately packed and wrapped in a way that it is judged to be robust enough for air transportation.
- b. When cargo is temporarily stored outdoors, appropriate measures shall be taken to prevent damage caused by rain and snow.
- c. Any snow and ice remaining on the cargo or unit loading device shall be removed before loading cargo on the aircraft.
- d. When containers and baggage are loaded in the cargo compartment, rainwater and snow on them shall be removed before they are carried in.
- e. If it is stormy when cargo is loaded and there is a possibility that a large amount of rainwater has got inside, be very careful.

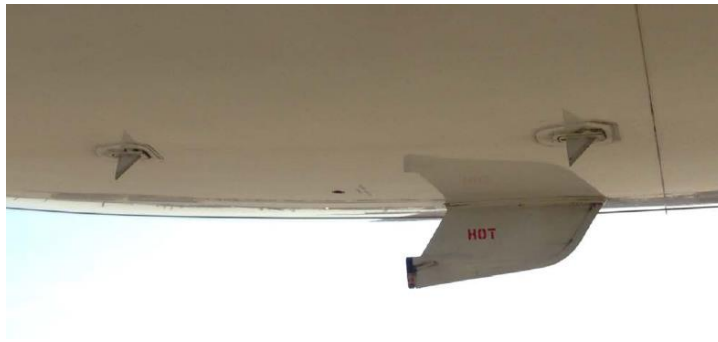
Figure 3-5: Drain mast

A drain mast is installed to discharge water from the galley and lavatory wash-basins. It is always heated during flight and controlled to prevent water from freezing. A failure of this heating function may cause ice blocks to form. It is important to confirm that the heating function of these areas works properly at the time of maintenance.

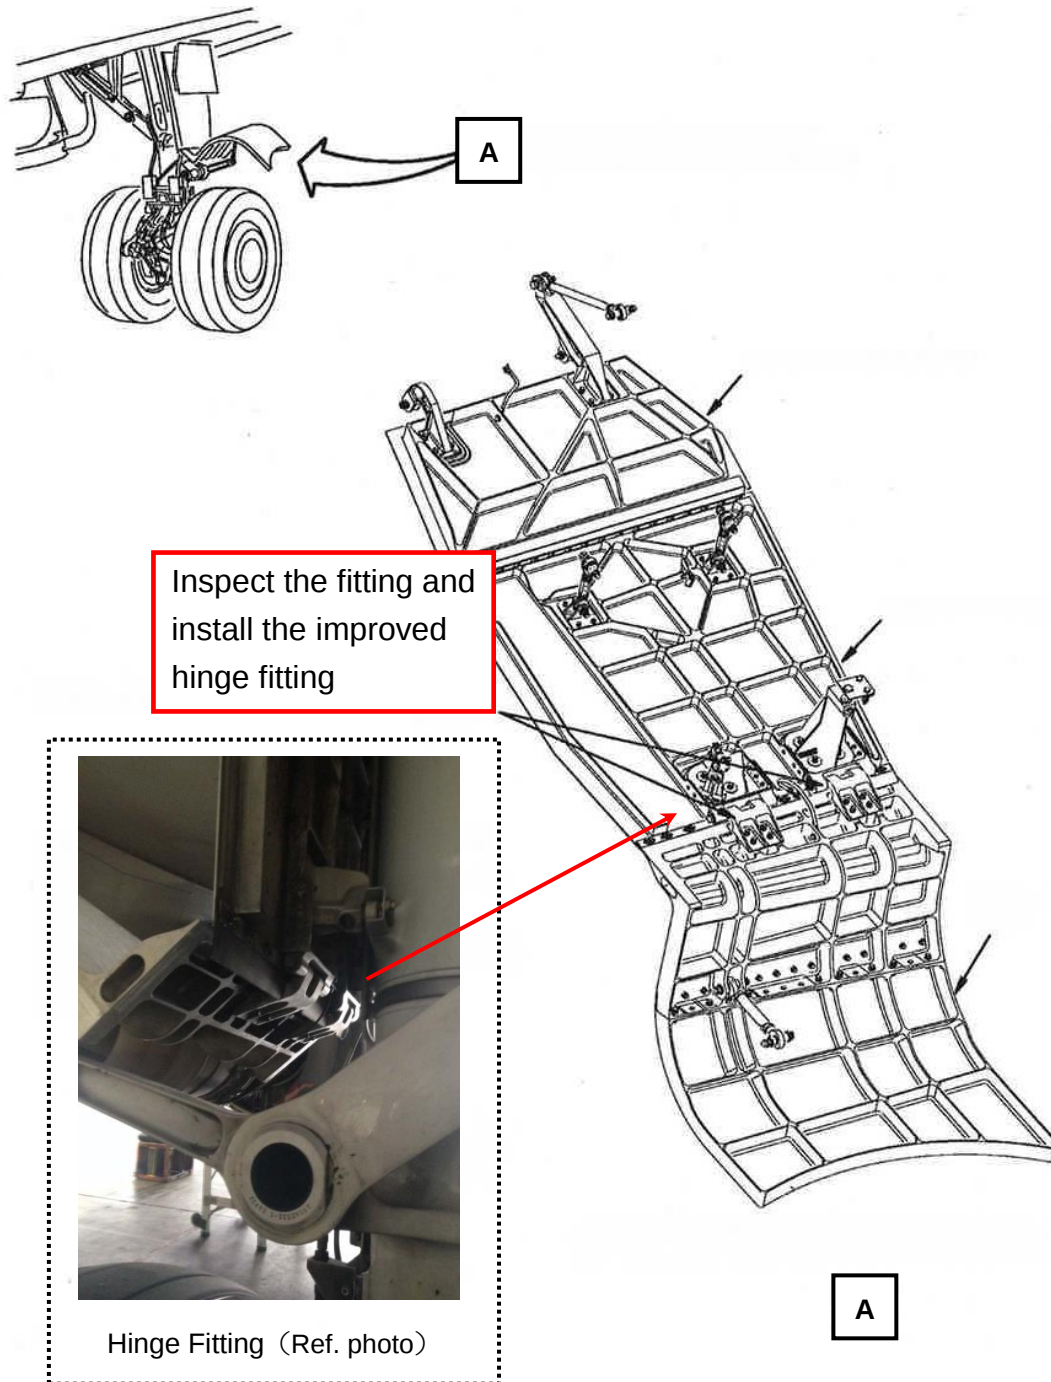
Fig. 1-1

| Model | Title |
|---|---|
| B737 | DOORS – Landing Gear Doors – Inboard Main Landing Gear Door Hinge Fittings – Inspection and Replacement (SB 737-52A-1167) |

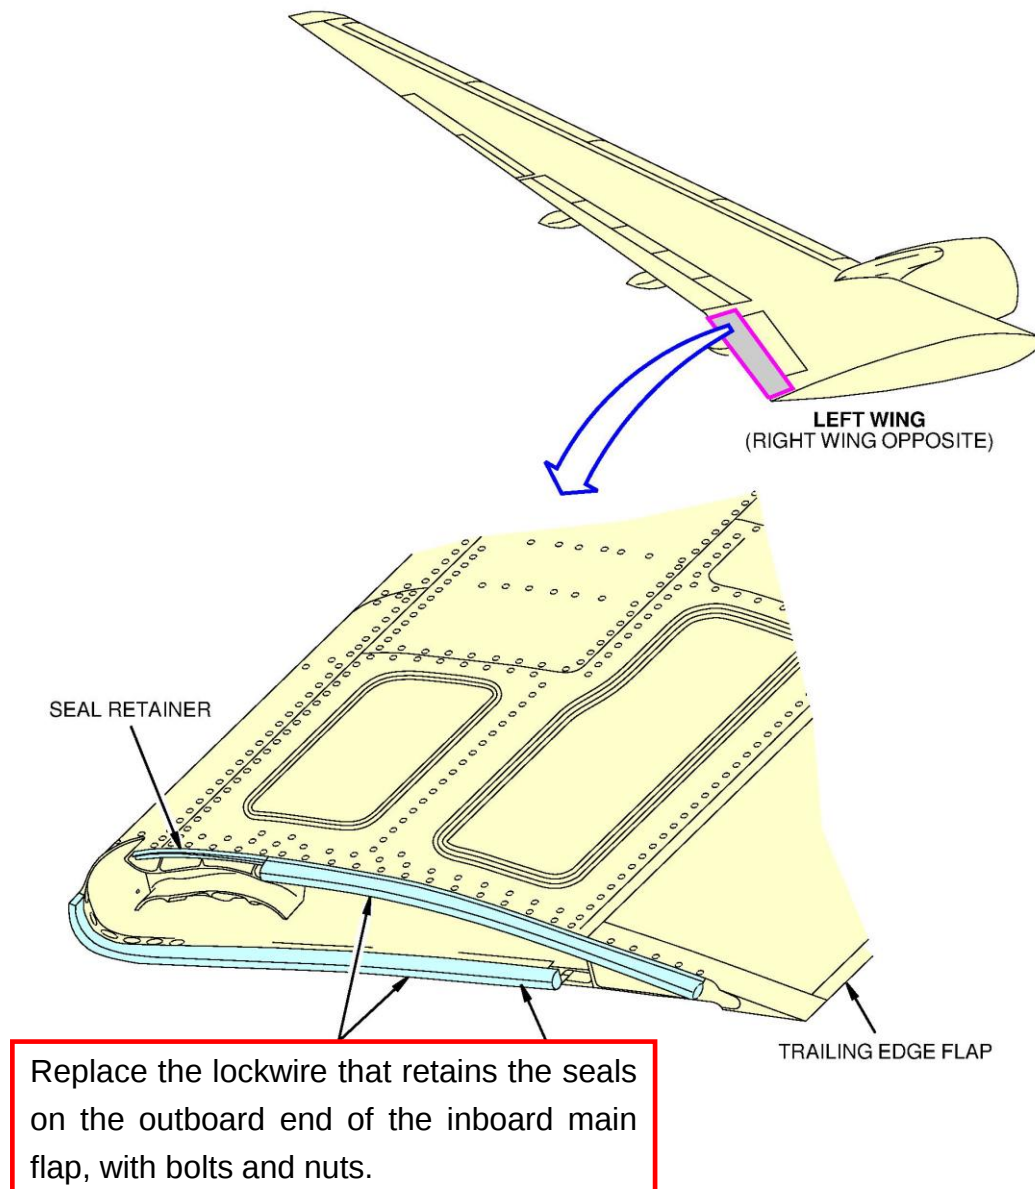
Fig. 1-2

| Model | Title |
|---|---|
| B737 | WINGS – Trailing Edge Flaps – Inboard Main Flap Seal Fastener Change<br>(SB 737-57-1331) |

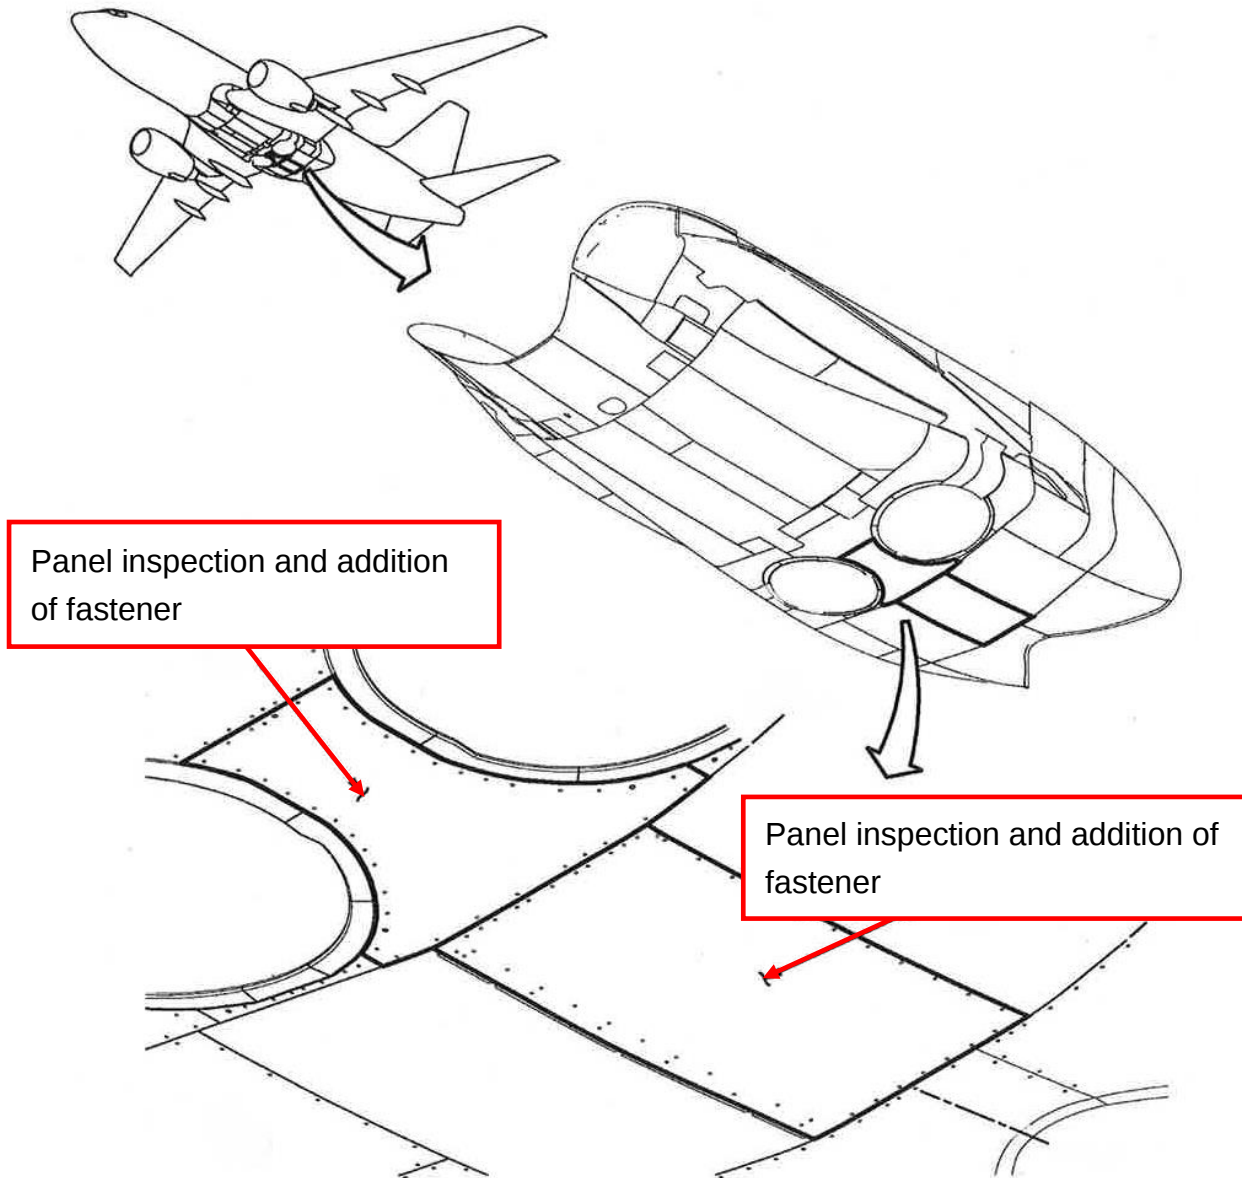
Fig. 1-3

| Model | Title |
|---|---|
| B737 | FUSELAGE – Fillet Fairings – Aft Wing to Body Fairing – Panel 194E and Aft Center Wheel Well Panel 193D – Inspection and Rework (SB 737-53-1307) |

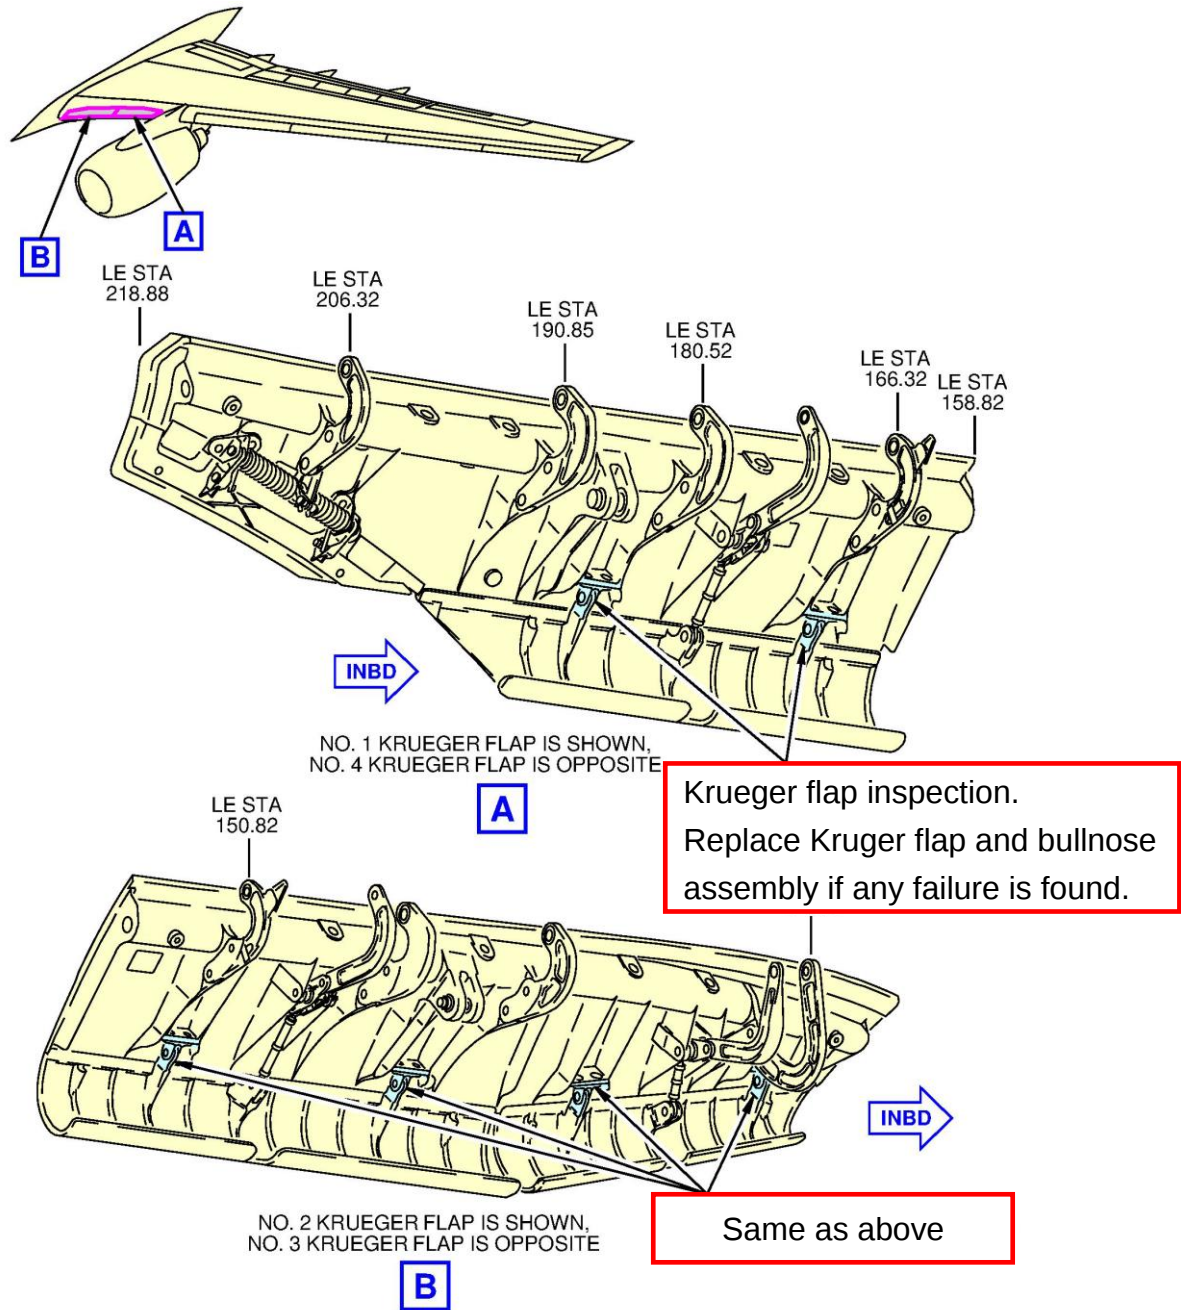
Fig. 1-4

| Model | Title |
|---|---|
| B737 | WINGS – Leading Edge And Leading Edge Devices – Krueger Flap Inspection<br>(SB 737-57A-1327) |

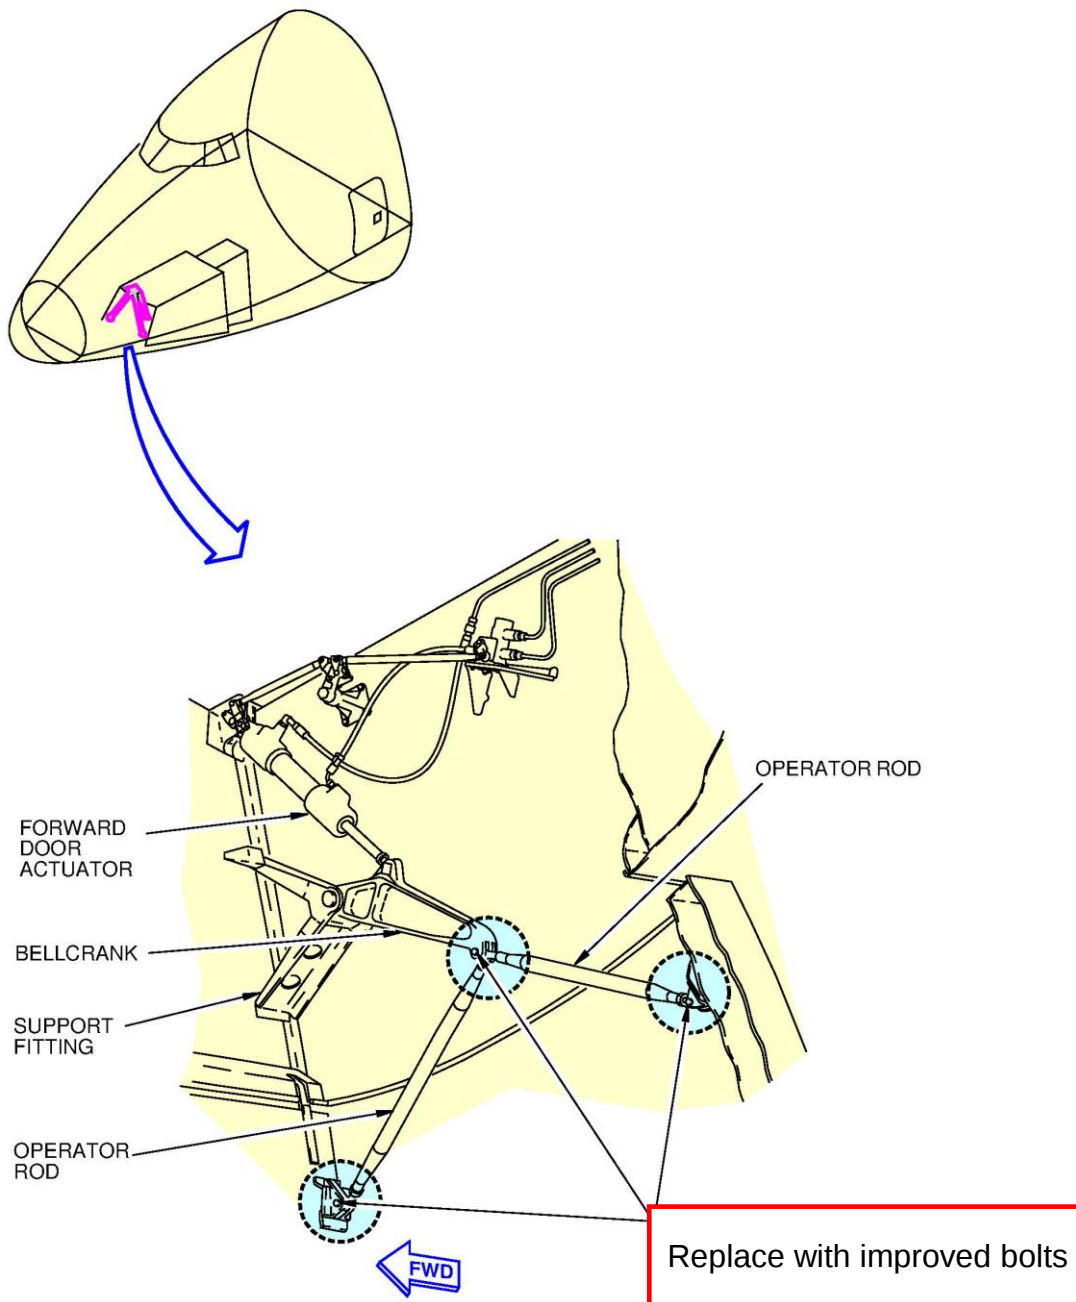
Fig. 1-5

| Model | Contents of Measure |
|---|---|
| B747 | FUSELAGE – Wheel Wells – Nose Landing Gear Forward Door Operator Rod Bolt Replacement (SB 747-53-2894) |

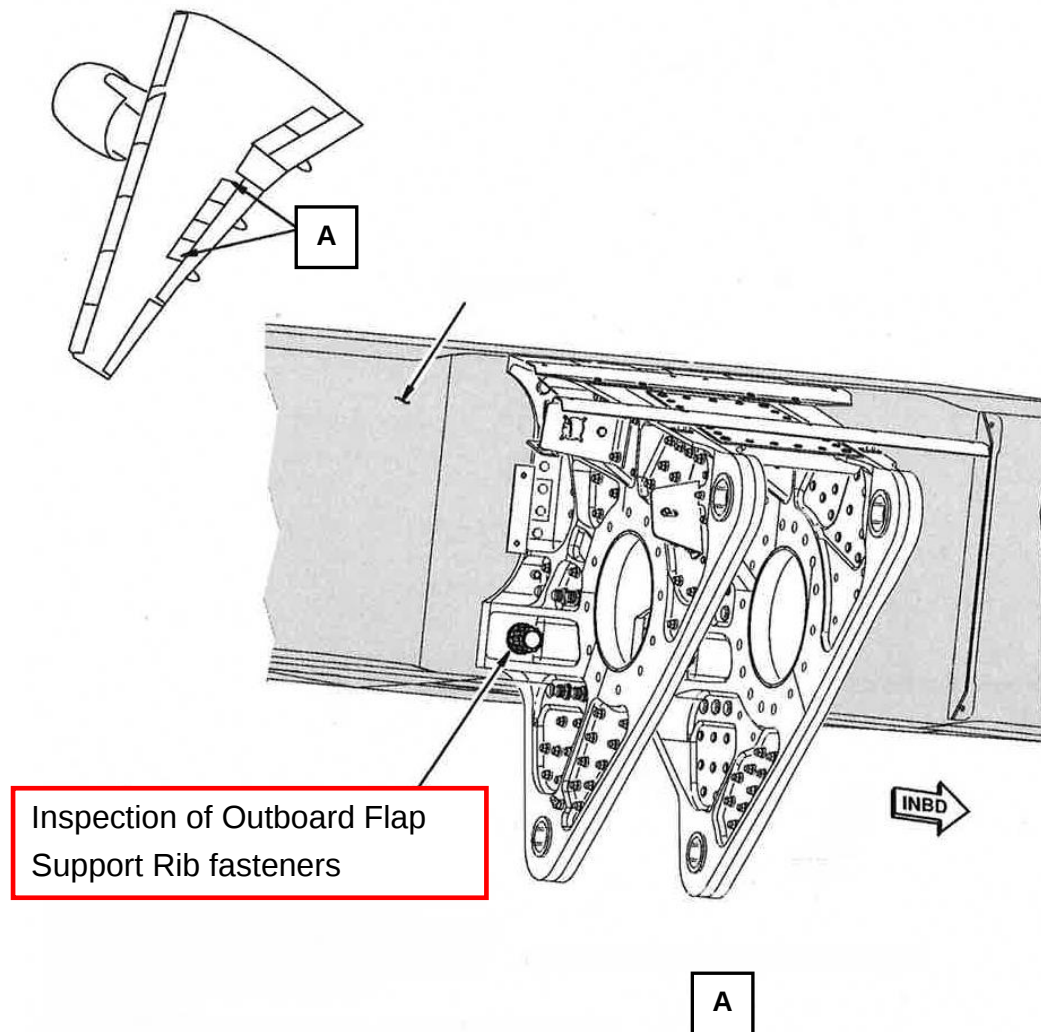
Fig. 1-6

| Model | Title |
|---|---|
| B767 | WINGS – Trailing Edge and Trailing Edge Devices – Outboard Flap Support Rib<br>Nut Fracture Inspection (SB 767-57A-0131) |

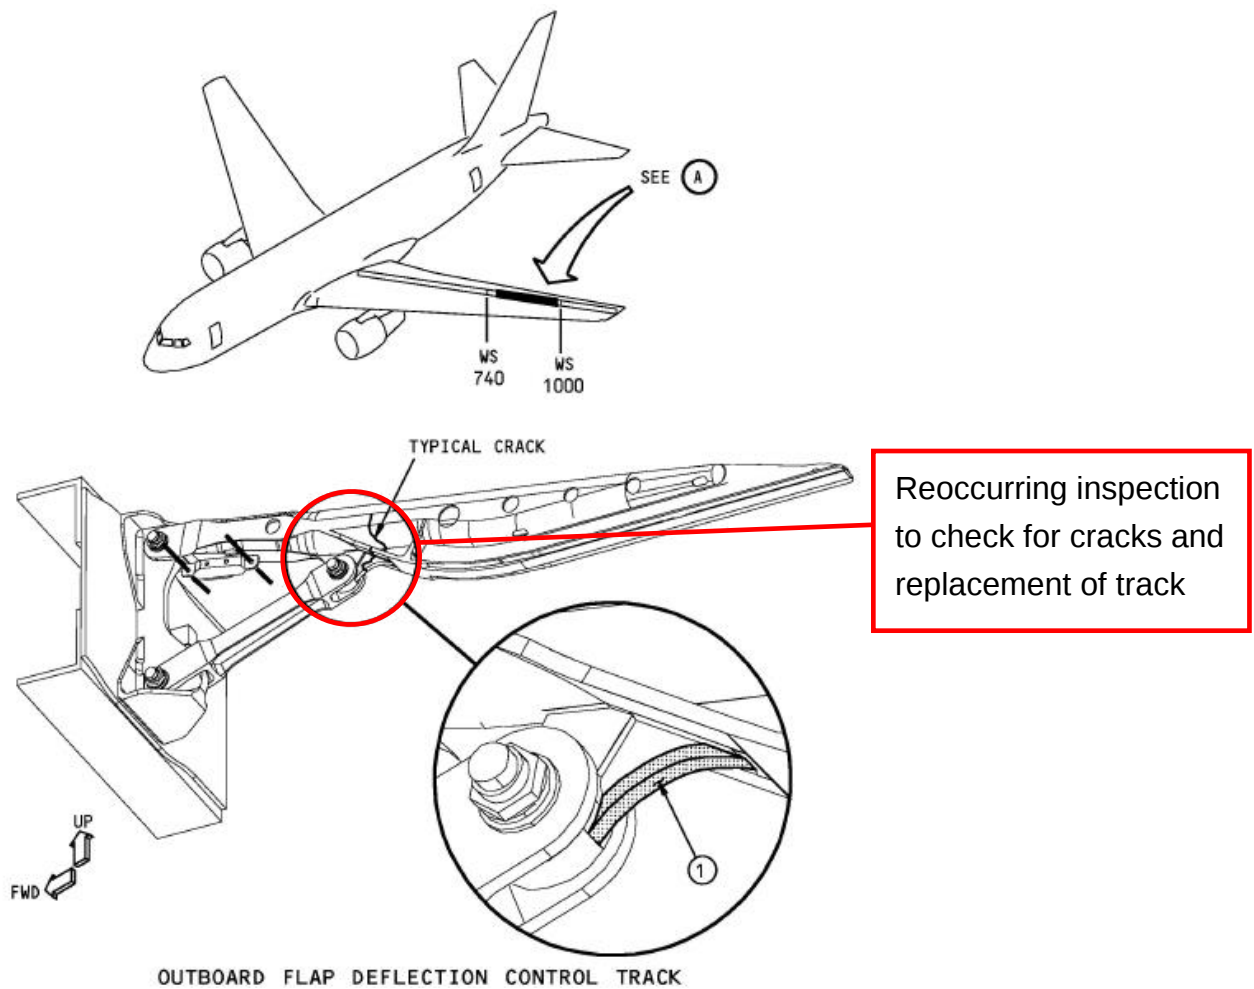
Fig. 1-7

| Model | Title |
|---|---|
| B767 | FLIGHT CONTROLS - Flaps - Outboard Flap Deflection Control Track<br>-Inspection/Replacement (SB 767-27-0184) |

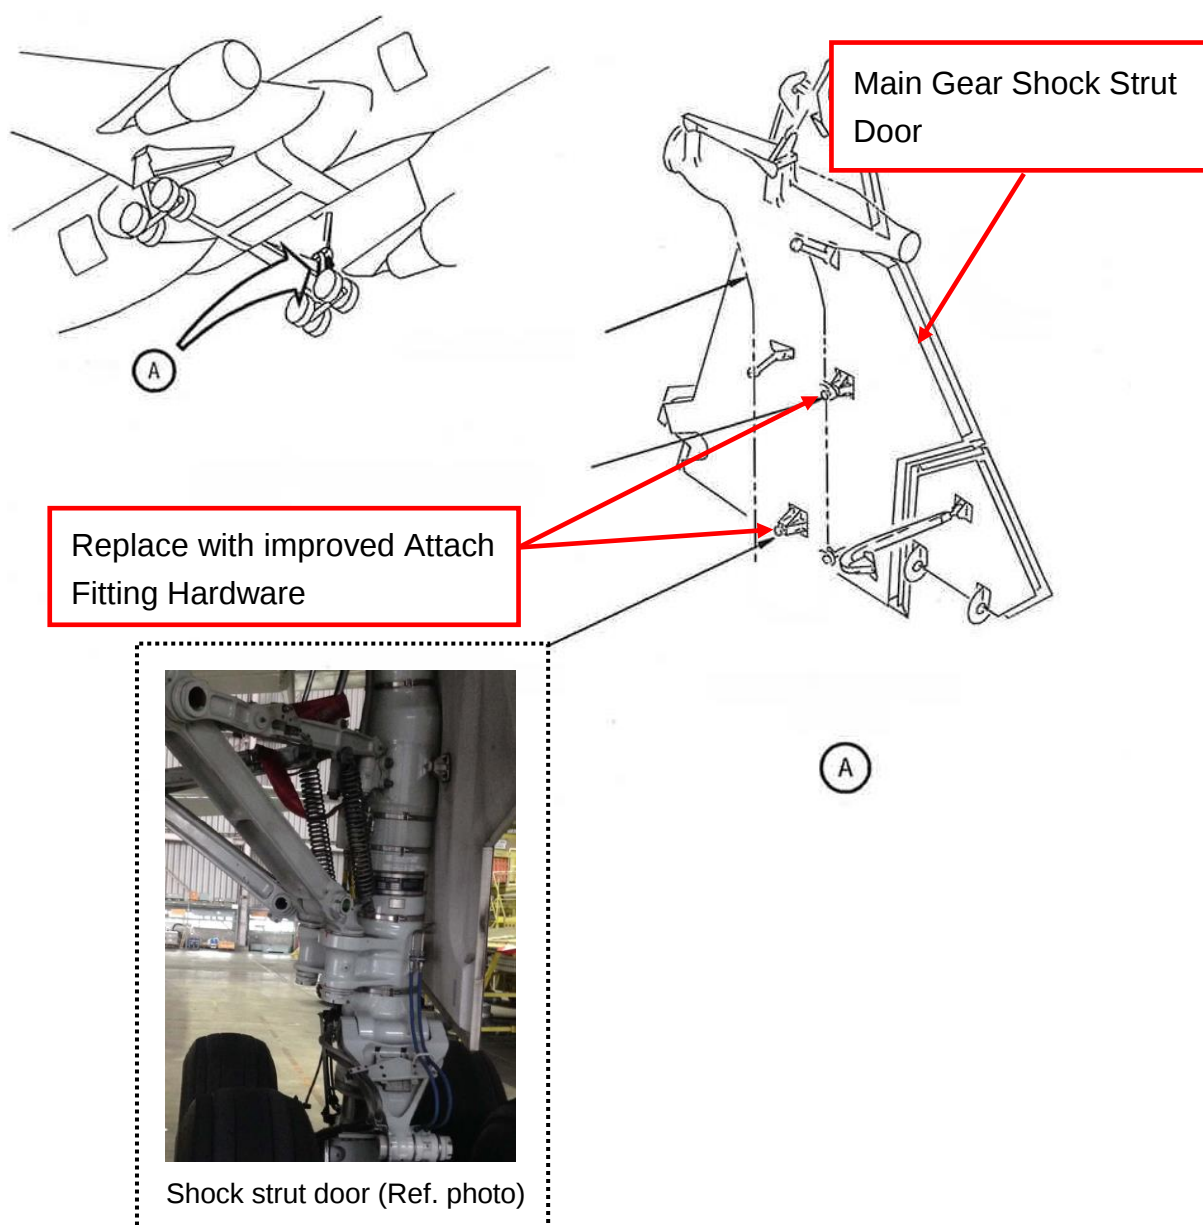
Fig. 1-8

| Model | Title |
|---|---|
| B767 | LANDING GEAR – Main Landing Gear and Doors – Main Gear Shock Strut Door and Linkage – Mid and Lower Attach Fitting Hardware Replacement<br>(SB 767-32-0194) |

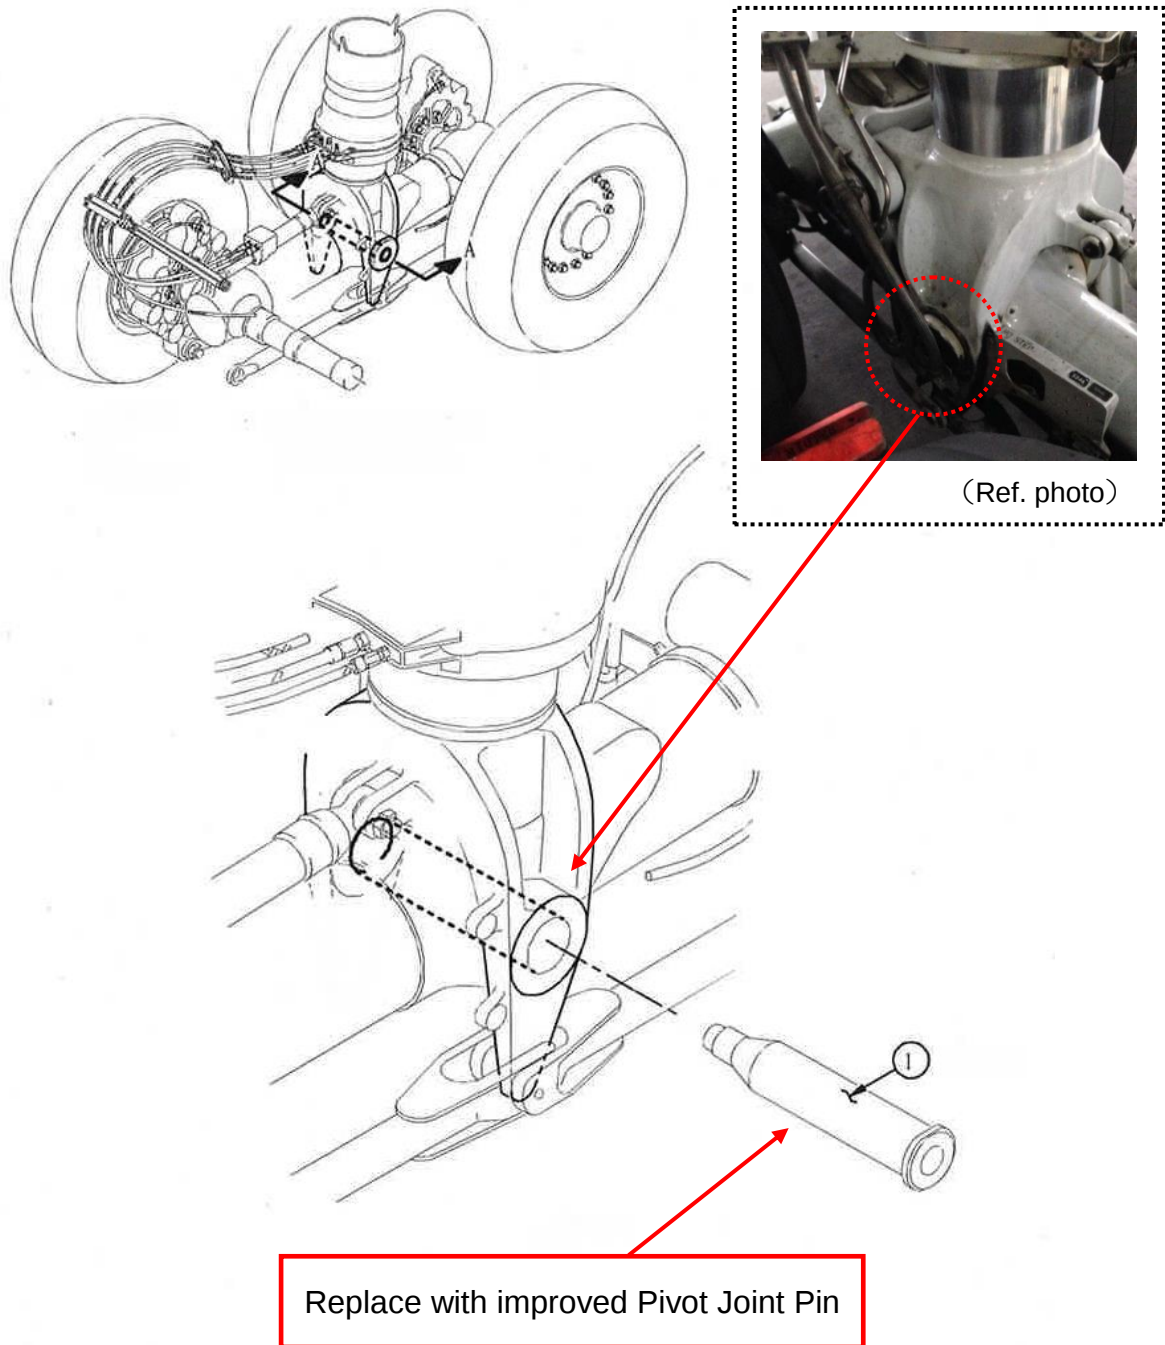
Fig. 1-9

| Model | Title |
|---|---|
| B767 | LANDING GEAR – Main Landing Gear Bogie Beam Pivot Joint Pin Replacement<br>(SB 767-32A-0199) |

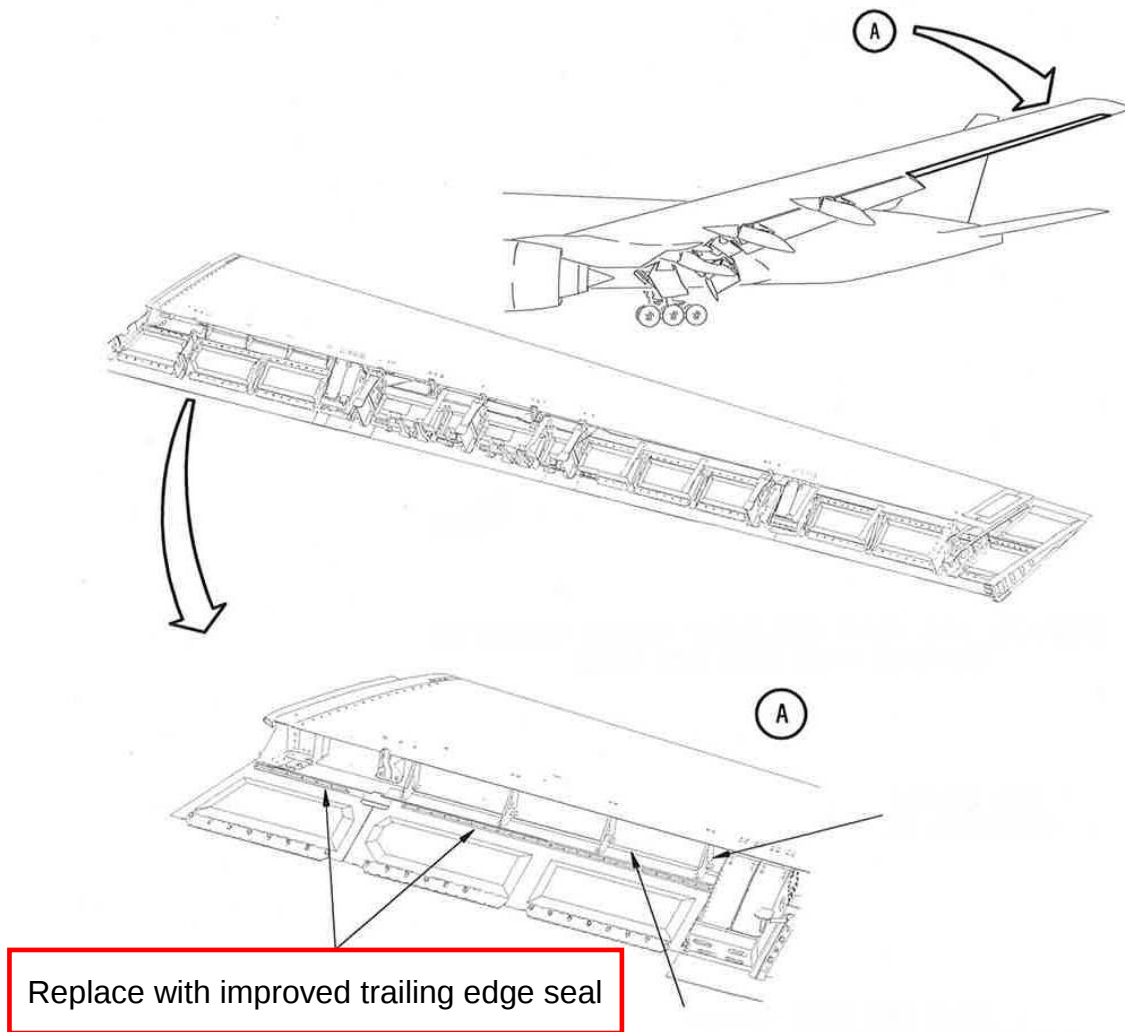
Fig. 1-10

| Model | Title |
|---|---|
| B777 | AILERONS AND FLAPERONS-Aileron Leading Edge Rib Addition And Fixed Trailing Edge Seal Replacement (SB 777-27-0022) |

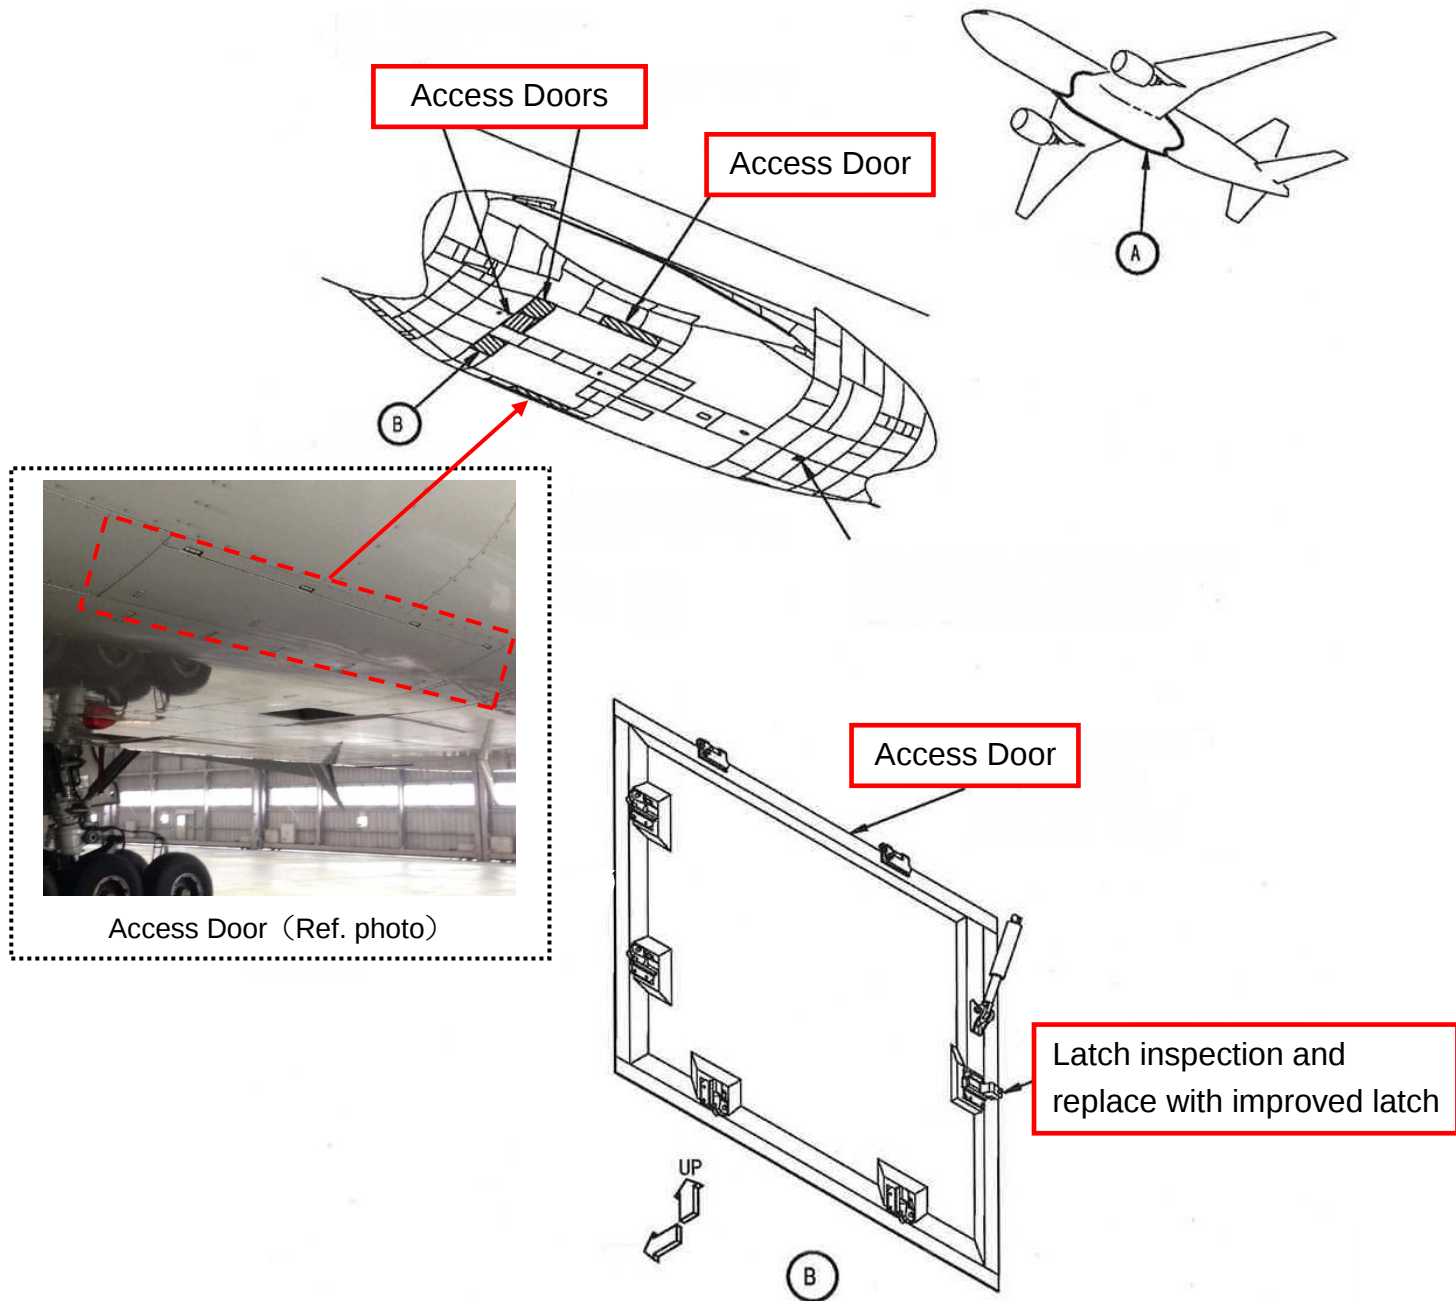
Fig. 1-11

| Model | Title |
|---|---|
| B777 | FUSELAGE - Section 44 - Aerodynamic Fairings - Underwing Fairing Access Doors -Rigging and Latch Replacement (SB 777-53-0050) |

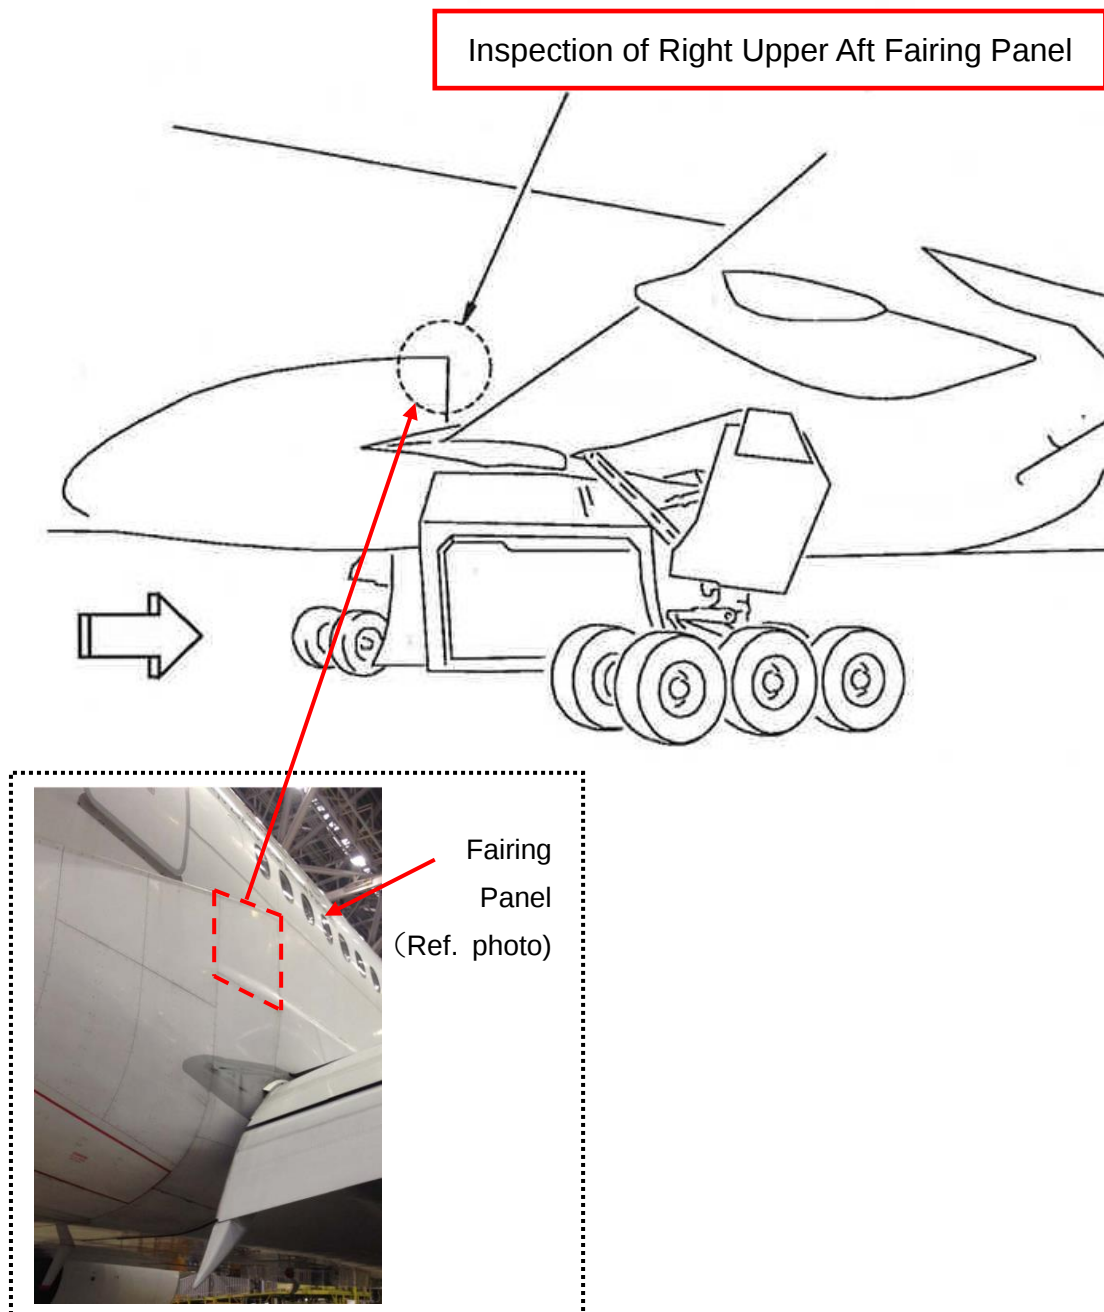
Fig. 1-12

| Model | Title |
|---|---|
| B777 | FUSELAGE - Aerodynamic Fairings - Right Upper Aft Fairing Panel Assembly<br>Misfair Inspection/Replacement (SB 777-53-0056) |

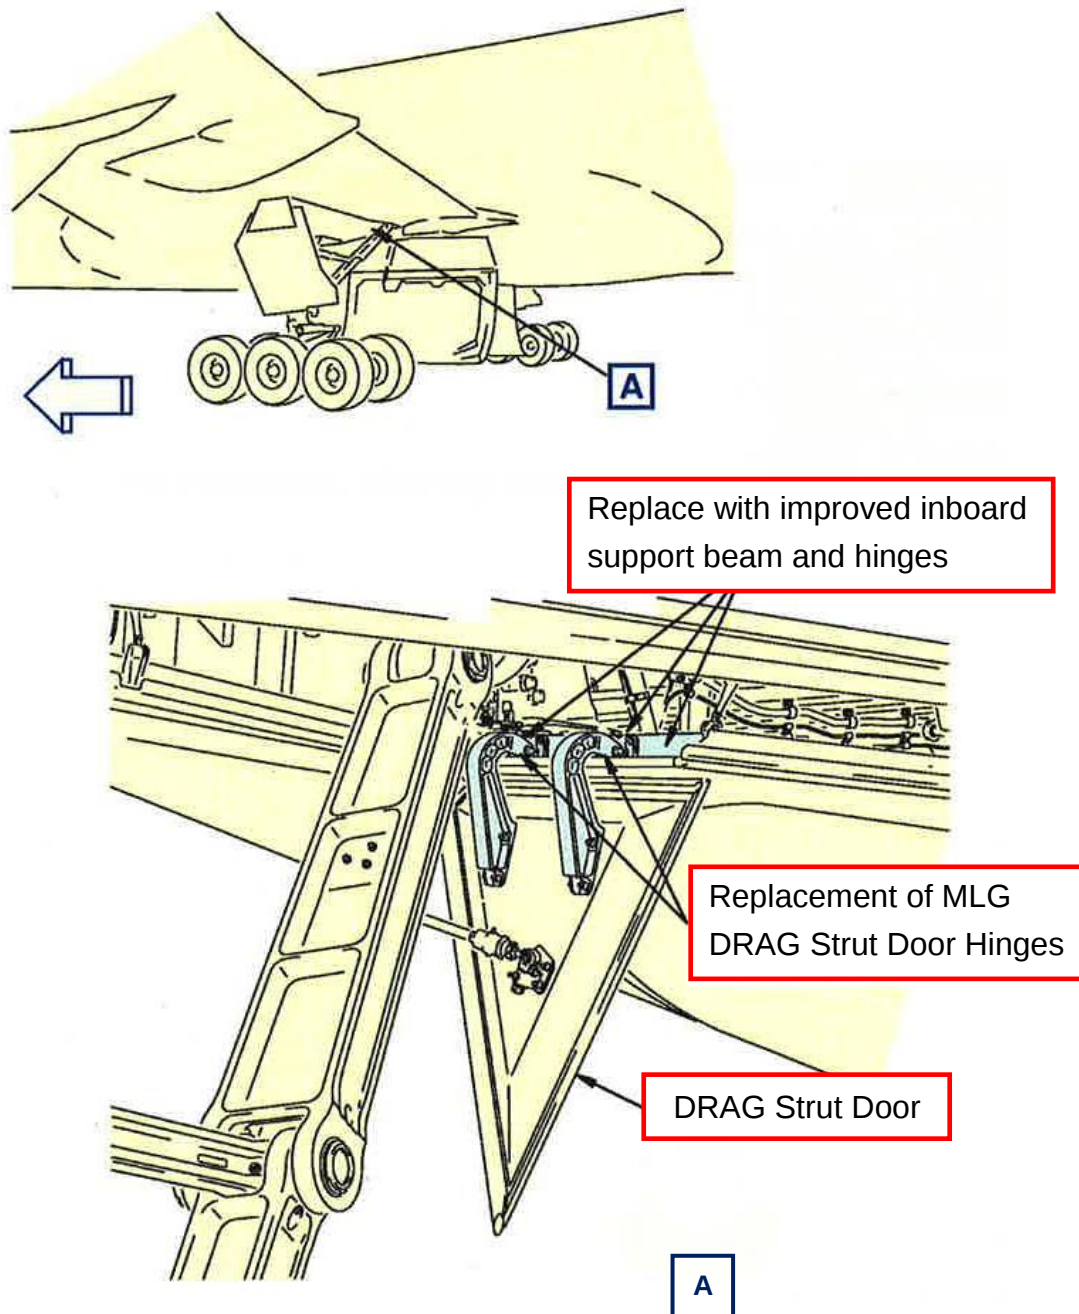
Fig. 1-13

| Model | Contents of Measure |
|---|---|
| B777 | WINGS - Wing Trailing Edge - Inboard Fixed Trailing Edge Support Beam Replacement (SB 777-57-0093) |

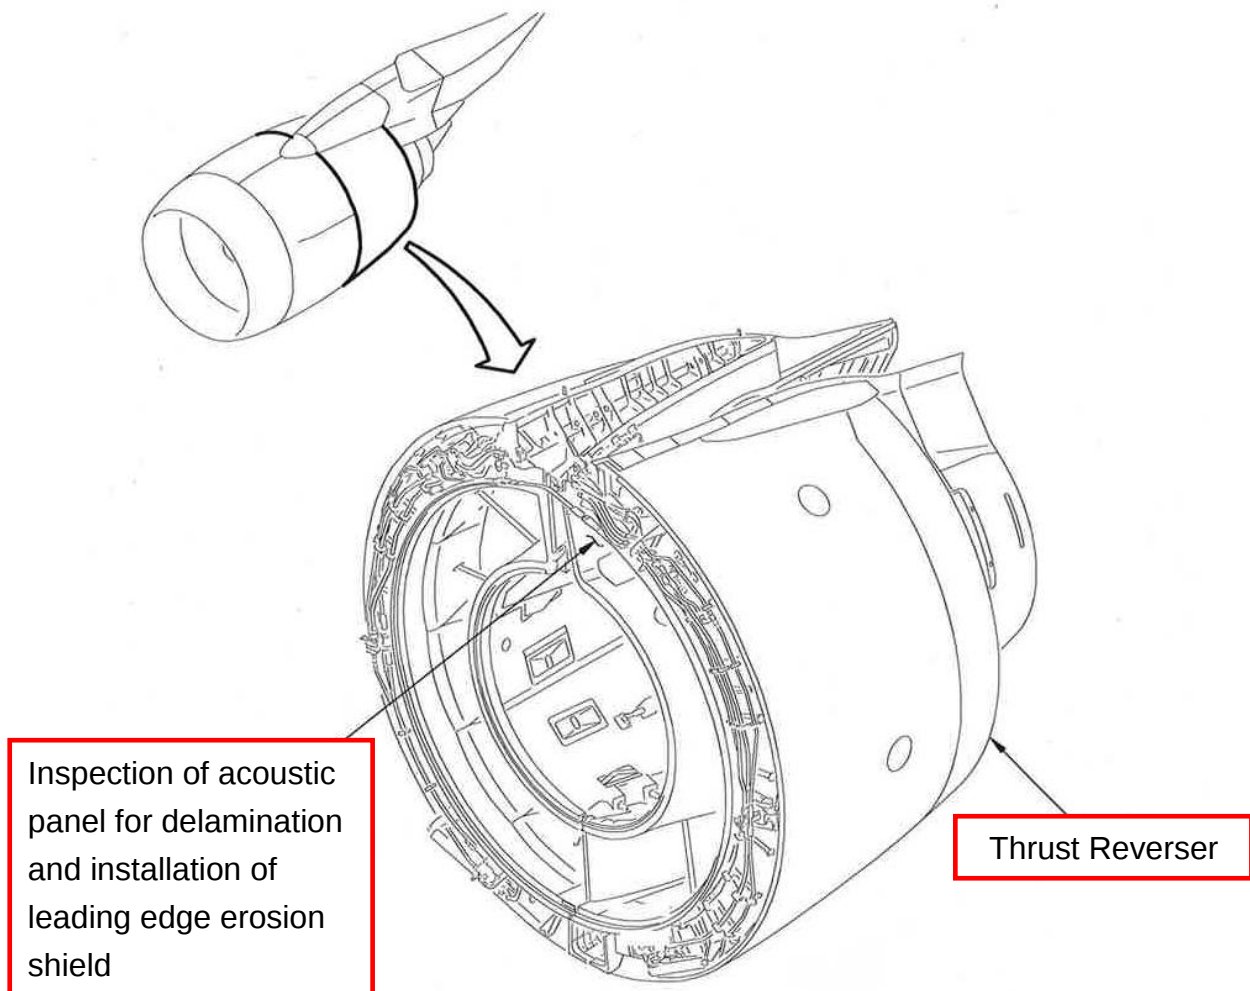
Fig. 1-14

| Model | Title |
|---|---|
| B777 | POWER PLANT (PW4000) - EXHAUST - THRUST REVERSER - UPPER<br>BIFURCATION EROSION SHIELD – ADDITION (SB 777-78-0022) |
