# Implementation of Measures to Prevent Objects Falling off Airplanes

January 2018

Civil Aviation Bureau of Japan,  
Ministry of Land, Infrastructure, Transport and Tourism  
Association of Air Transport Engineering and Research

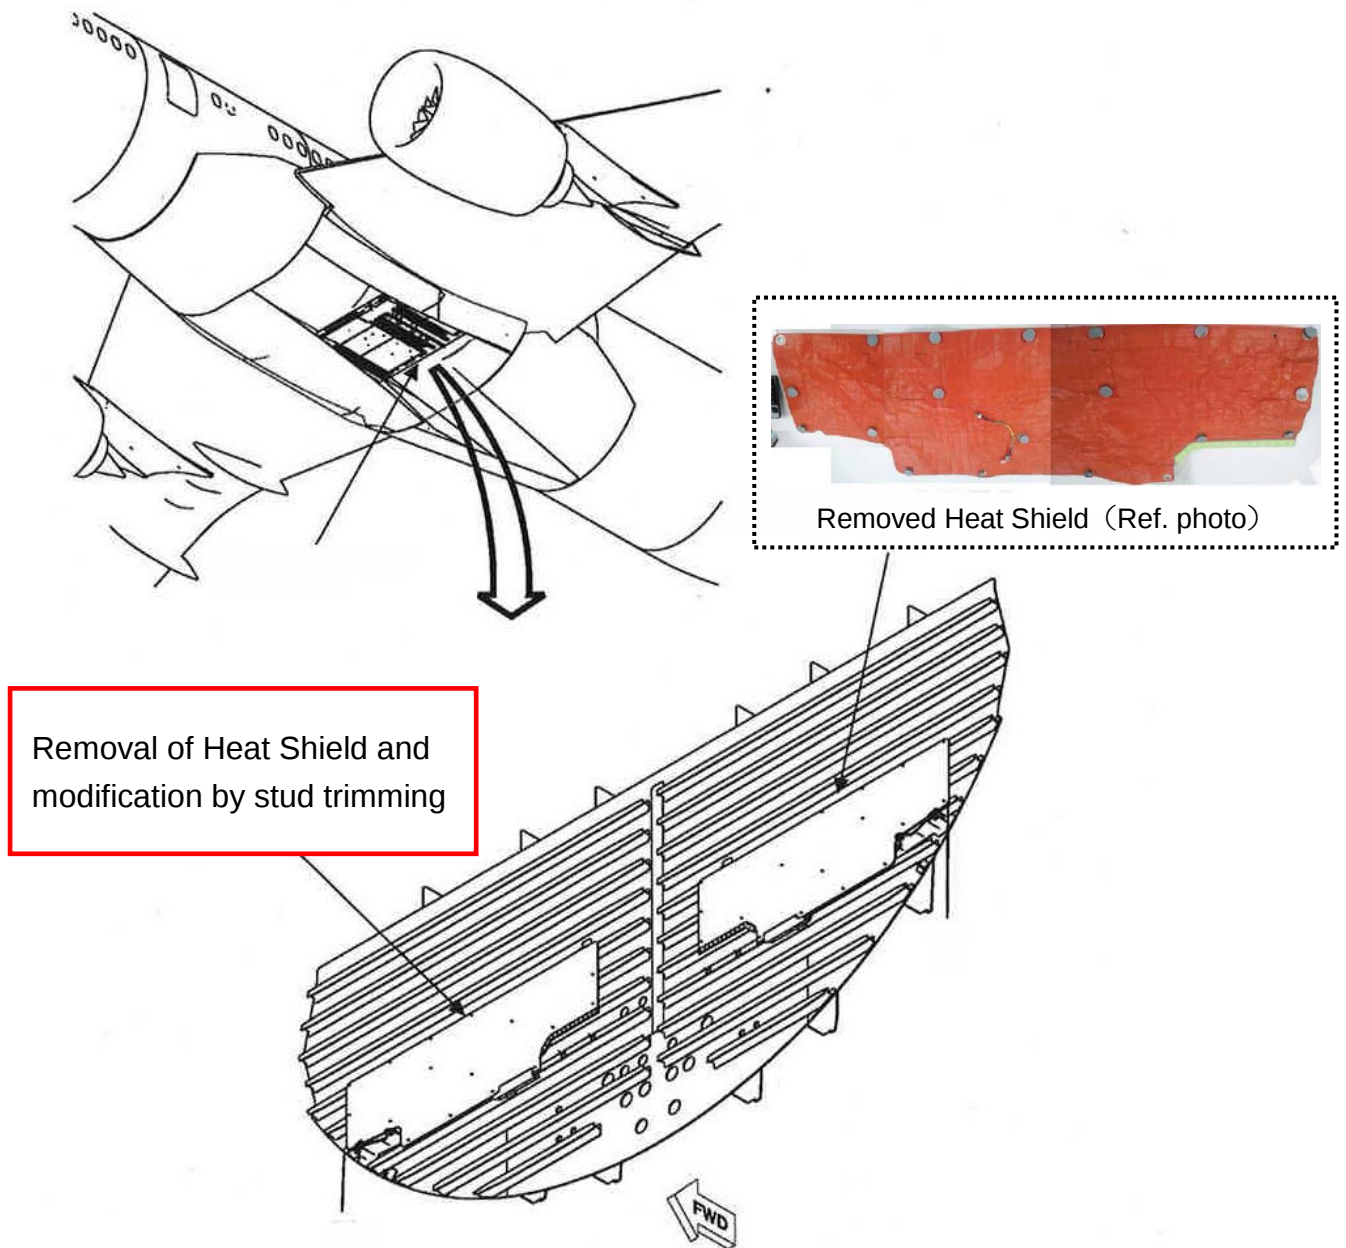
Fig. 1-15

| Model | Title |
|---|---|
| B787 | FUSELAGE - Main Landing Gear Wheel Well Structure – Section45 – Aft Wheel Well Bulkhead Heat Shield Click Bond Revision (SB 787-53-0022) |

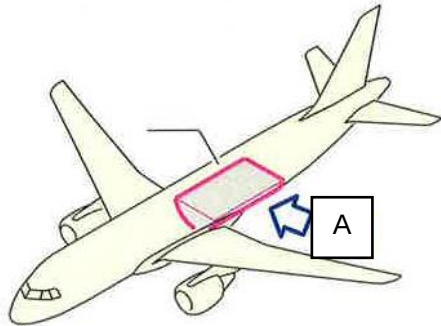
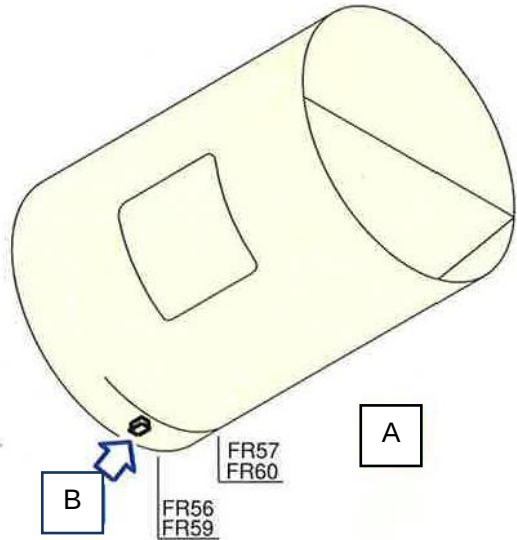
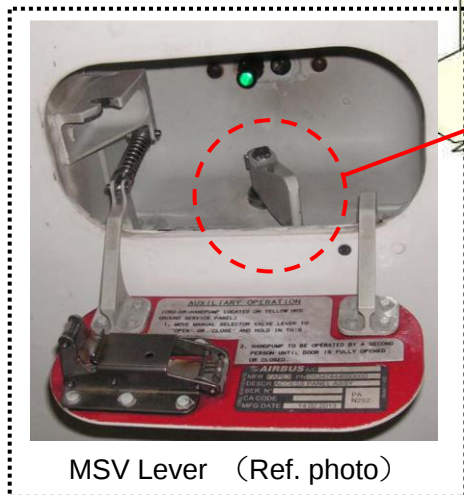
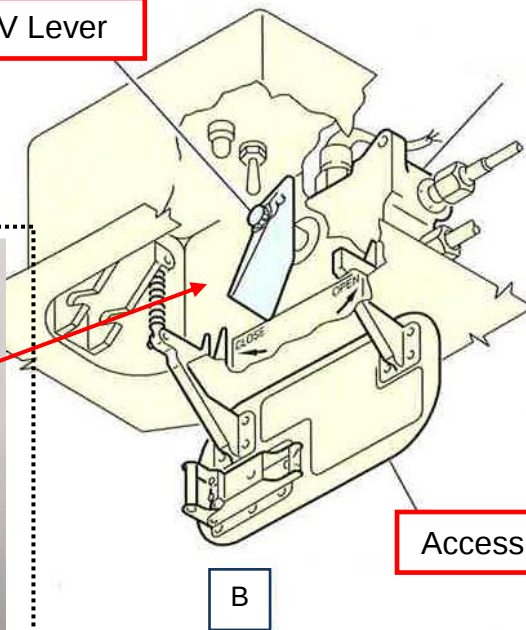
Fig. 2-1

| Model | Title |
|---|---|
| A320 | DOORS – CARGO COMPT DOOR HYD SYSTEM – IMPROVE LOCKING AND INTERFACE TOLERANCE OF MANUAL SELECTOR VALVE (MSV) LEVER<br>(SB A320-52-1160) |

Replace with improved MSV Lever

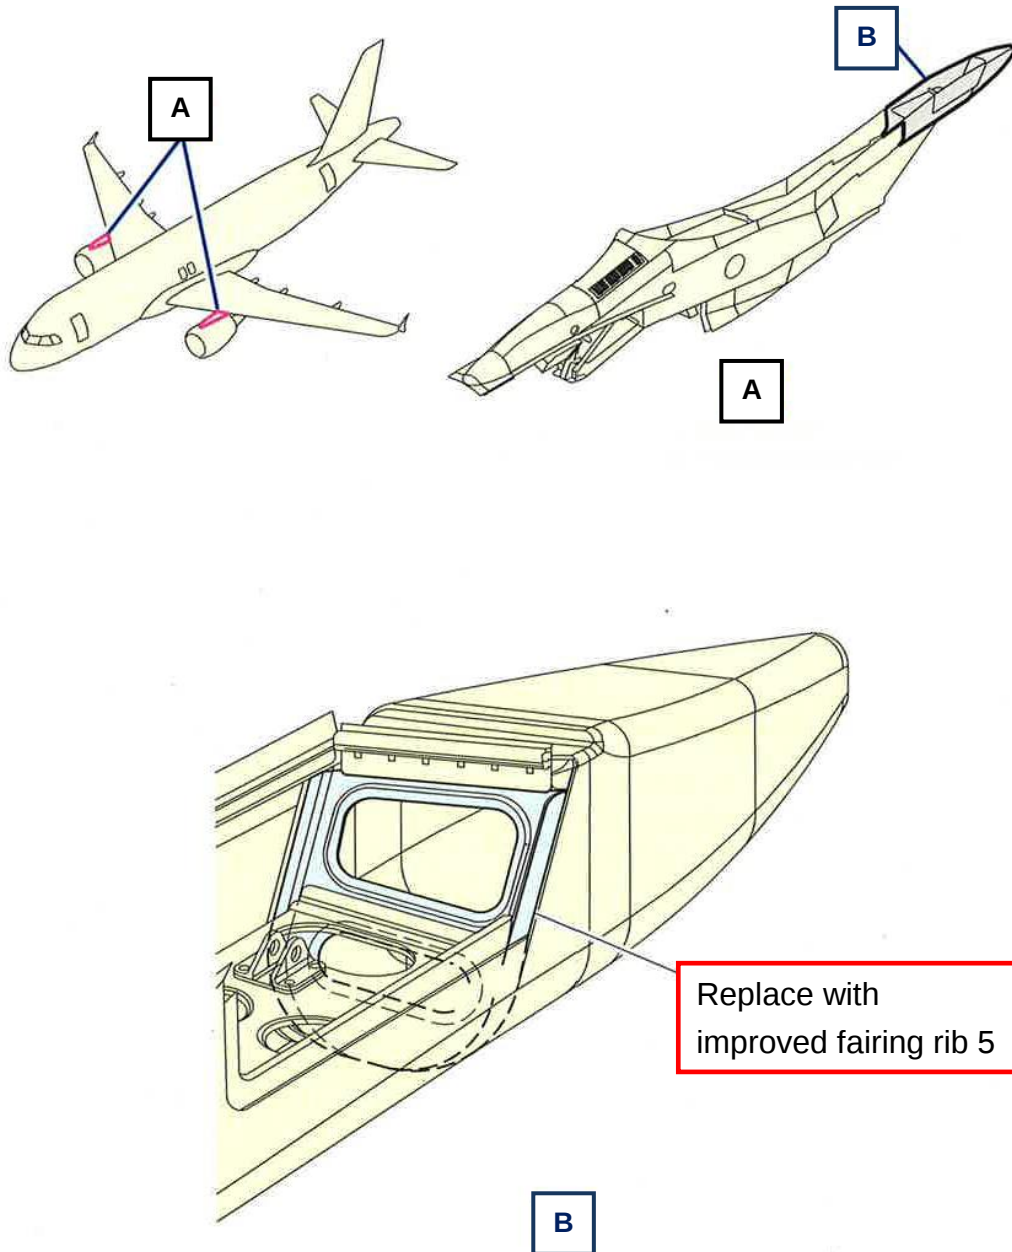
Fig. 2-2

| Model | Title |
|---|---|
| A320 | NACELLE & PYLON – AFT MOVABLE FAIRING – RIB 5 RE-DESIGN<br>(SB A320-54-1028) |

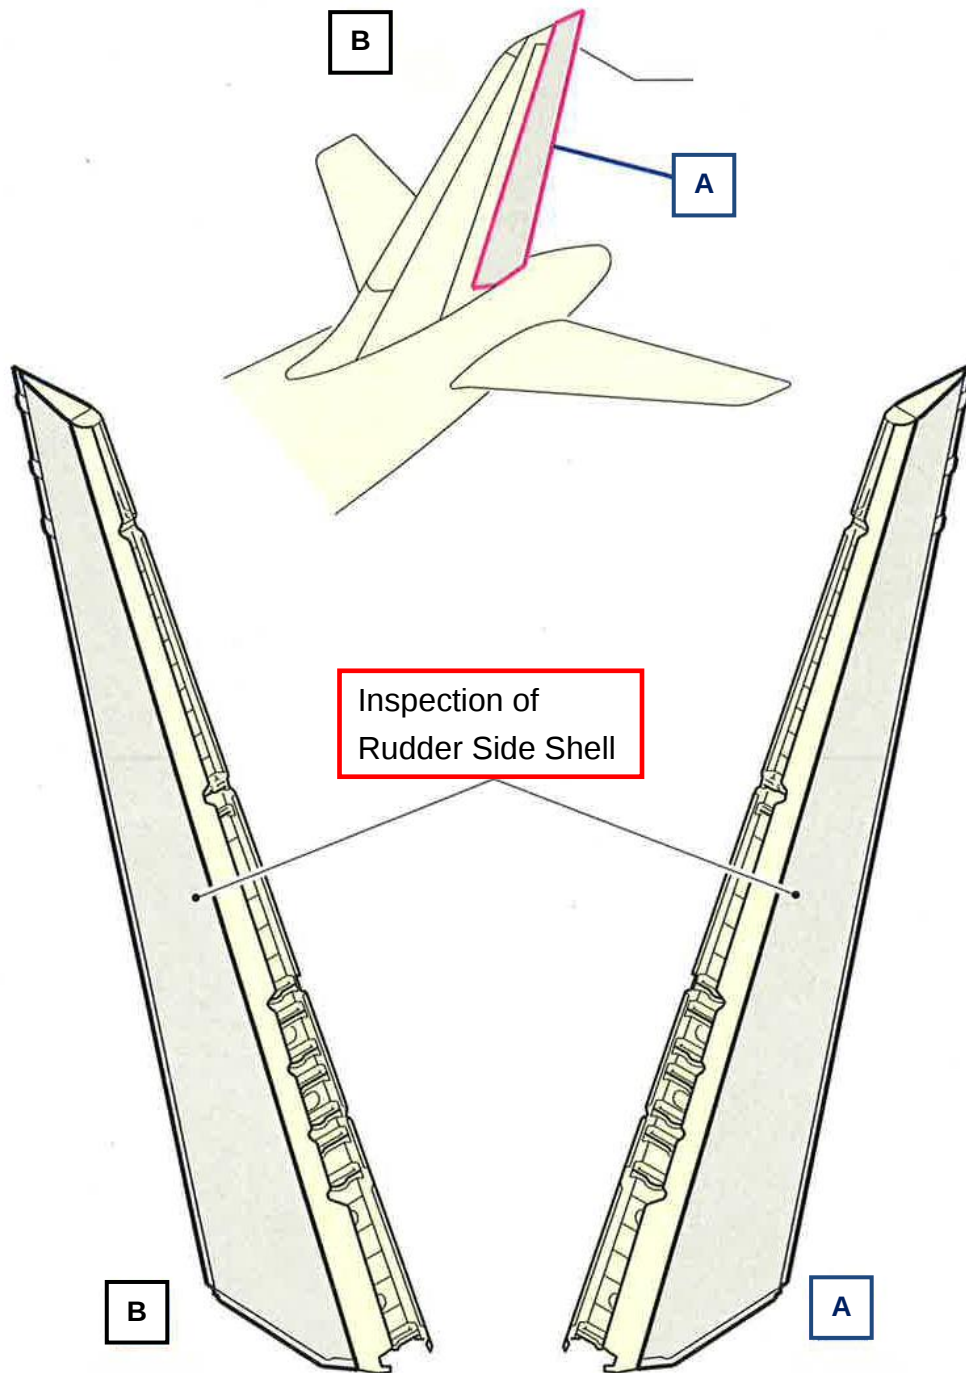
Fig. 2-3

| Model | Title |
|---|---|
| A320 | STABILIZERS - RUDDER SIDE SHELL SANDWICH REPAIR INSPECTION<br>(SB A320-55-1041) |

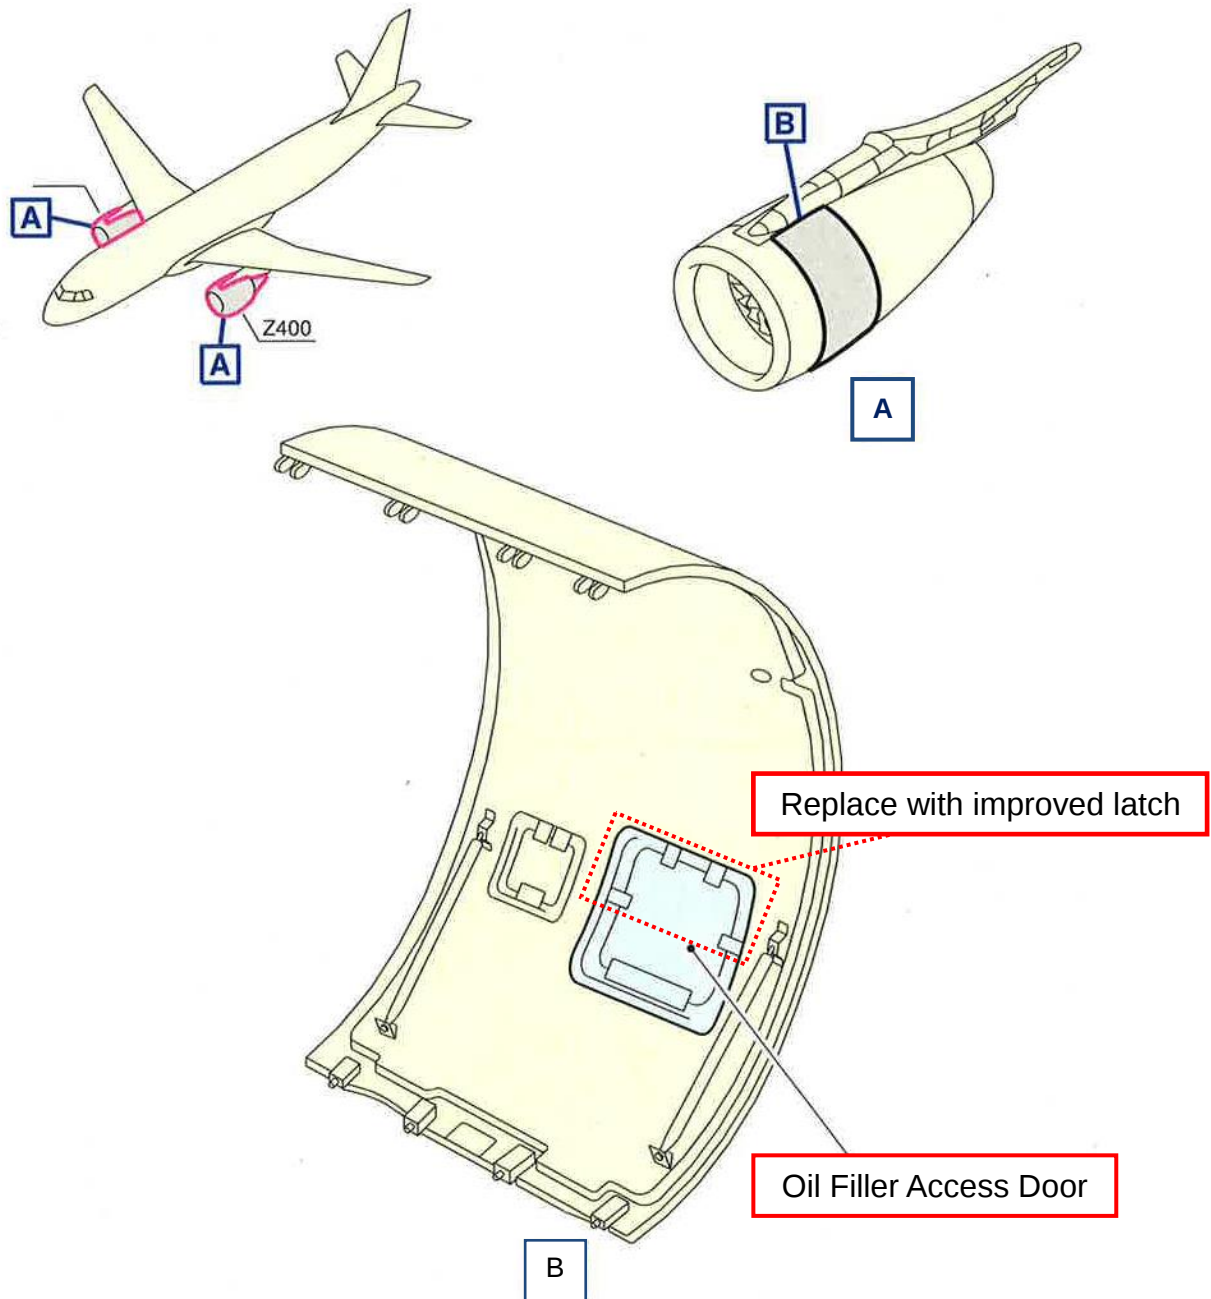
Fig. 2-4

| Model | Title |
|---|---|
| A320 | POWER PLANT - FAN COWL DOORS - INTRODUCE AN IMPROVED OIL FILLER DOOR LATCH DESIGN ON IAE ENGINE (SB A320-71-1061) |

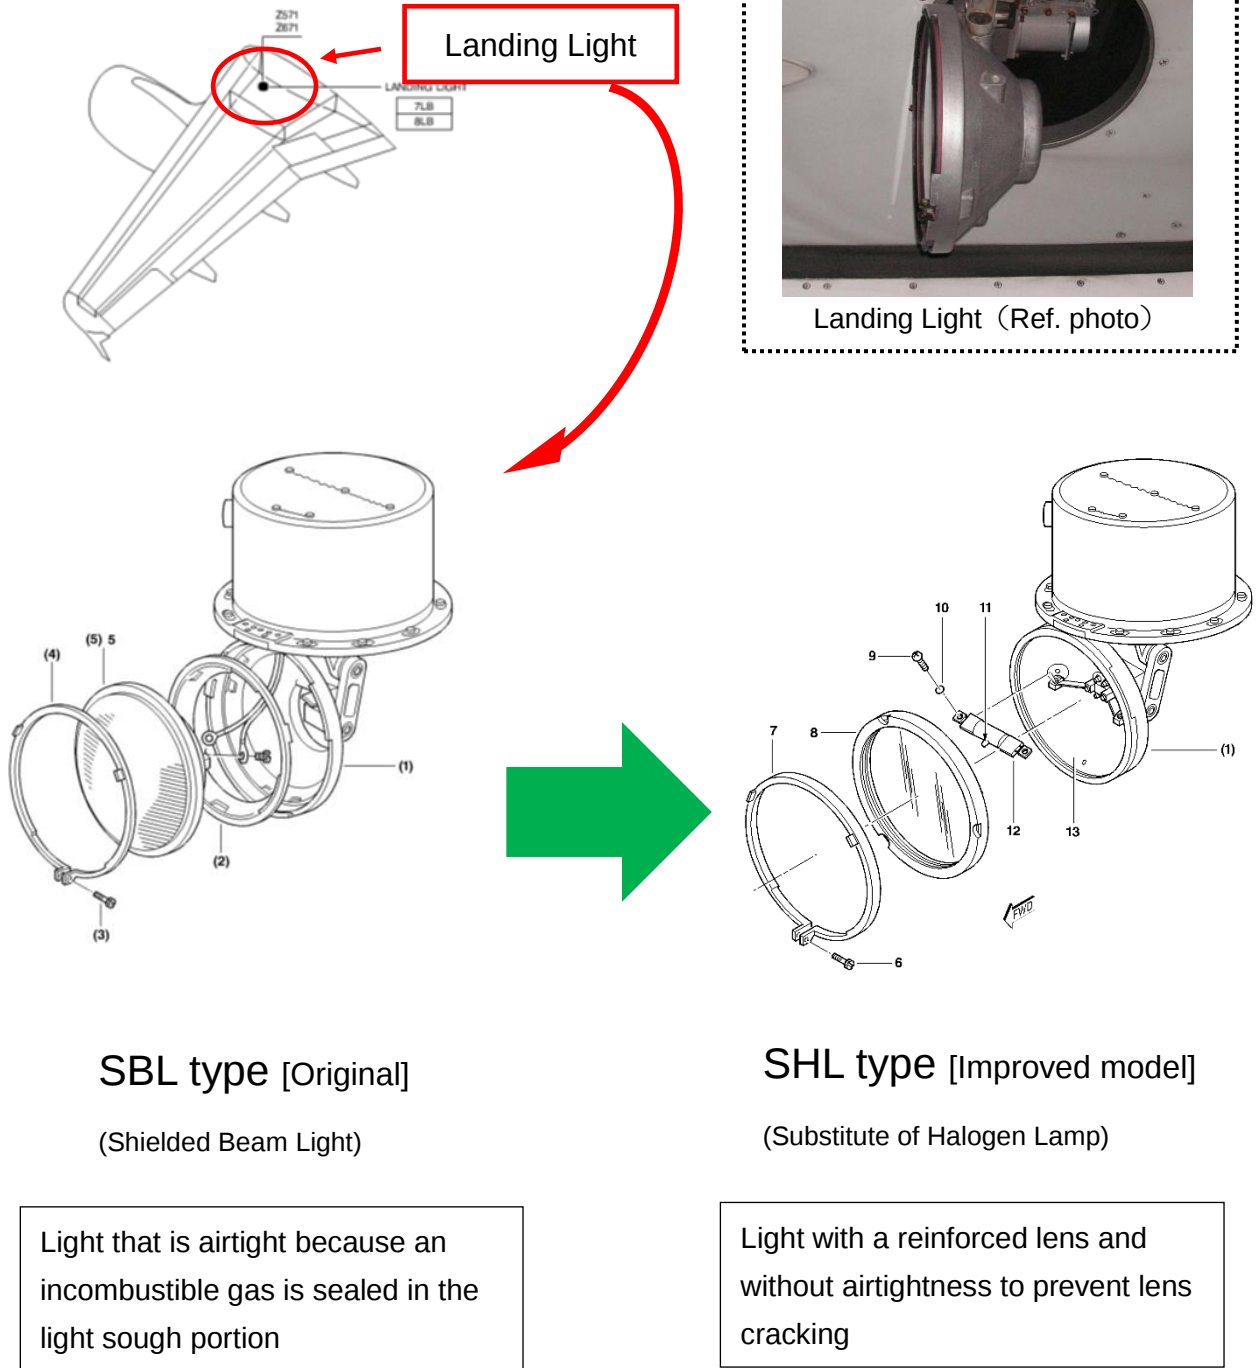
Fig. 2-5

| Model | Title |
|---|---|
| A320 | APPLY SHL TECHNOLOGY ON LANDING LIGHTS (TFU33.42.00.004) |

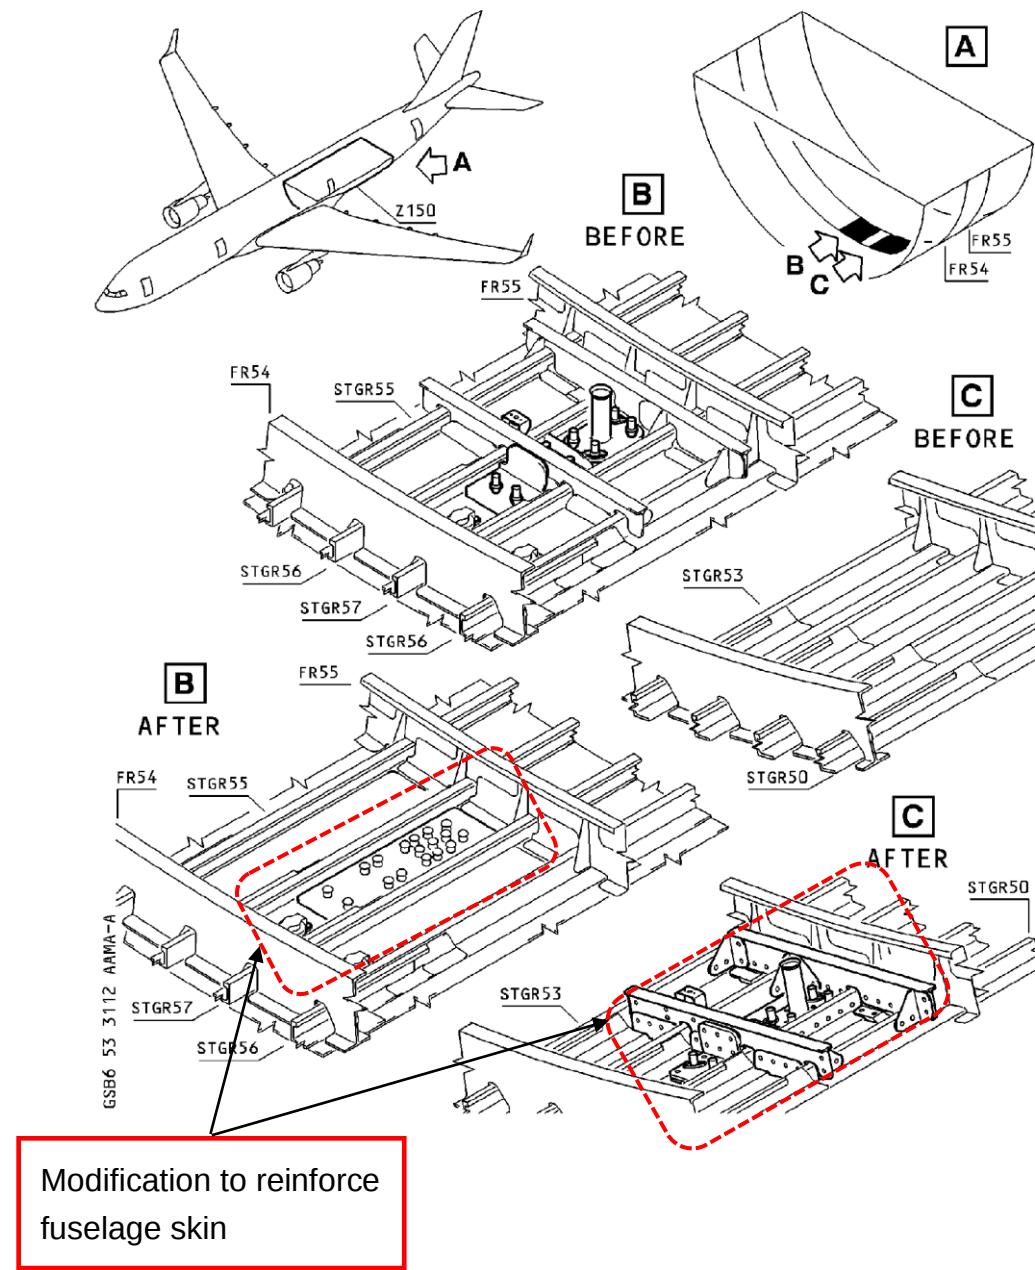
Fig. 2-6

| Model | Title |
|---|---|
| A330 | FUSELAGE – REAR FUSELAGE – RELOCATE VHF 2 ANTENNA<br>(SB A330-53-3112) |

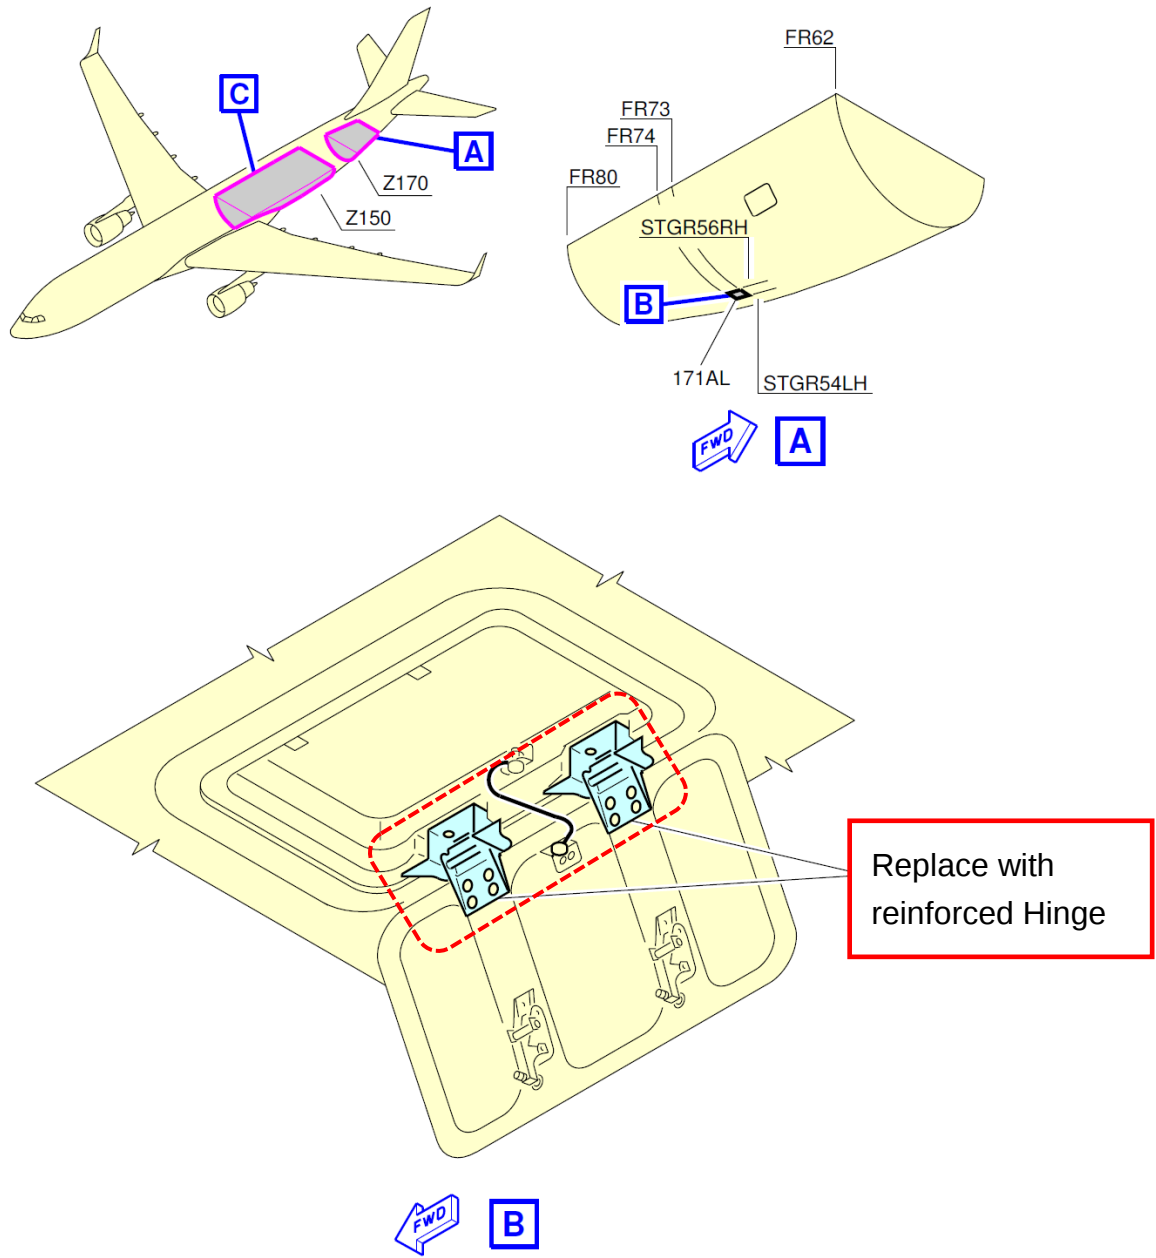
Fig. 2-7

| Model | Title |
|---|---|
| A330 | DOORS – SERVICE DOORS – IMPROVE SERVICE PANEL ACCESS DOORS IN SECTION 16 AND 18 (SB A330-52-3108) |

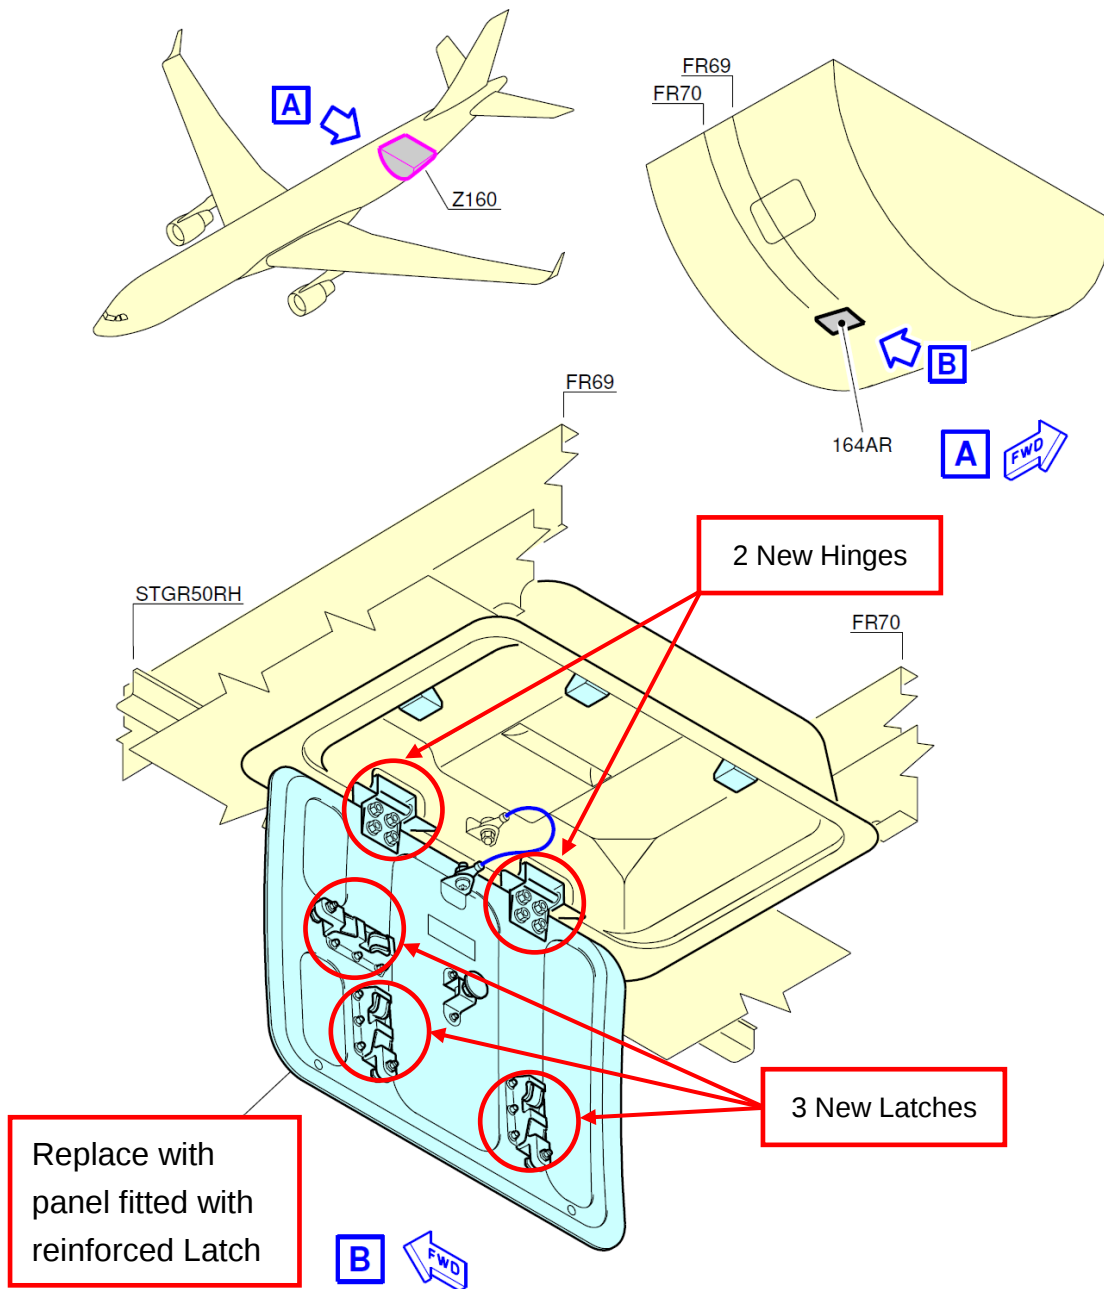
Fig. 2-8

| Model | Title |
|---|---|
| A330 | DOORS - SERVICE DOORS-MODIFICATION OF LATCHING MECHANISM OF POTABLE WATER SERVICE PANEL (SB A330-52-3086) |
