# Implementation of Measures to Prevent Objects Falling off Airplanes

January 2018

Civil Aviation Bureau of Japan,  
Ministry of Land, Infrastructure, Transport and Tourism  
Association of Air Transport Engineering and Research

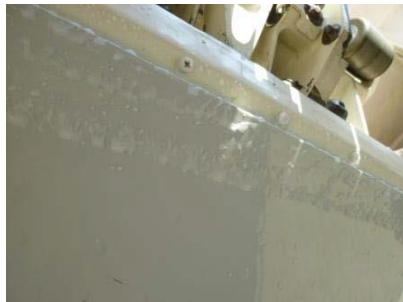
Ice accumulation on the cargo door may be caused by water leak or snow accumulation on cargo. It is important to remove moisture completely from the cargo and wrap it properly before loading. Take note of the following points:

Figure 3-4: Example of ice accumulation along the edge of the lower part of cargo door

- a. Make sure that cargo that has a potential for water leaks has been appropriately packed and wrapped in a way that it is judged to be robust enough for air transportation.
- b. When cargo is temporarily stored outdoors, appropriate measures shall be taken to prevent damage caused by rain and snow.
- c. Any snow and ice remaining on the cargo or unit loading device shall be removed before loading cargo on the aircraft.
- d. When containers and baggage are loaded in the cargo compartment, rainwater and snow on them shall be removed before they are carried in.
- e. If it is stormy when cargo is loaded and there is a possibility that a large amount of rainwater has got inside, be very careful.

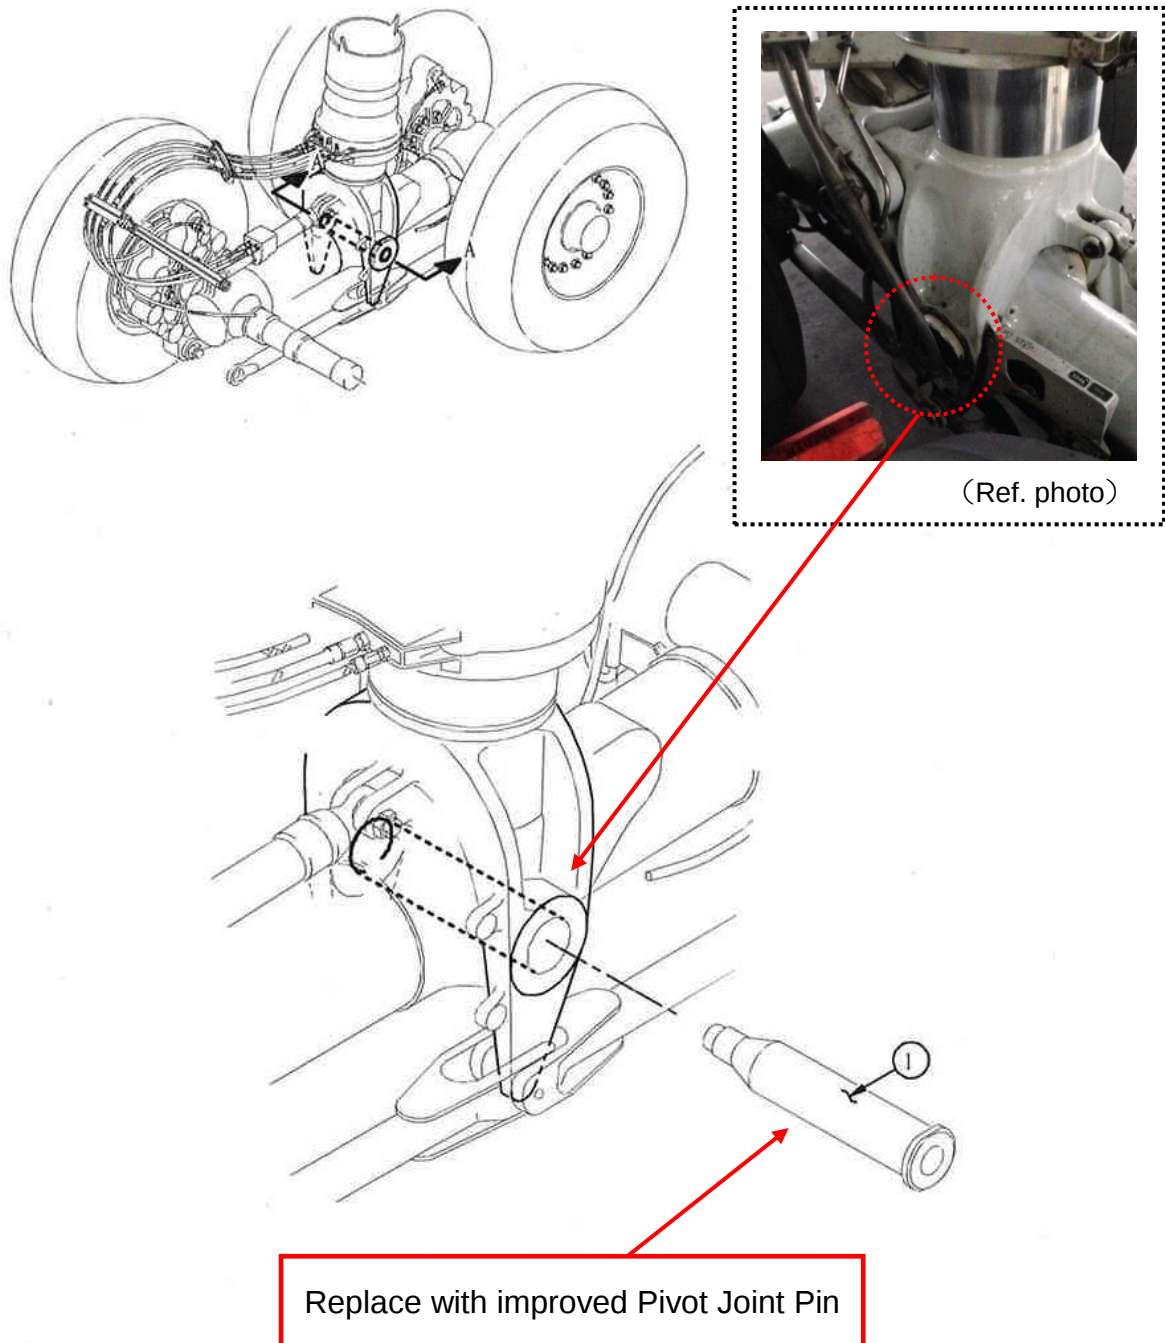
Fig. 1-9

| Model | Title |
|---|---|
| B767 | LANDING GEAR – Main Landing Gear Bogie Beam Pivot Joint Pin Replacement<br>(SB 767-32A-0199) |

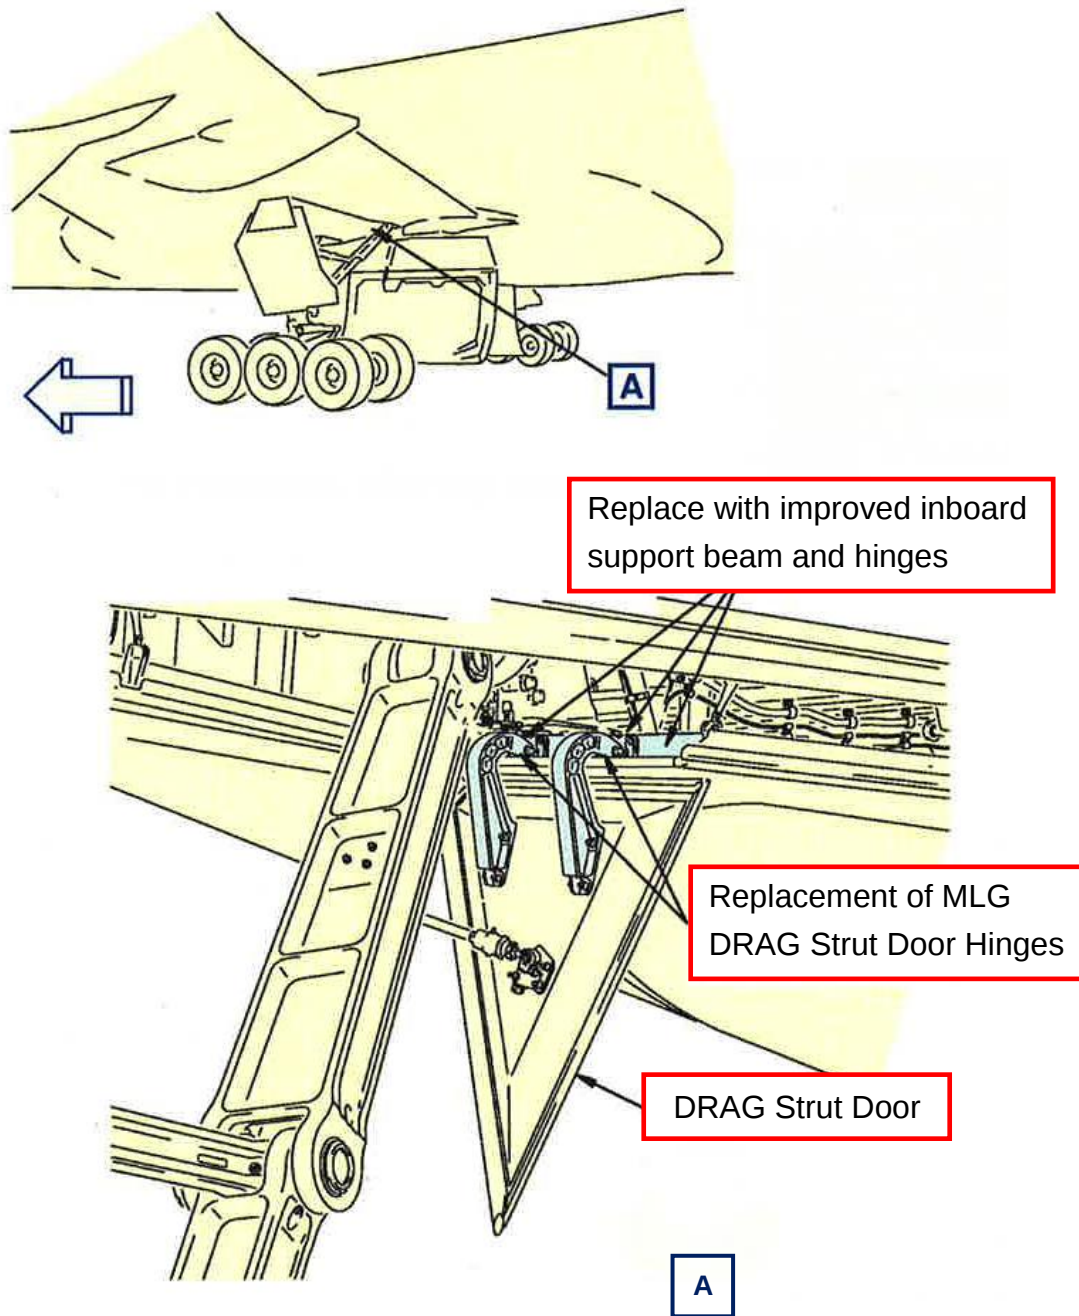
Fig. 1-13

| Model | Contents of Measure |
|---|---|
| B777 | WINGS - Wing Trailing Edge - Inboard Fixed Trailing Edge Support Beam Replacement (SB 777-57-0093) |

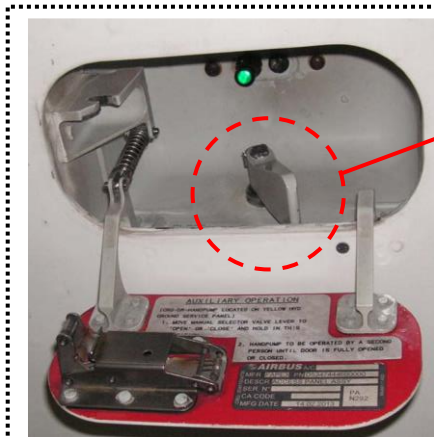
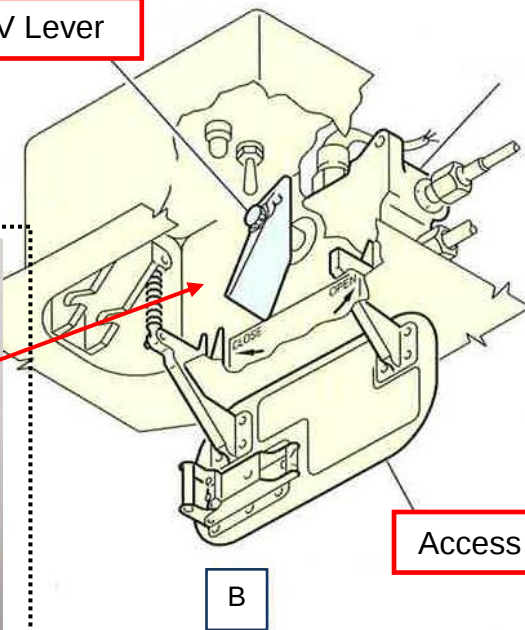
Fig. 2-1

| Model | Title |
|---|---|
| A320 | DOORS – CARGO COMPT DOOR HYD SYSTEM – IMPROVE LOCKING AND INTERFACE TOLERANCE OF MANUAL SELECTOR VALVE (MSV) LEVER<br>(SB A320-52-1160) |

MSV Lever (Ref. photo)

Replace with improved MSV Lever

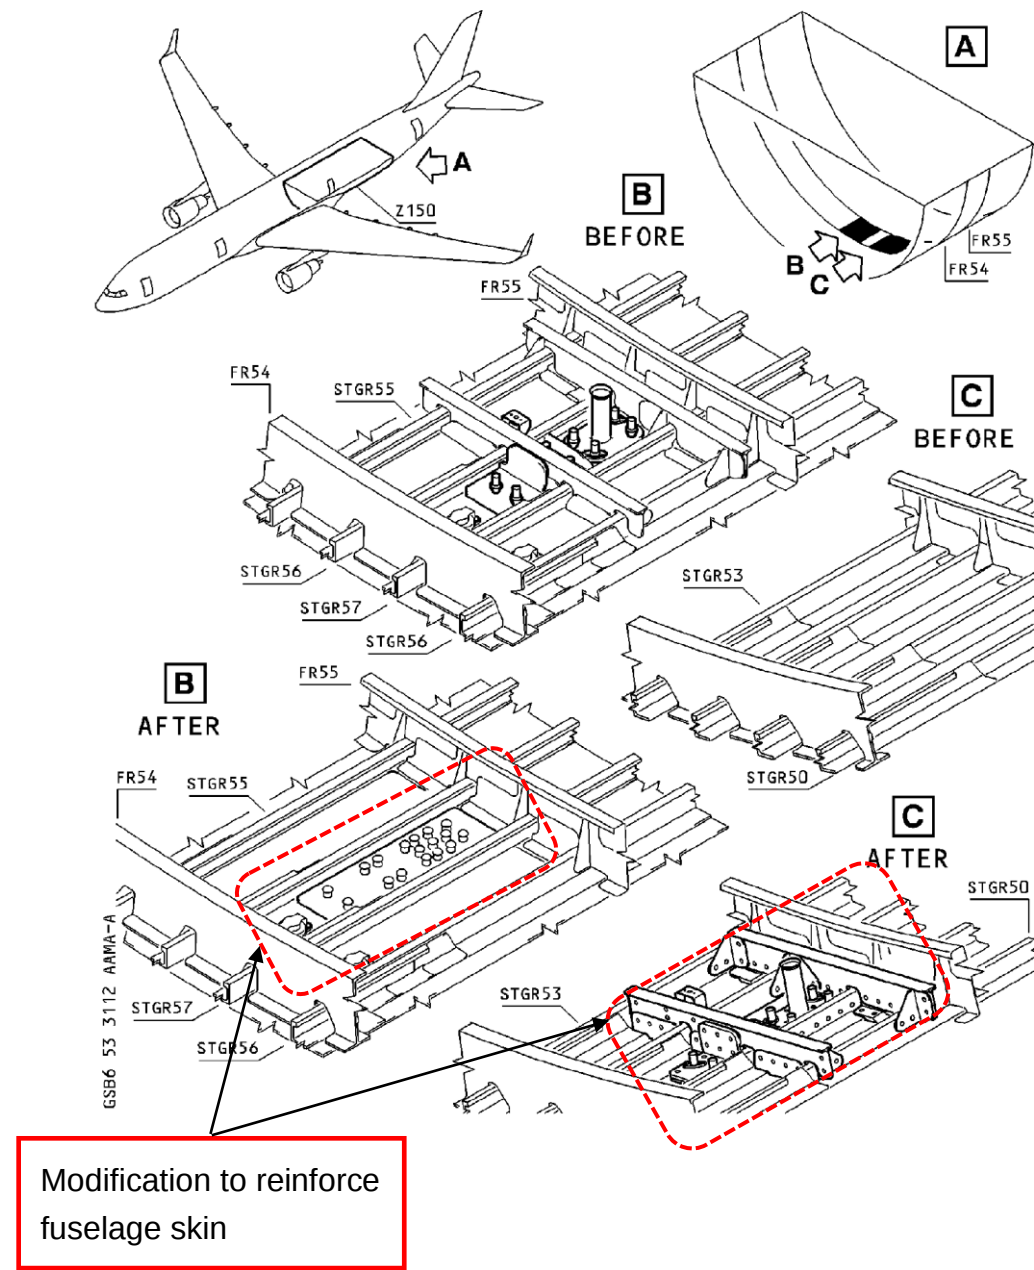
Fig. 2-6

| Model | Title |
|---|---|
| A330 | FUSELAGE – REAR FUSELAGE – RELOCATE VHF 2 ANTENNA<br>(SB A330-53-3112) |
