# Bureau Enquêtes Accidents pour la Sécurité de l'Aéronautique d'État (State Aviation Safety Investigation Bureau - BEA-É) Safety Investigation Report

T-2023-22-I

| Event date: | 20 December 2023 |
| Type of aircraft | TBM 700 |

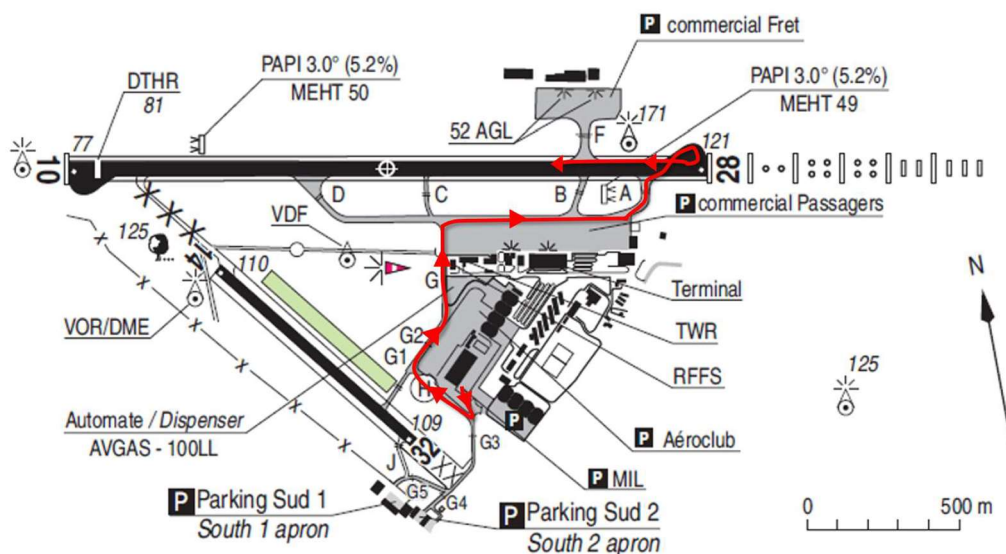
Several meters after brake release, the aeroplane struck a first elevated light<sup>5</sup> located close to the taxiways. The aircraft's path resulted in it striking four other runway edge lights. Feeling an unusual vibration from the auxiliary landing gear that they equated with a puncture, the crew decided to abort take-off and inform the airport's control tower.

Figure 1: reconstruction of the portion of interest of the flight path

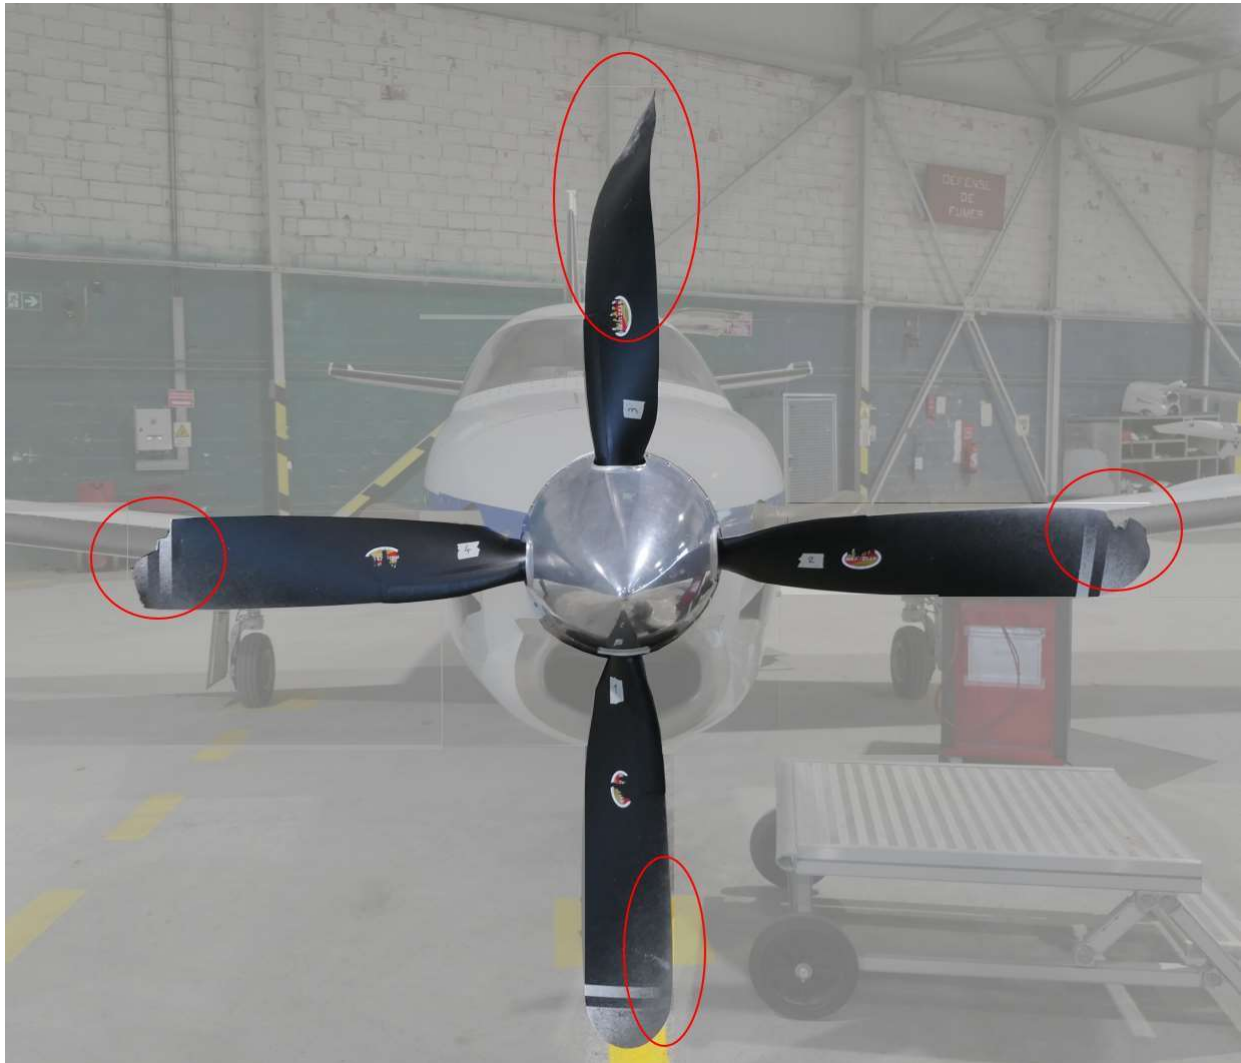
Most of the damage to the four propeller blades was at their tips and included notches, deformation and loss of material.

Figure 3: view of the damaged propeller

The damages visible on the propeller were concentrated at the end of each blade in the final quarter, less than 20 cm from the blade tip. The remainder of the propeller was intact. At least four pieces were torn off due to the violent impact with an obstacle that must have been located at a height, considering the propeller's ground clearance<sup>16</sup> (20 cm), of between 30 and 40 cm.

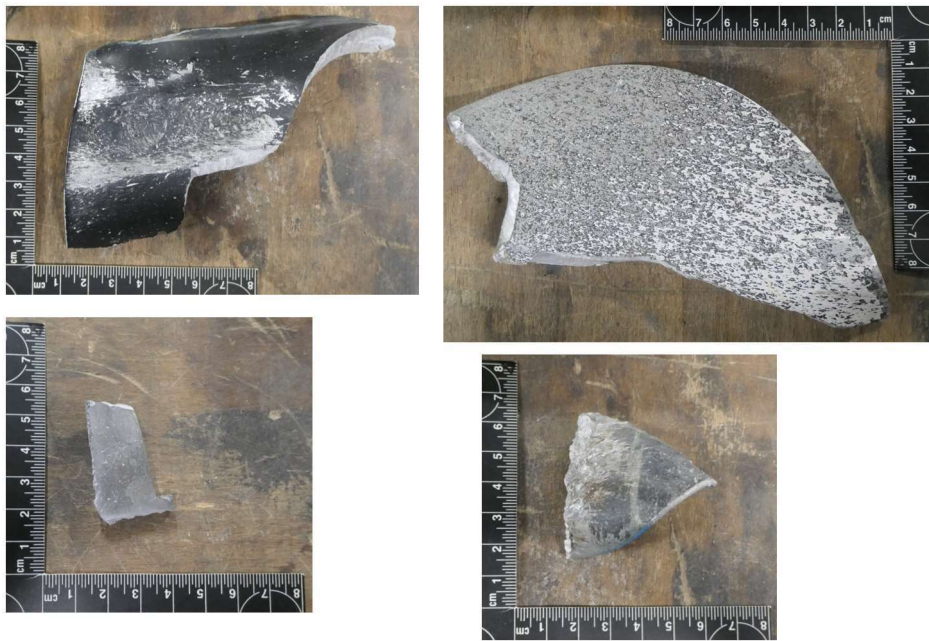
Four pieces of blade, corresponding to the pieces missing from the propeller, were found on the runway.

Figure 4: propeller pieces

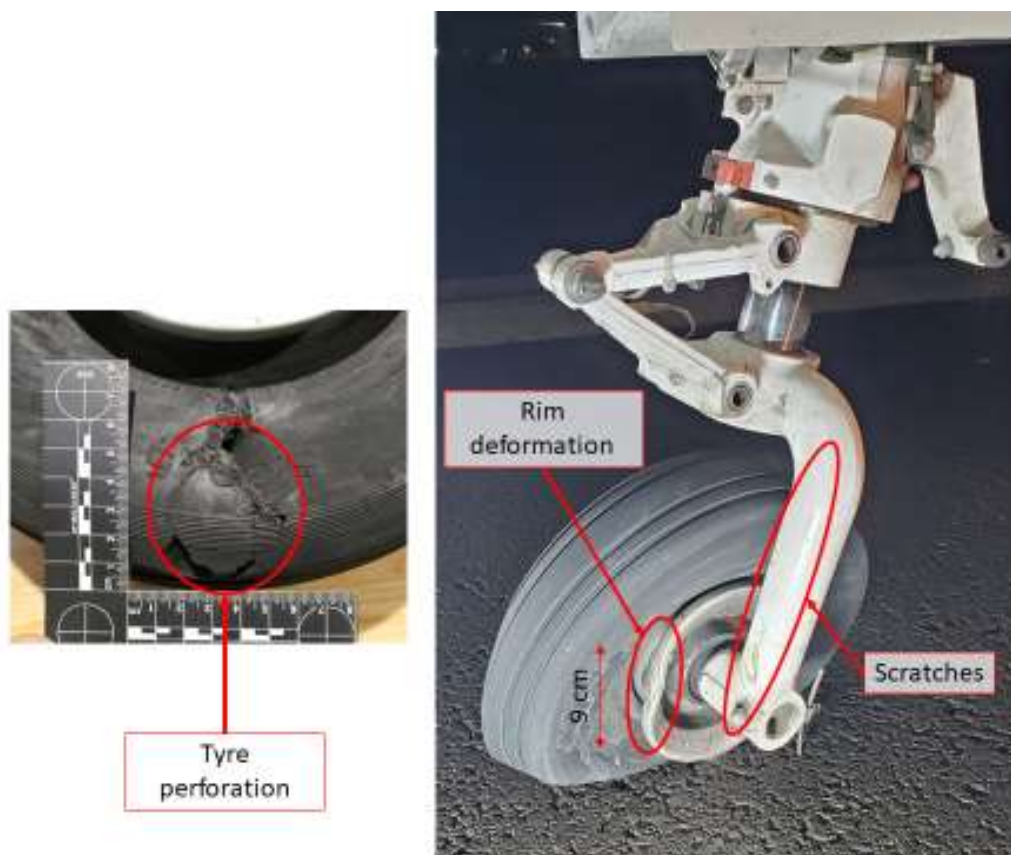
The auxiliary landing gear was damaged in three ways:

- The tyre was deflated and had a 5 cm hole on one of its flanks
- The rim had several scratches and a considerable deformation over a length of 9 cm
- Scratches were visible over the entire inside of the landing gear strut below the damper.

Figure 5: damaged auxiliary landing gear

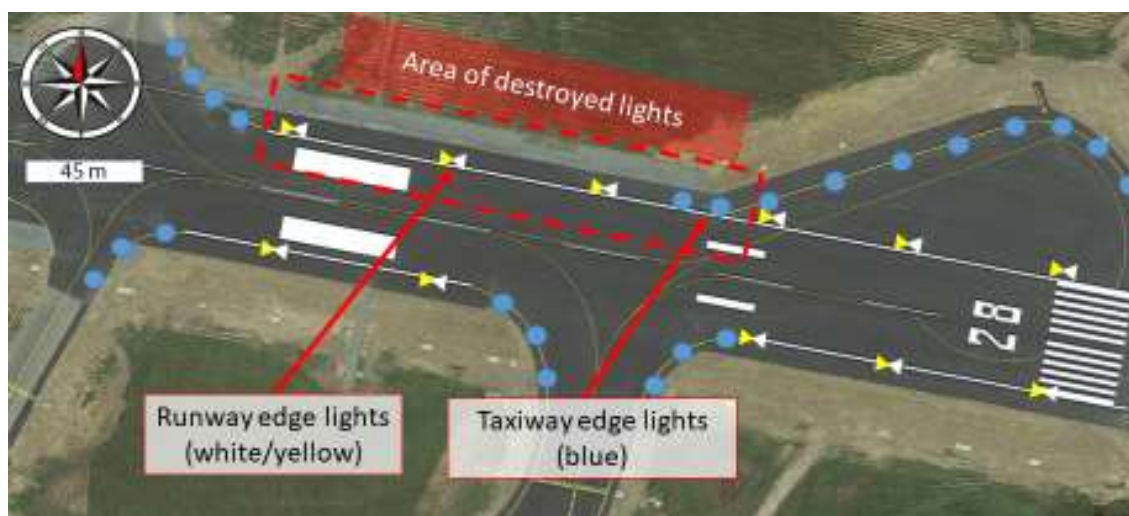
On the north side of the main runway, close to the threshold of runway 28, three elevated runway edge lights and two elevated taxiway edge lights were destroyed.

Figure 6: schematic diagram of the incident area

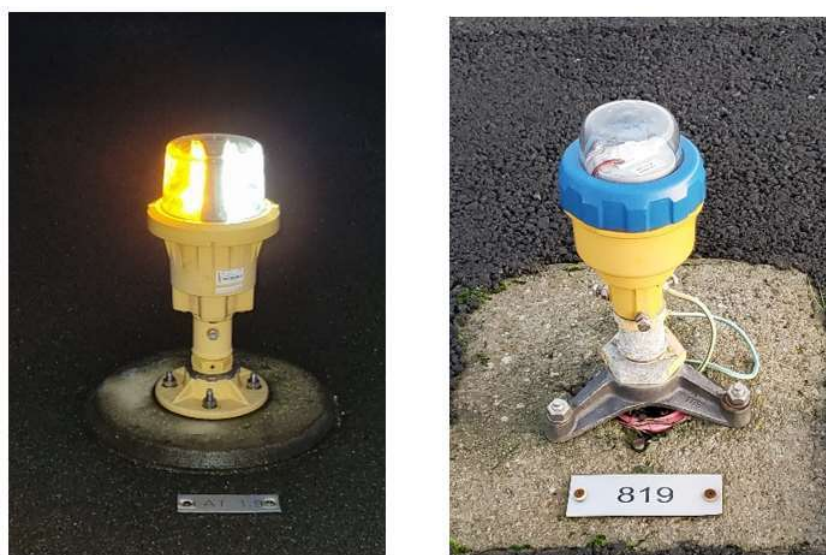
Figure 7: elevated runway edge lights (white/yellow) and elevated taxiway lights (blue)

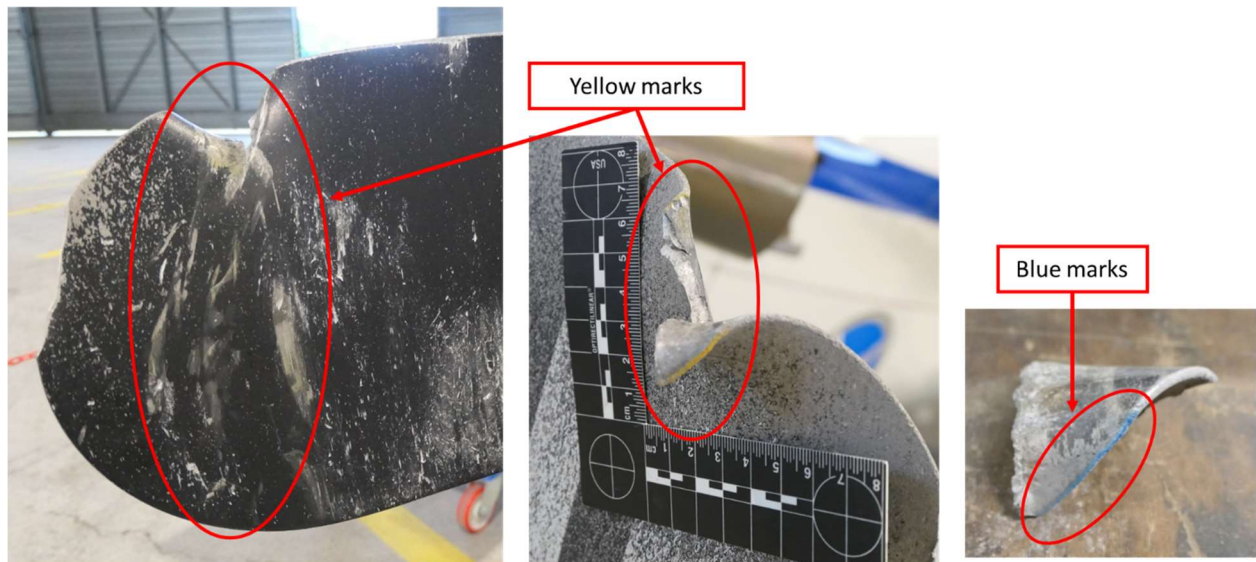
The analysis of the damage revealed the presence of yellow and blue marks on the blades and on some debris.

Figure 10: visible marks on the propeller blades and debris

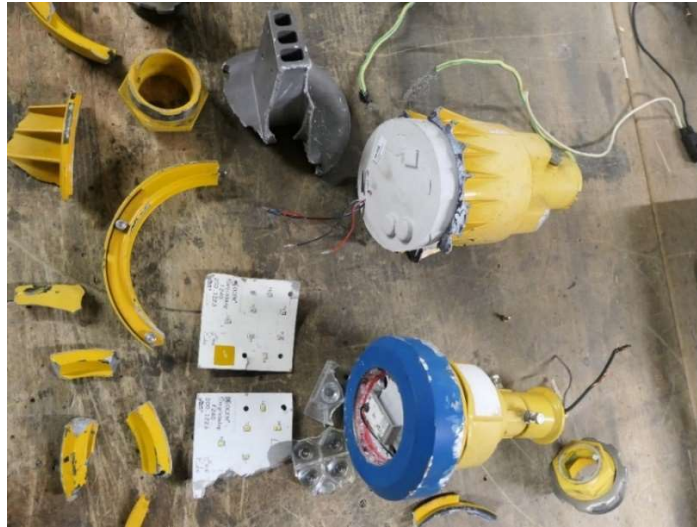
The five lights destroyed were elevated lights located at a height of 35 cm (runway edge lights) and 29 cm (taxiway edge lights). The metal parts of these lights were covered with a yellow coating. The taxiway edge lights were fitted with a blue metal ring. The examination of the debris showed that the damage was caused by violent impact with the metal sections. This damage was consistent with the findings on the propeller (colour marks and location of deformation).

Figure 11: debris from the destroyed lights

During the take-off run, the propeller blades struck five lights located along the north edge of the runway.

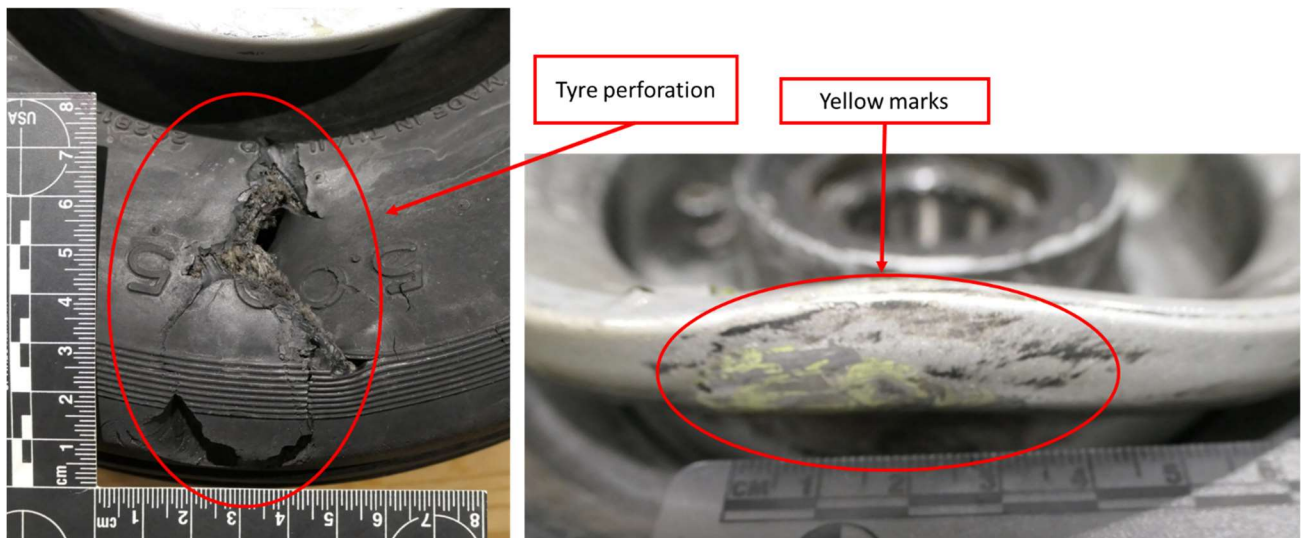
The main damage was visible on the tyre, which was perforated, and on the rim, of which one part was distorted by an impact that left a yellow mark. Yellow friction marks were also visible on the auxiliary landing gear strut.

Figure 12: damage to the auxiliary landing gear

**The tyre puncture and damage to the auxiliary landing gear strut resulted from the impact with one or more lights.**

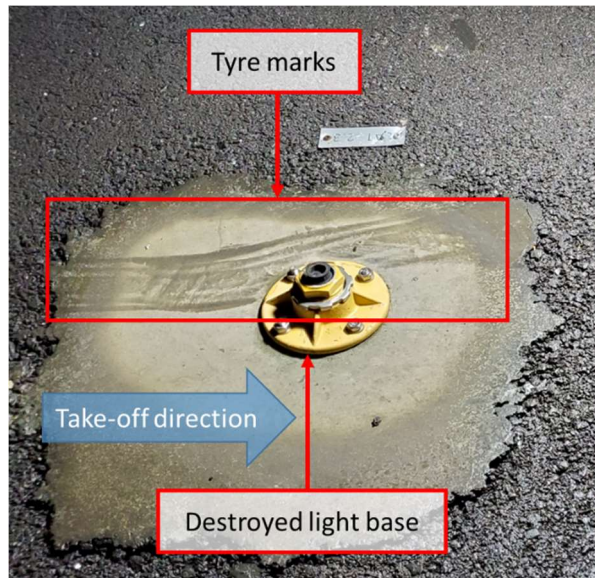
On the runway, near the location of one of the destroyed lights, the marks of a tyre similar to an auxiliary landing gear tyre were visible and showed a path deviated due to the struck light. This observation fits with the crew's statement that described vibrations from the auxiliary landing gear.

Figure 13: tyre marks

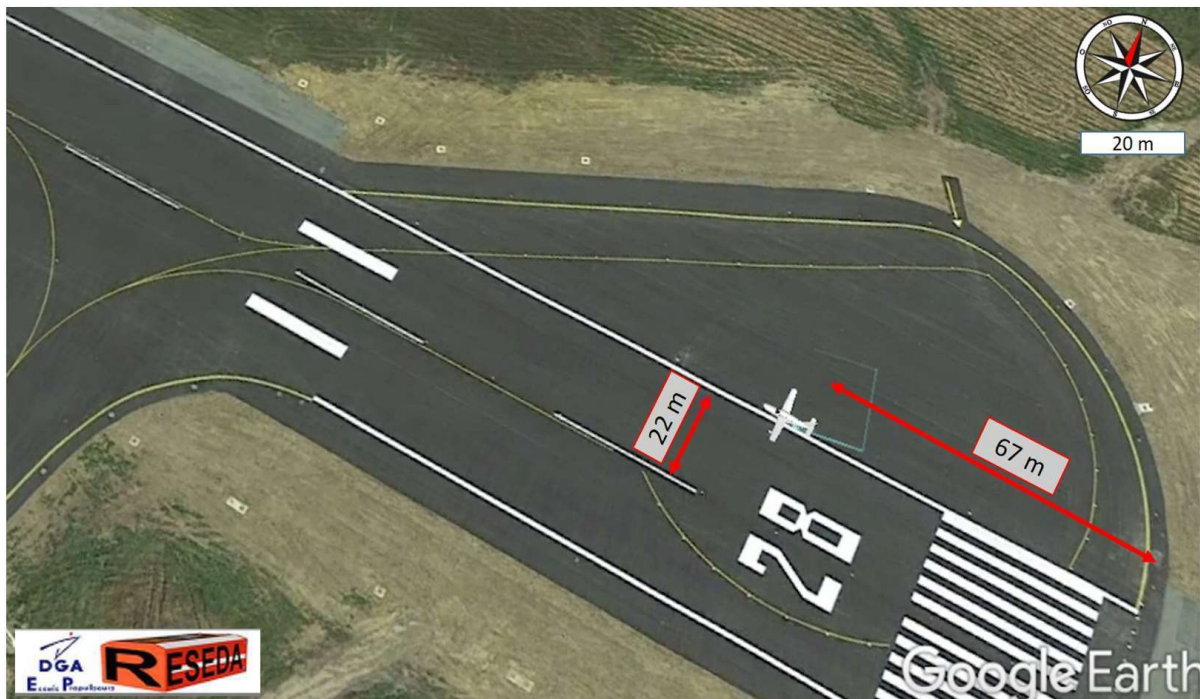
The analysis of data from the flight recorder confirmed that the TBM 700 was lined up on the north edge of the runway after partially following the path to the turn pad. When it received clearance for take-off, the TBM 700 was positioned 67 m from the threshold of runway 28 with an offset to the north by 22 m in relation to the centreline.

Figure 14: position of the TBM 700 at the start of the take-off

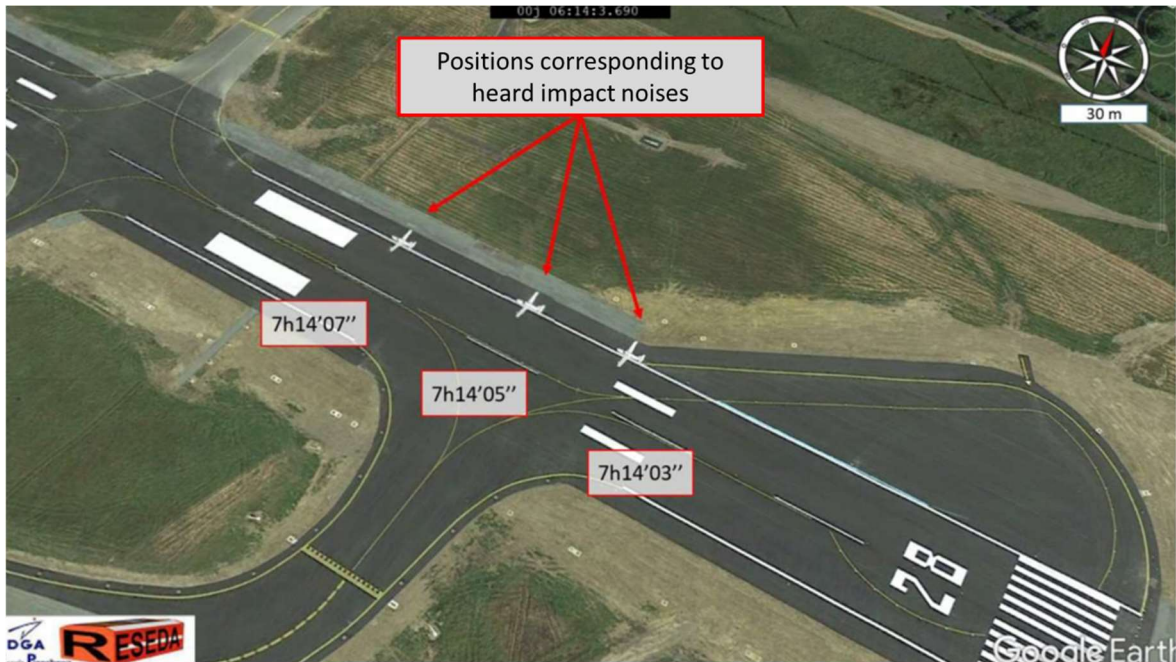
Impact noises could be clearly heard on the read-out of the cockpit voice recorder. Synchronisation of the path with the sound revealed that these impacts corresponded to the position of the damaged lights. Only the impact with the last light was not clearly picked up due to a louder ambient noise probably generated by the damaged propeller.

Figure 15: positions of the TBM 700 during impacts with the lights

**The TBM 700 performed a take-off run identifying the north edge of the runway as the centreline and struck lights with the propeller and the auxiliary landing gear.**

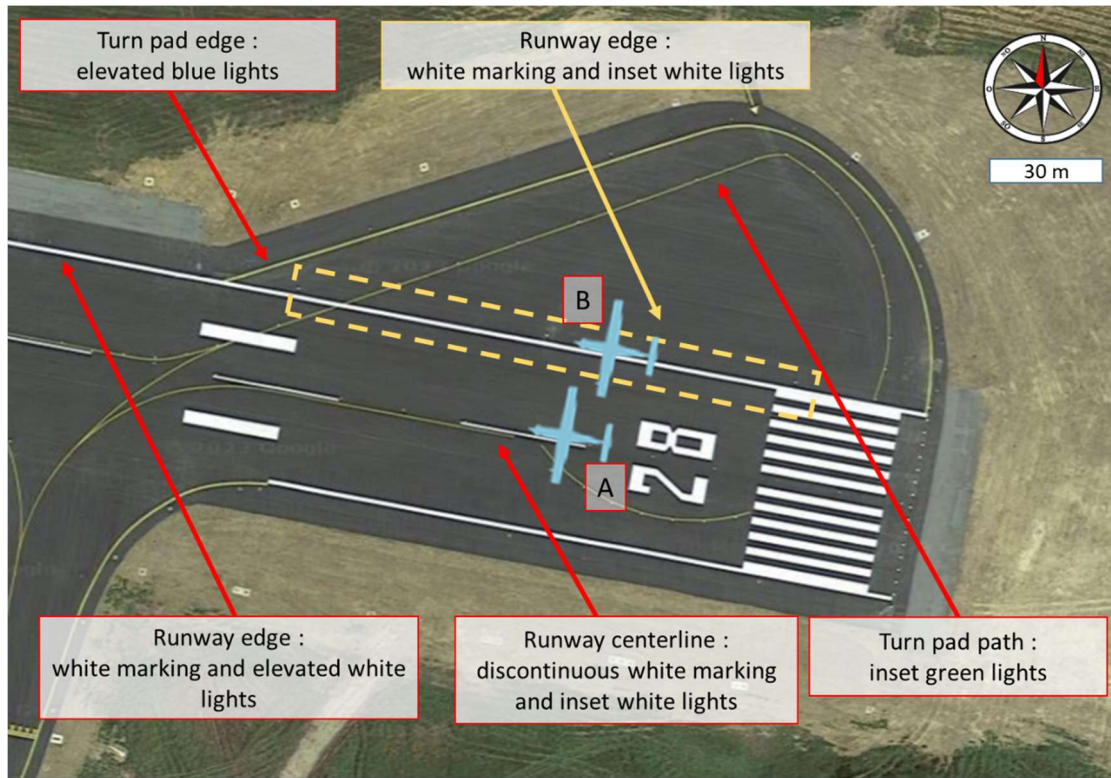
The runway centreline lights are white directional lights inset into the centreline of runway 28 at the threshold. The runway edge lights distanced from the taxiways comprise white and yellow elevated lights. At the boundary of the runway and the turning area, the lighting is similar to that of the runway centreline: inset white lights and white ground markings (area demarcated by yellow dots on the figure below).

Figure 16: marking and lights in the runway 28 threshold area

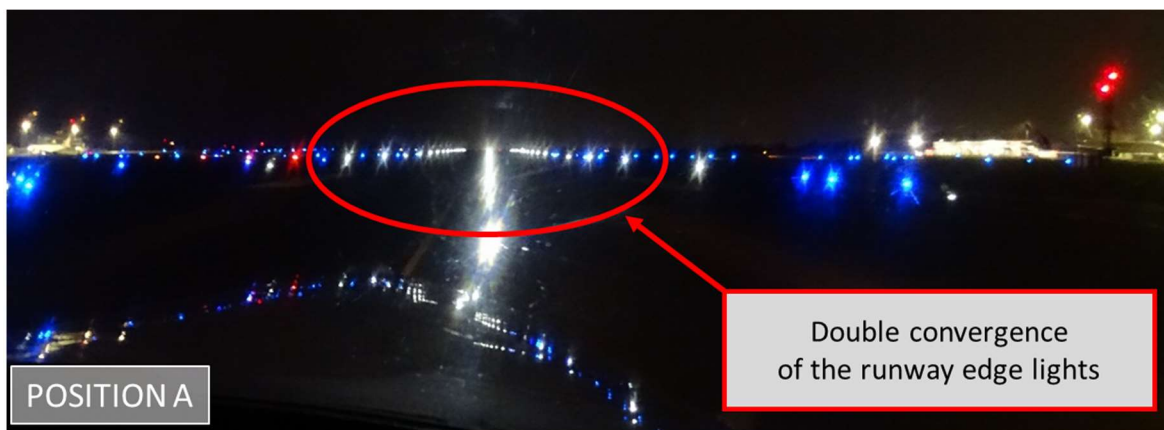
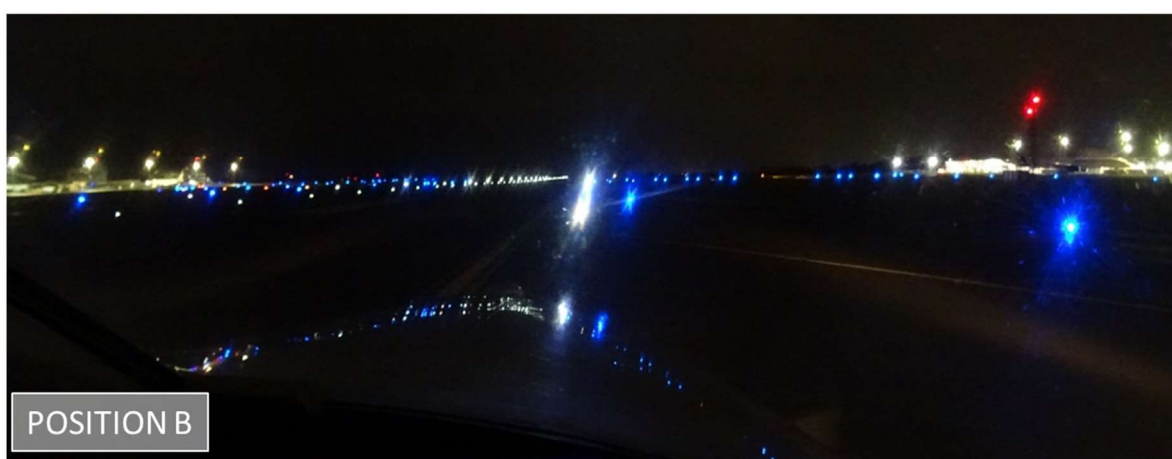
Only the double convergence of the runway edge lights enables a differentiation to be made between the two positions.

Figure 17: views from the cockpit of the TBM 700 located at positions A and B

**Viewed from the cockpit of the TBM 700 located at the threshold of runway 28, in the dark, it is difficult for the crew to differentiate a line-up on the runway centreline from a line-up on the north edge of the runway.**

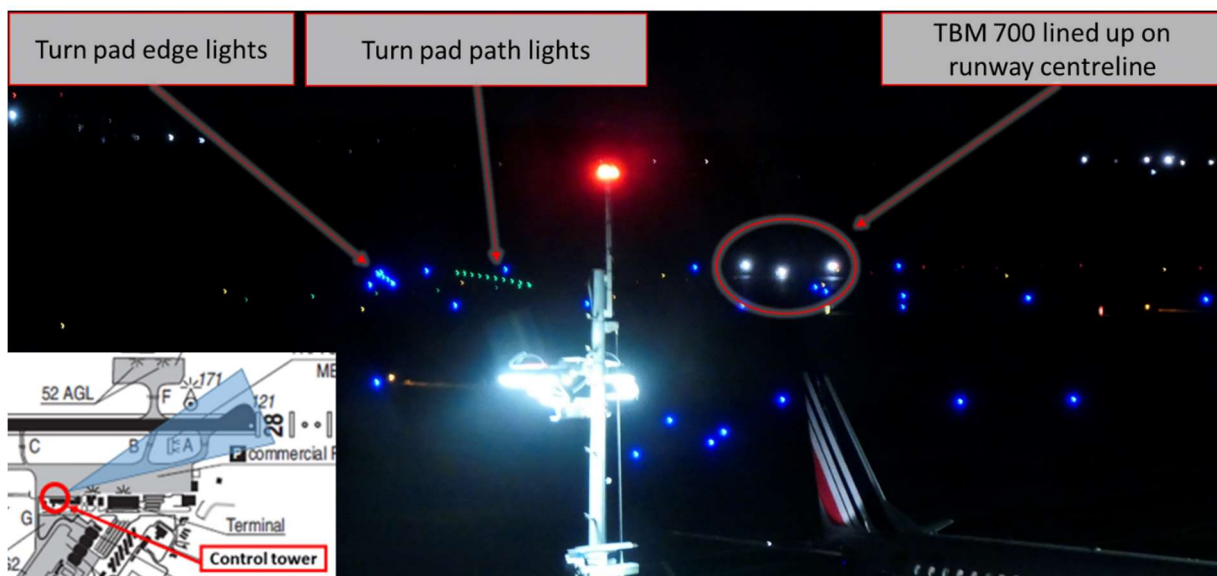
At Rennes airport, although the positioning of the control tower enables the duty controller to have sight of a TBM 700 located in the threshold area of runway 28, the latter is unable to see the runway centreline and edge lights due to their bidirectional nature.

Figure 18: TBM 700 lined up on the centreline of runway 28 as seen from the control tower

**From the Rennes control tower, in the dark, it is not possible to see whether a TBM 700 is correctly lined up on the centreline of runway 28.**
