REPORT

AVIATION 2026/03

***Air accident in the sea west of Sotra,
Vestland County, Norway on 28 February
2024 with Sikorsky S-92A, LN-OIJ,
operated by Bristow Norway AS***

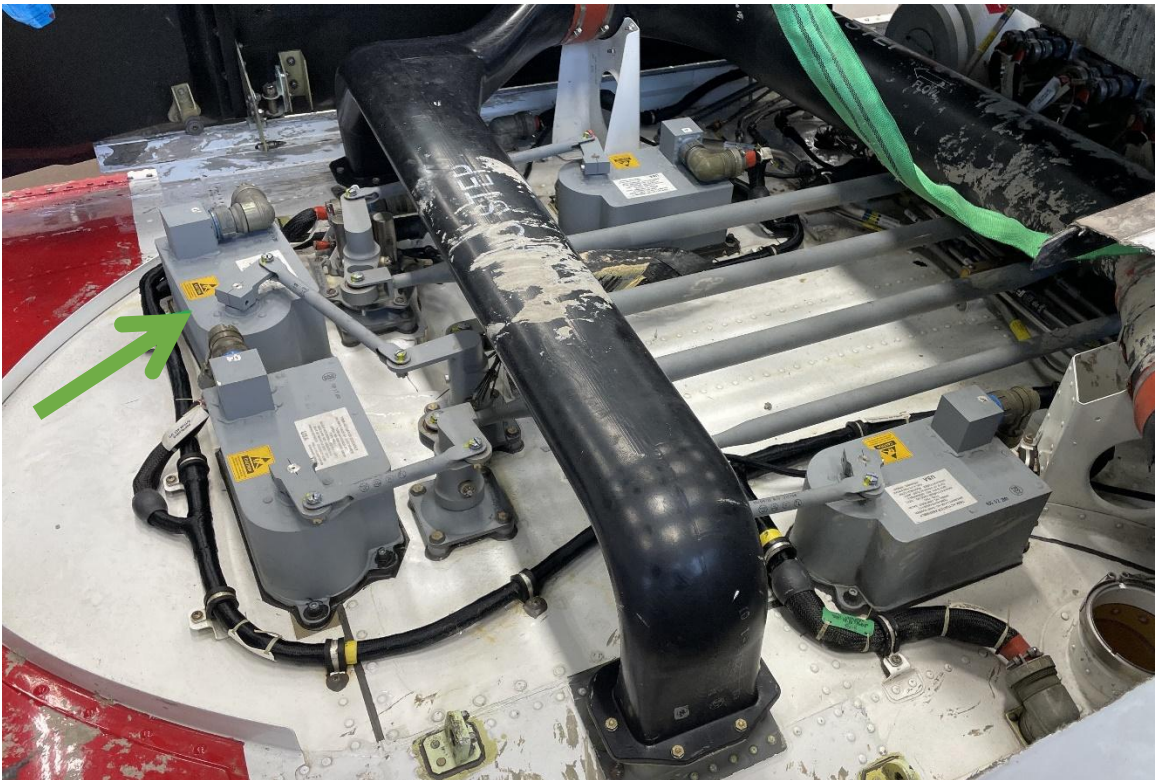
Figure 6: The four trim actuators installed on the upper deck above the cockpit on LN-OIJ. A green arrow points at the pitch trim actuator. Photo: NSIA

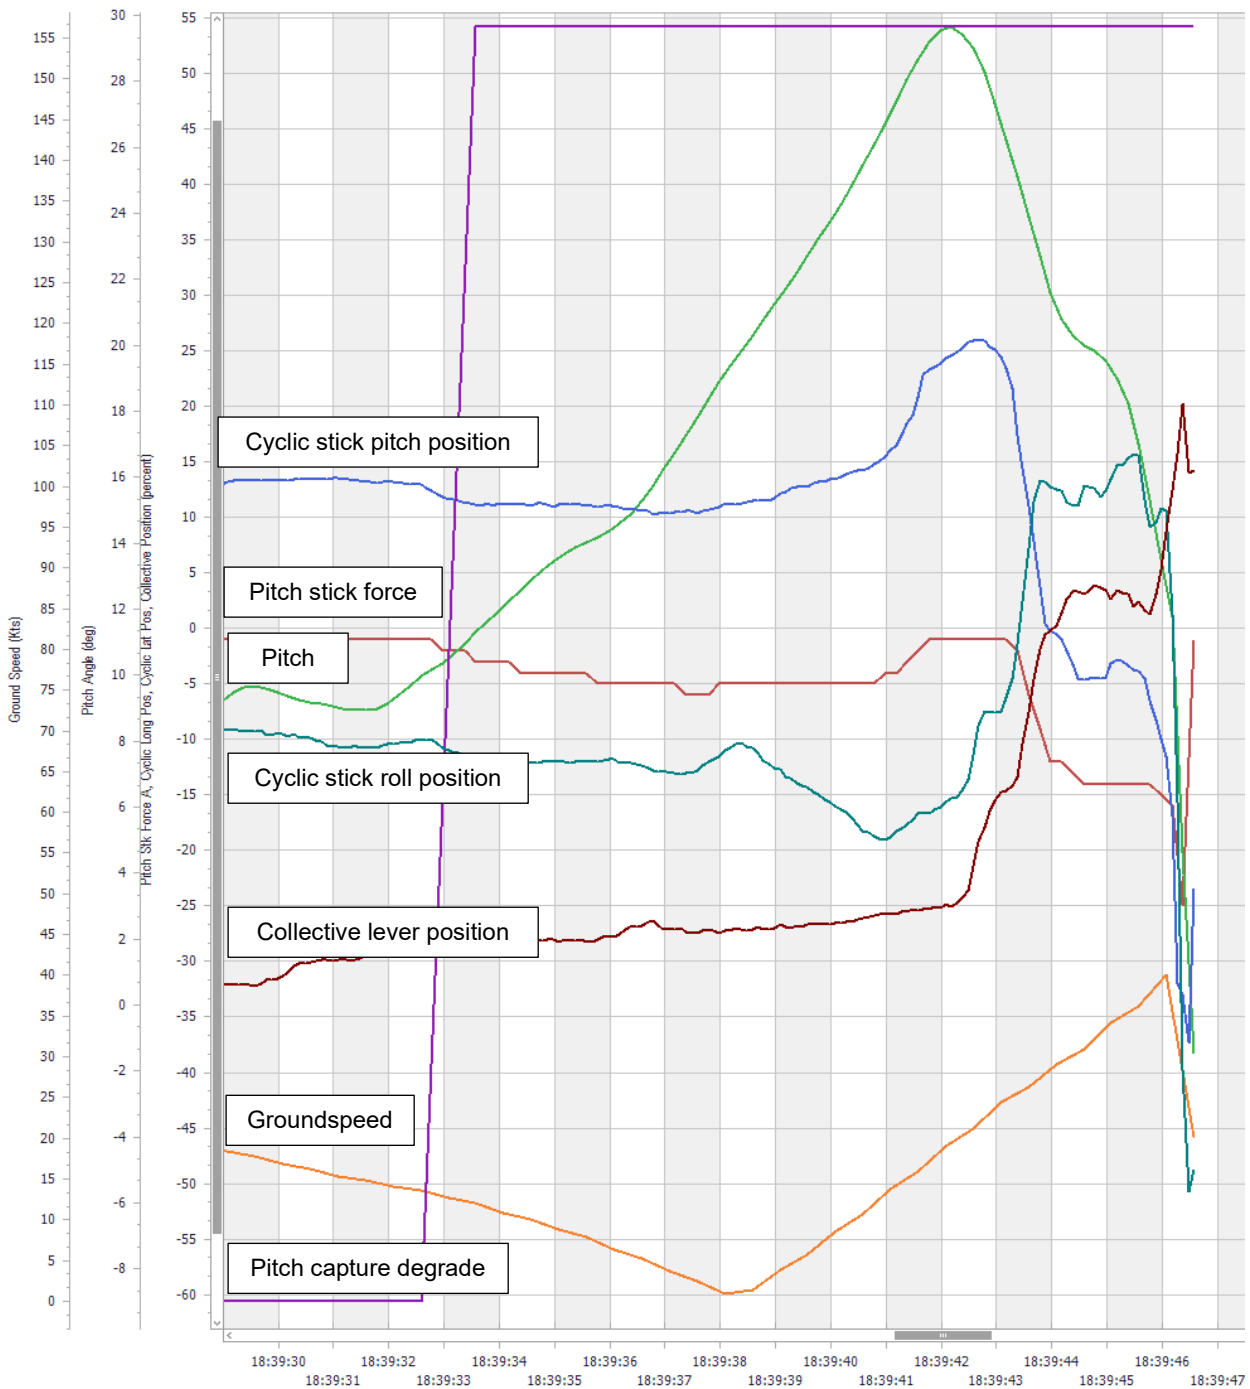
Figure 21: The last 16 seconds of HUMS data for the flight. Pitch angle (green), cyclic stick pitch position (blue), cyclic stick roll position (turquoise), collective position (dark brown), ground speed (orange), pitch stick force (light brown) and the pitch capture degrade (purple). Source: NSIA

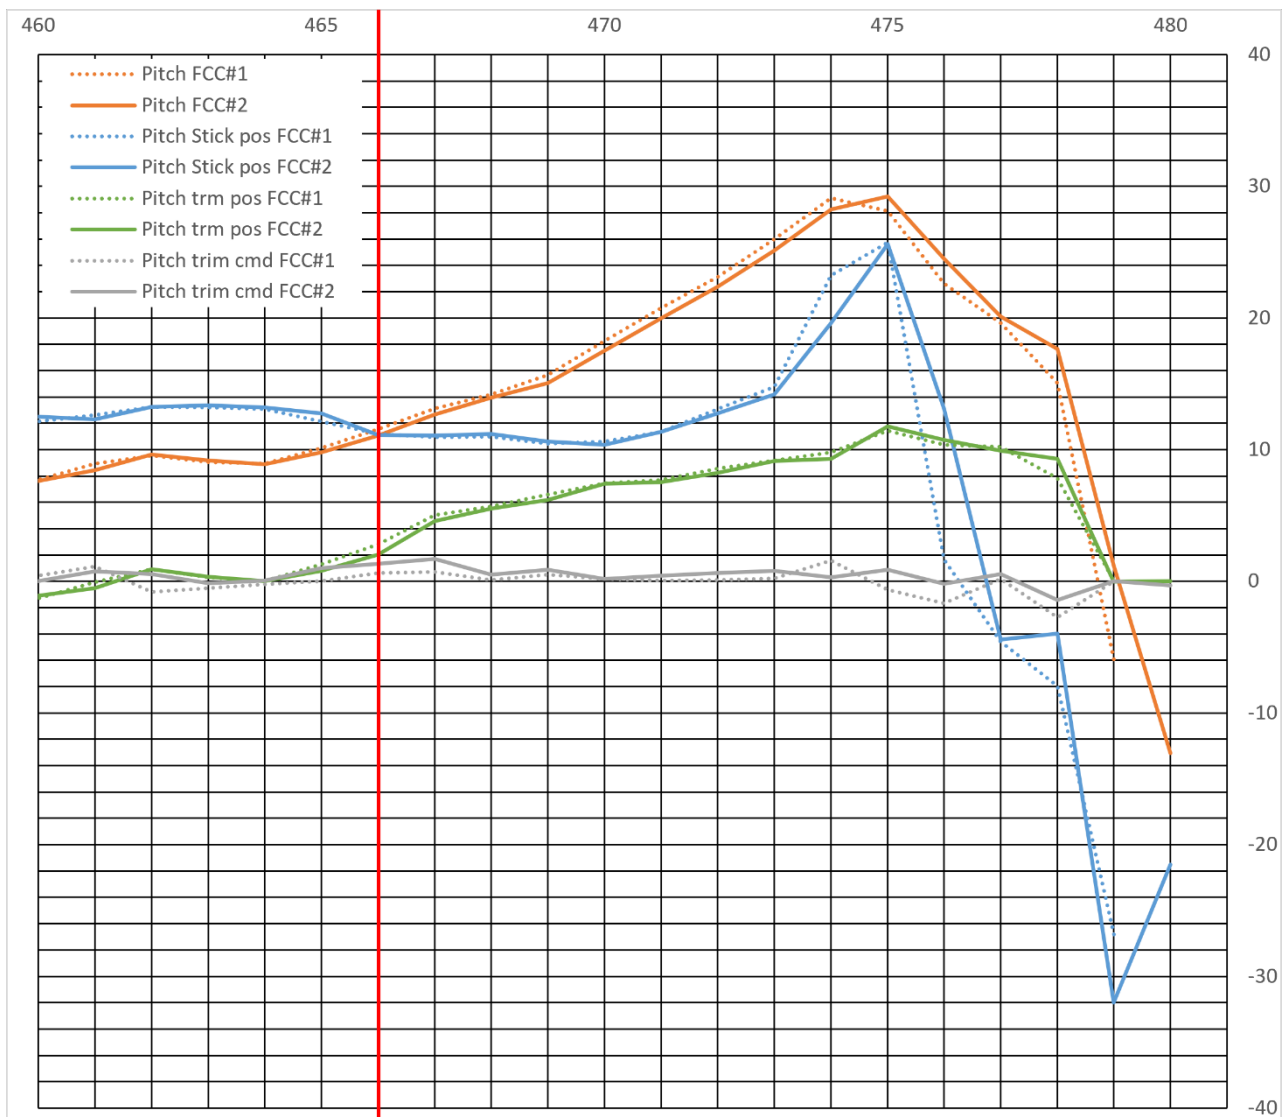
Figure 22: The last 20 seconds from the FCC circular buffer. The data plotted is pitch (orange), cyclic stick pitch position (blue), pitch trim position (green) and pitch trim command (grey). The dashed lines are from FCC 1 and solid lines are from FCC 2. The red line is approximately where the pitch degrade is activated. Source: NSIA

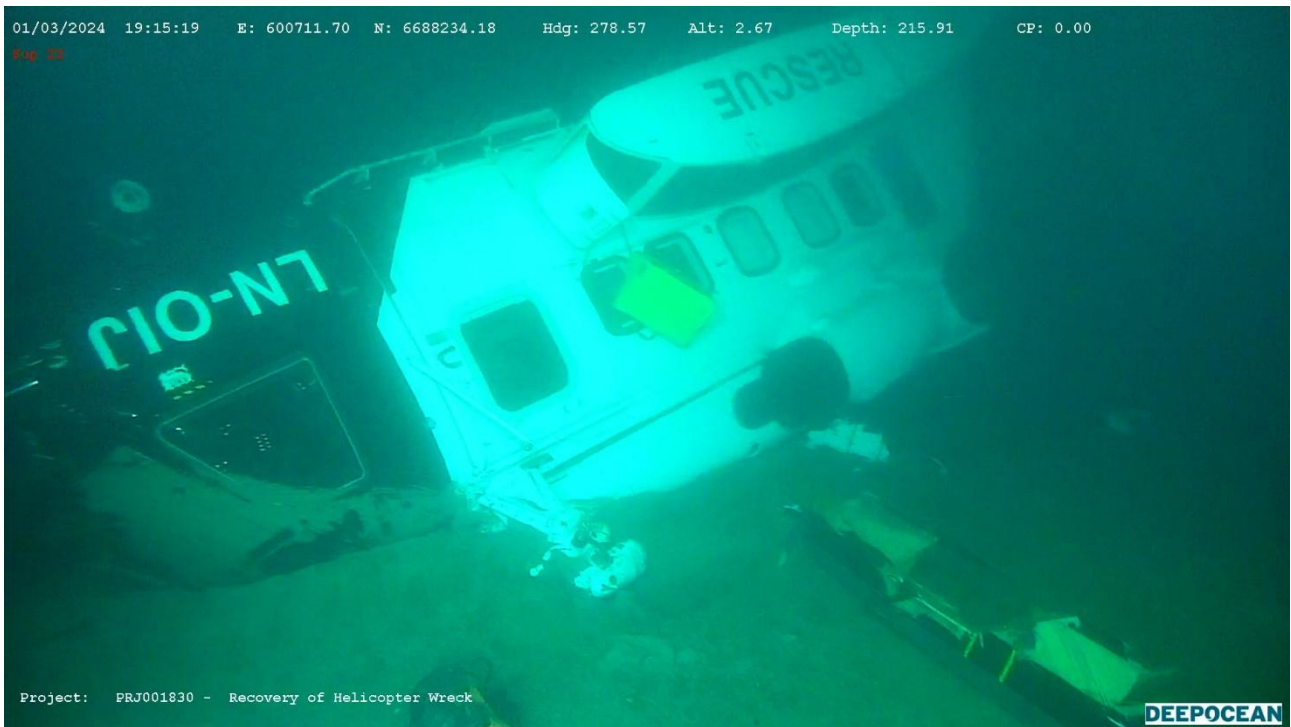
Figure 26: LN-OIJ as found on the seabed. Photo: Deepocean/NSIA

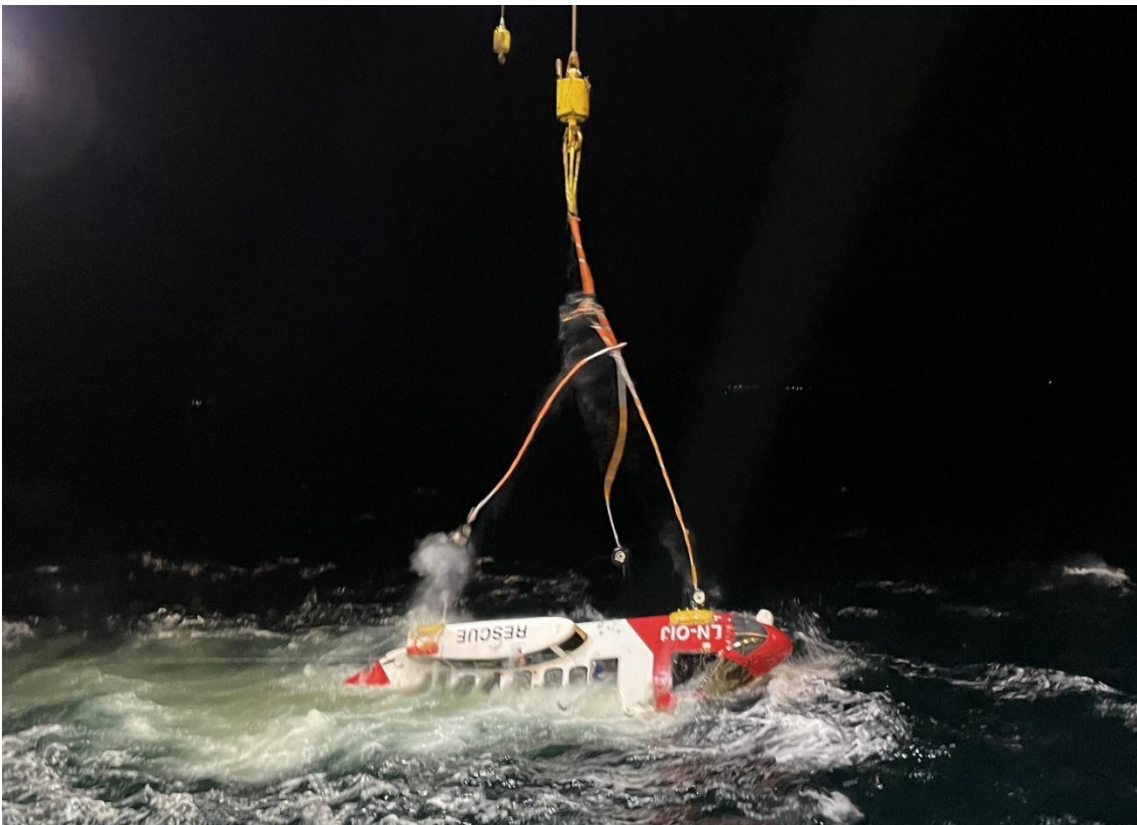
Figure 27: The moment when the left main wheels were pulled loose during first attempt of hoisting the helicopter. Note water flowing through all the windows at the left side. Photo: NSIA

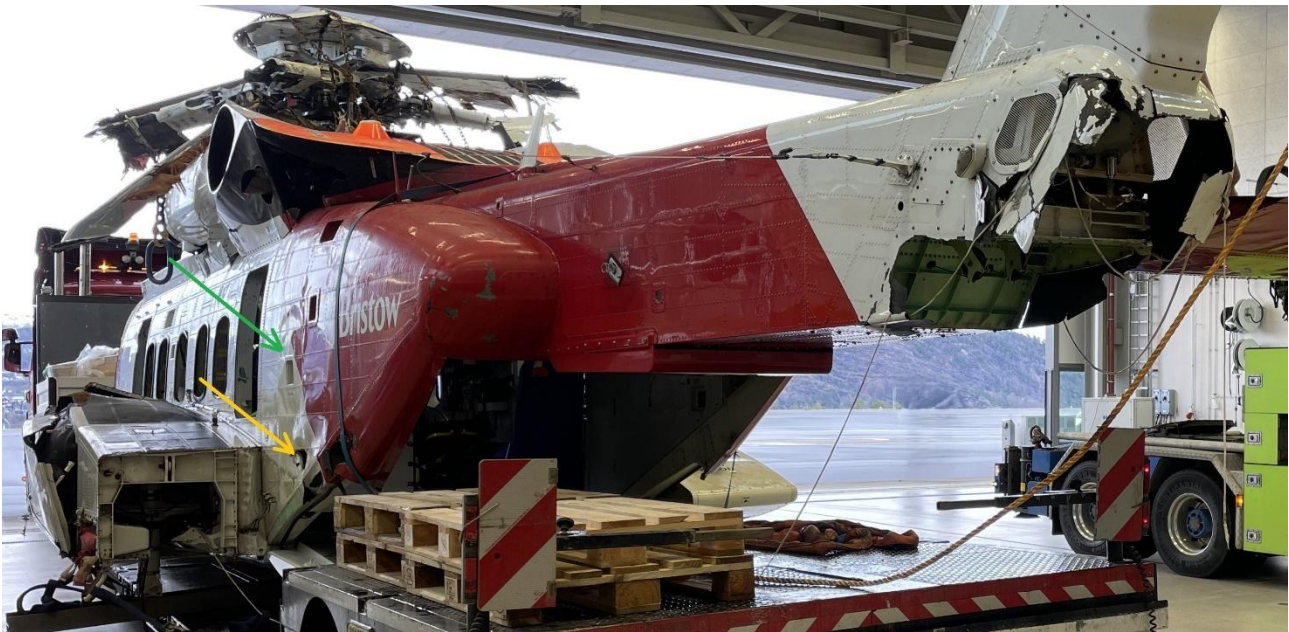
Figure 29: The helicopter seen from the aft left quarter. The aft part of the left sponson is missing. A hole on the fuselage side adjacent to the sponson indicate that the missing part was forced into the fuselage (yellow arrow). The green arrow points towards hydro deformation. Also noticeable is the missing aft door and the damaged tail boom. Photo: The NSIA

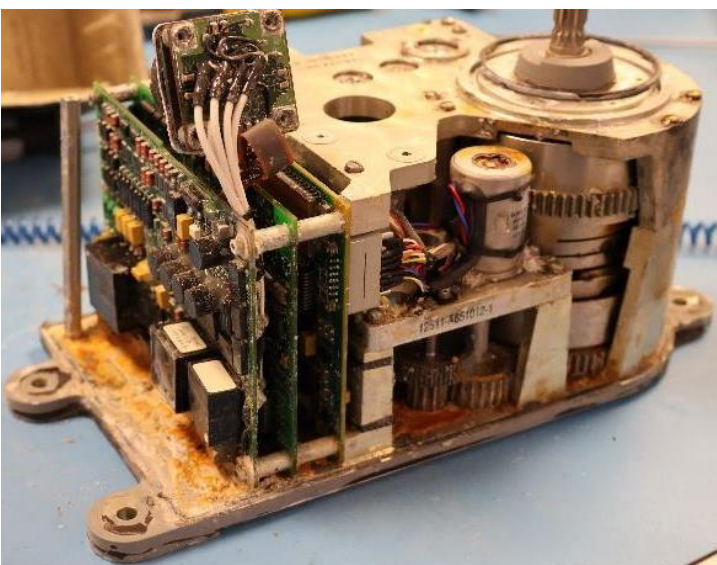
Figure 47: Photo showing the internal corrosion of the trim actuators and the three circuit cards.
Photo: Collins Aerospace / NSIA

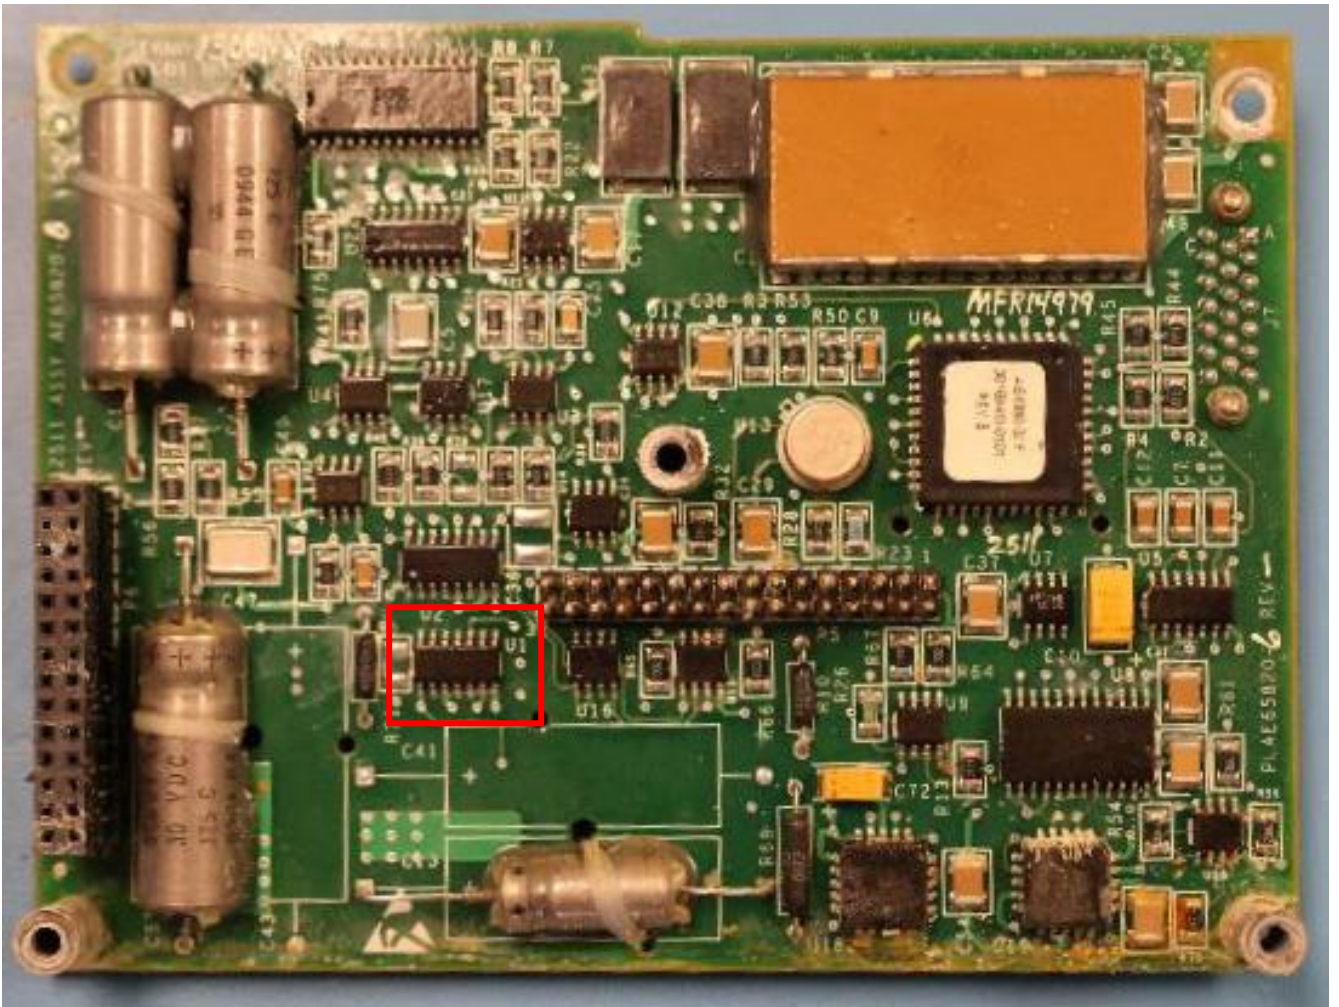
Figure 48: Photo of the motor driver card from LN-OIJ's pitch trim actuator with the failed component highlighted in red. Photo: Collins Aerospace. Illustration: NSIA

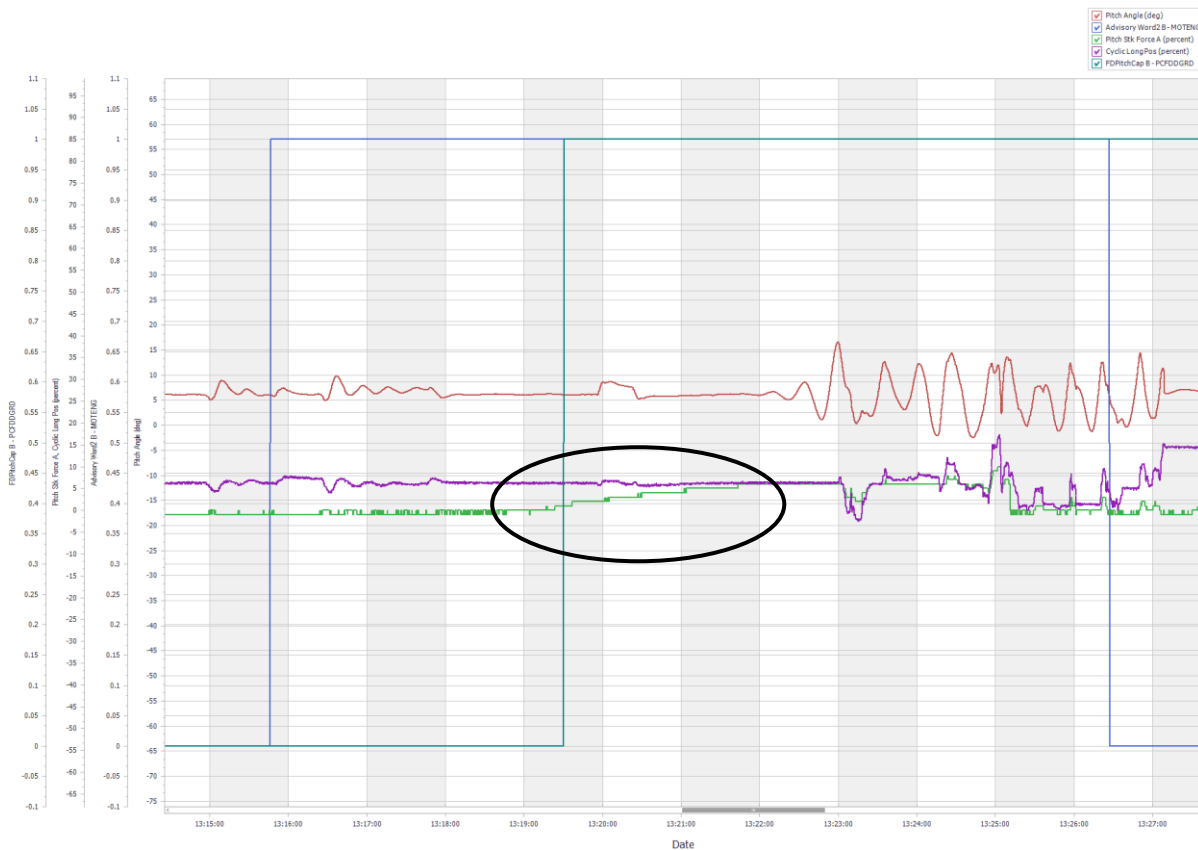
Figure 49: HUMS data for the second SIL trial with the pitch trim actuator motor driver card from LN-OIJ. The black circle marks where the stick force (green) starts increasing, while the cyclic (purple) is relatively stationary. Source: Sikorsky/NSIA.
