Runway excursions on take-off involving Airbus A330-323, 9M-MTL, and Boeing 787-9, VN-A819

Melbourne Airport, Victoria, on 7 and 18 September 2023

ATSB Transport Safety Report

AO-2023-043

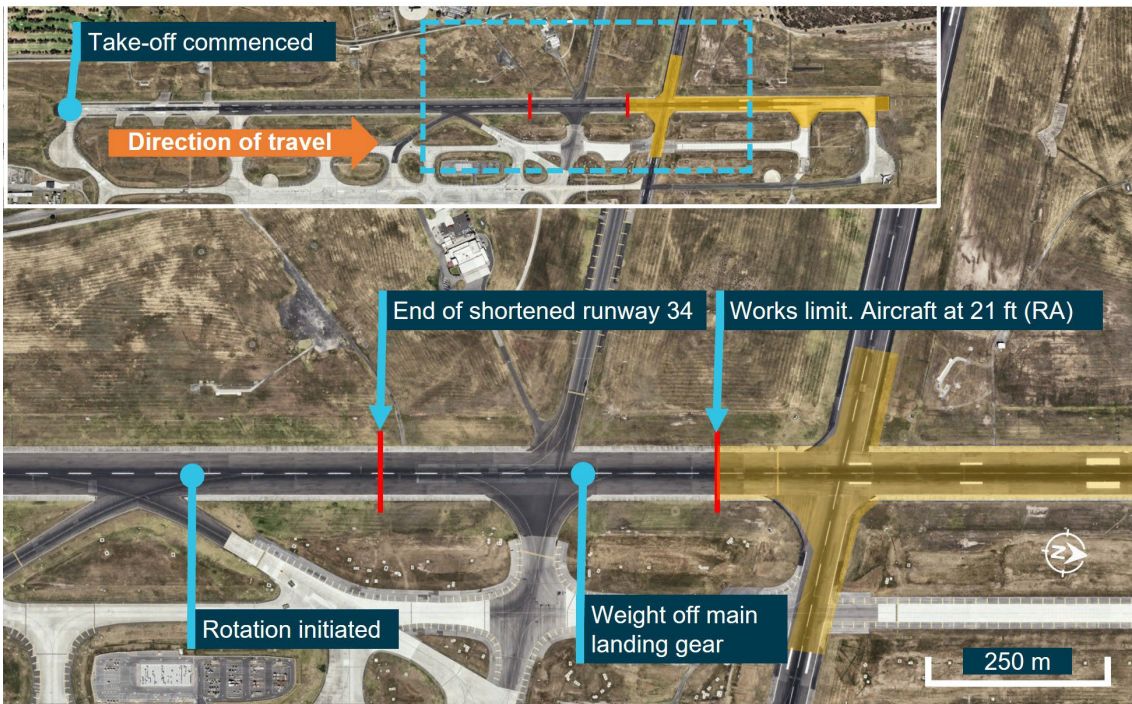
Figure 3: 9M-MTL take-off relative to runway works

²⁰ Radio altitude is calibrated to record zero height above ground as the main landing gear touches the runway in typical landing attitude. The values in this report are corrected for the additional aircraft pitch angle on take-off which would introduce a small error due to the position of the radio antennae. Additionally, the A330 position data was recorded at 2 second intervals, which would also introduce a small uncertainty in the aircraft position and height, however, the relevant data point was adjacent to the works limit.

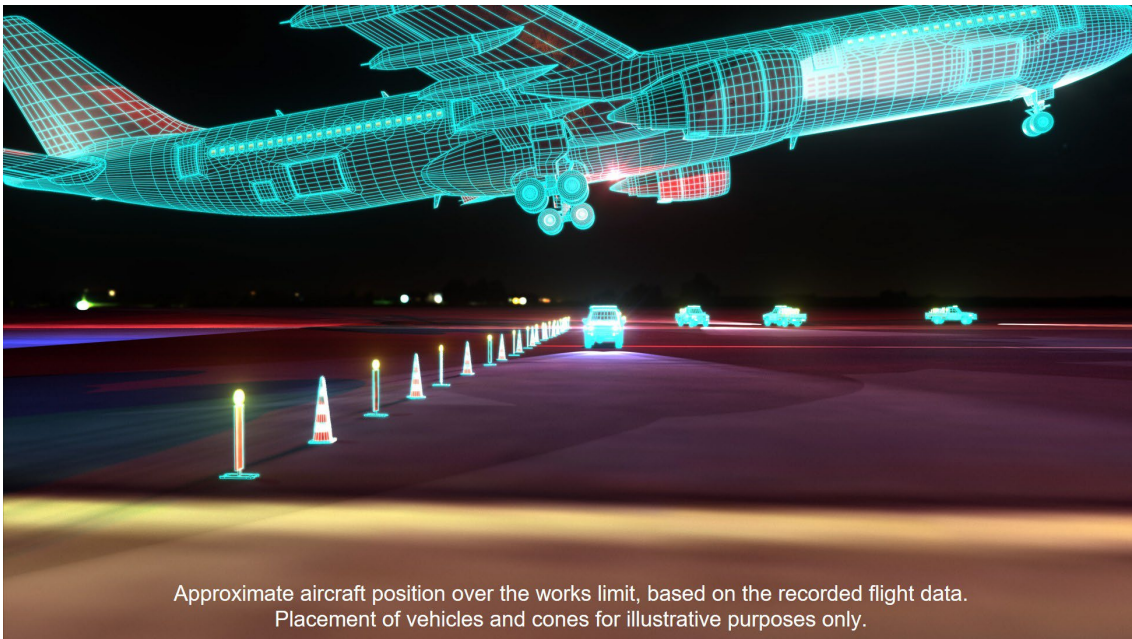
Figure 4: Visual impression of 9M-MTL over works limit

The jet blast from each aircraft impacted runway unserviceability lights,⁴ works lights and marker cones. Personnel were active in the works area at the time of both occurrences. No personnel were physically injured, however there was a reported stress-related injury as a result of the proximity of the aircraft to the works area during the second occurrence. There was no damage to either aircraft, or injuries to passengers, and both flight crews continued with their planned flights.

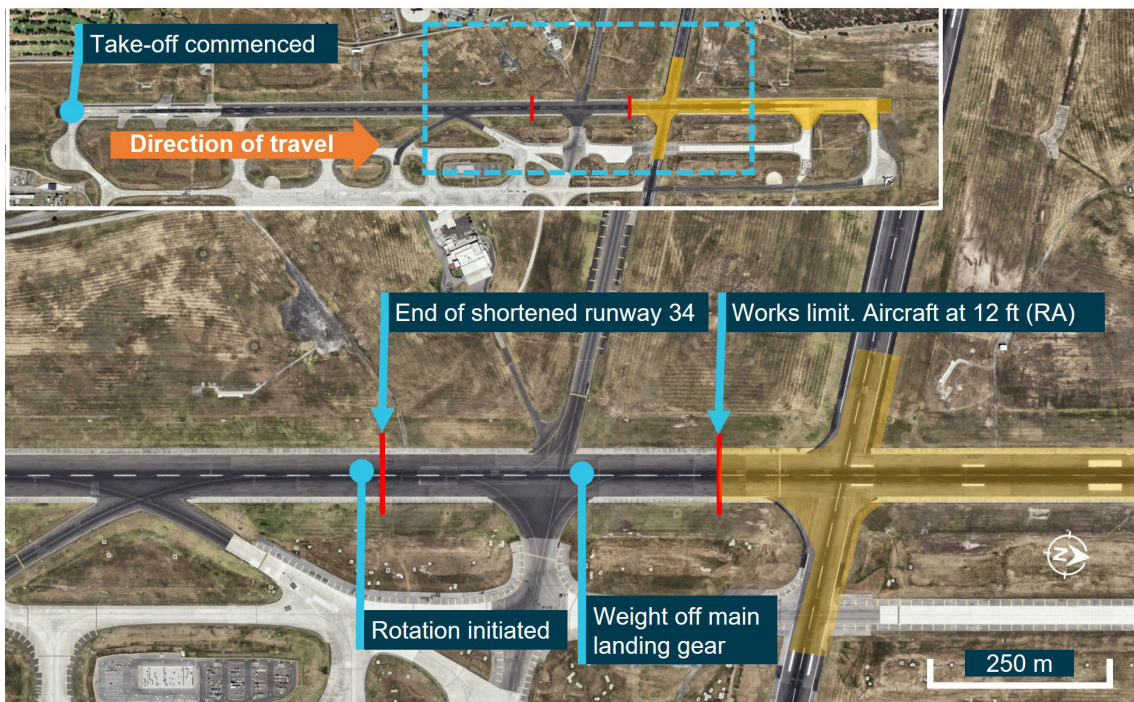
Figure 6: VN-A819 take-off relative to runway works

During the take-off run, the PM and PIC observed that the runway end lights appeared closer than normal at lift-off. ATSB flight data analysis identified the lift-off point³¹ as just past the runway intersection with taxiway E (Figure 6). As the aircraft crossed the works limit line, the recorded radio altitude was approximately 15 ft (4.5 m).³² A visual impression of the proximity of the aircraft to the works limit is shown in Figure 7.

Jet blast on the works limit displaced and damaged unserviceability lights and marking cones. There were no reported physical injuries, however, one worker reported a stress-related injury as a result of the close proximity of the aircraft to their vehicle.

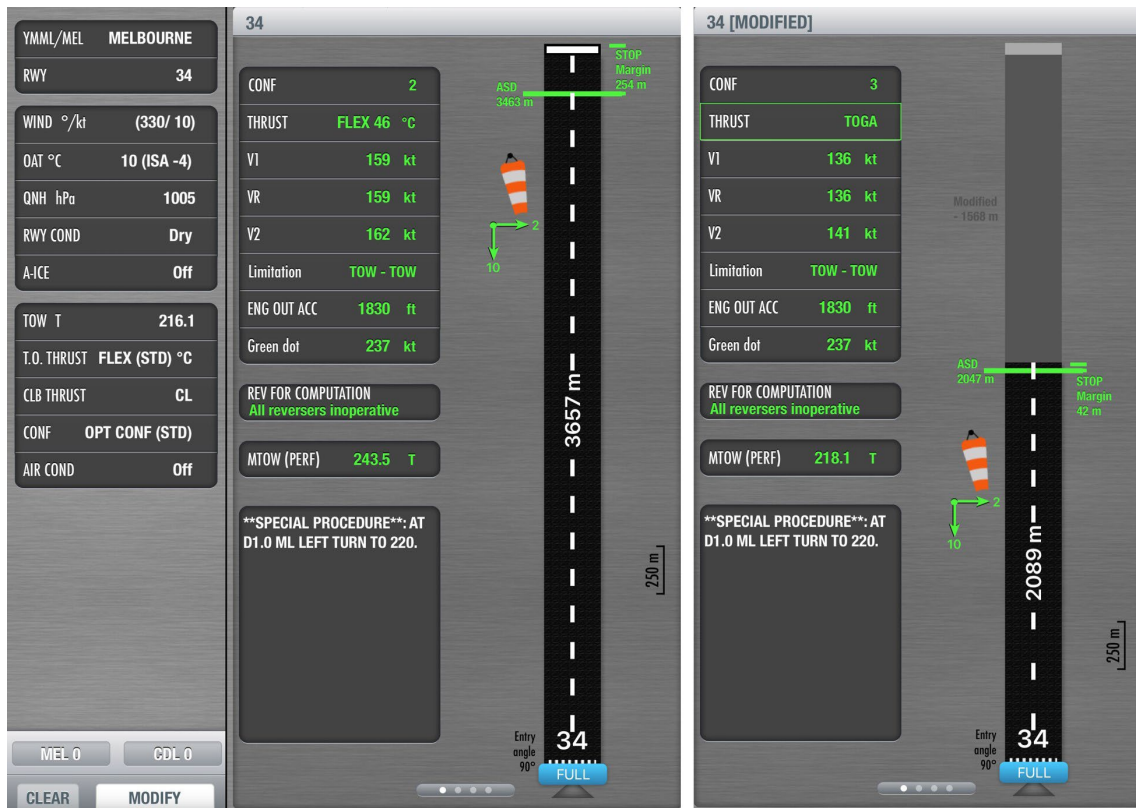
Figure 8: Airbus *Flysmart* screen images showing performance comparison for 9M-MTL for conditions representative of 7 September 2023. Melbourne runway 34 full-length (centre of image) and reduced-length (right).

Runway 34 full length	Runway 34 reduced length
Thrust: reduced-thrust 42 °C	Thrust: TOGA
Flaps: 5	Flaps: 20
V _i : 165 kt	V ₁ : 144 kt
V _R : 166 kt	V _R : 146 kt
ASDR: 3,500 m	ASDR: 2,205 m

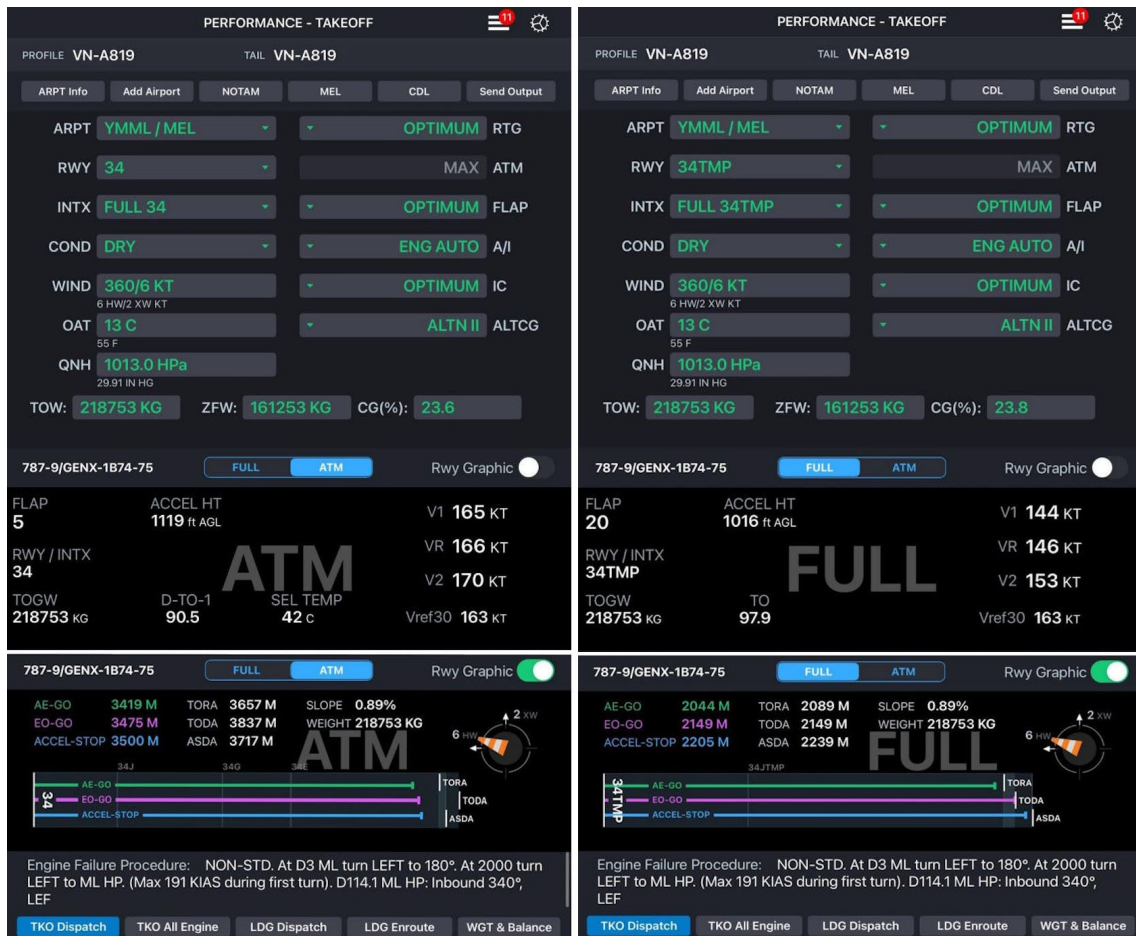
Figure 9: Boeing OPT screen images showing performance comparison for VN-A819 for conditions representative of 18 September 2023 – Melbourne runway 34 full-length (left) and reduced-length (right)

Selections from top left: ARPT (Airport), RWY (Runway), INTX (Intersection), COND (RWY condition), WIND, OAT (outside air temperature), QNH. Key differences being the INTX selection of 34 vs 34 TMP, and the resulting engine select temperature of 42°C vs 'FULL' thrust. The runway graphic at the bottom show the take-off distances required against those available, along with the actual figures.

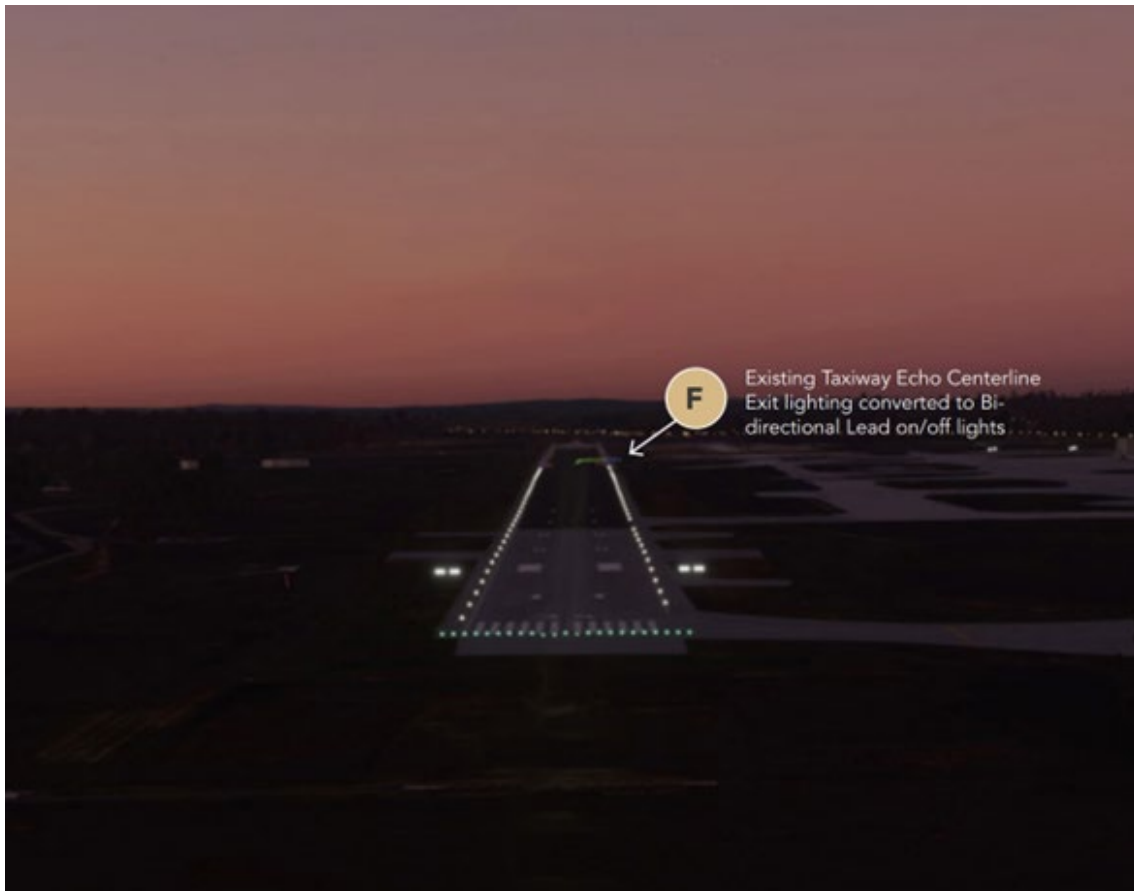
Figure 13: Illustration indicative of modified runway 34 lighting on approach at night

The unserviceability lights and orange strobe lights at the works limit were visible in CCTV video of the occurrence take-offs, with the camera located on the roof of the terminal building at a distance of approximately 900 m.

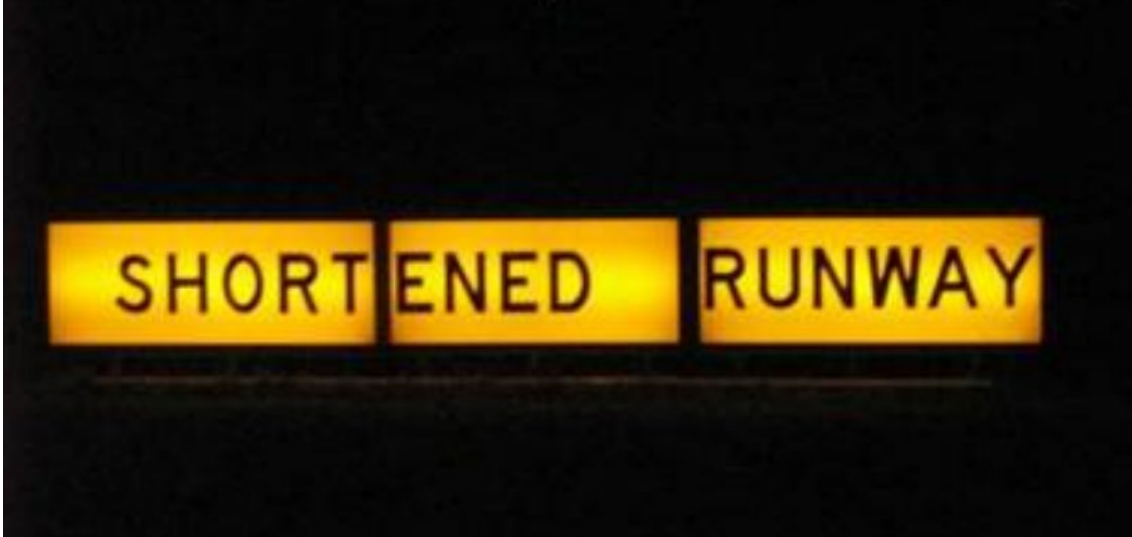
Figure 18: Shortened runway sign used at Changi Airport during resurfacing works

which was probably because they were not expecting a change to the take-off length. The report also noted that the amended TORA sign was 'of the same size, font and colour indicating the shortened distance' and that the sign 'did not contain any attention-getter to draw the crew's attention to the reduced TORA'.

Among the immediate safety actions taken by Singapore ATC, was to ensure that all aircraft assigned to runway 20C were reminded of the reduced TORA by having air traffic controllers highlight the information to them during flight crew communications with both the clearance delivery and runway controllers.
