Final Report

B777-300ER, 9V-SWM Turbulence Event over Myanmar

21 MAY 2024

TIB/AAI/CAS.231

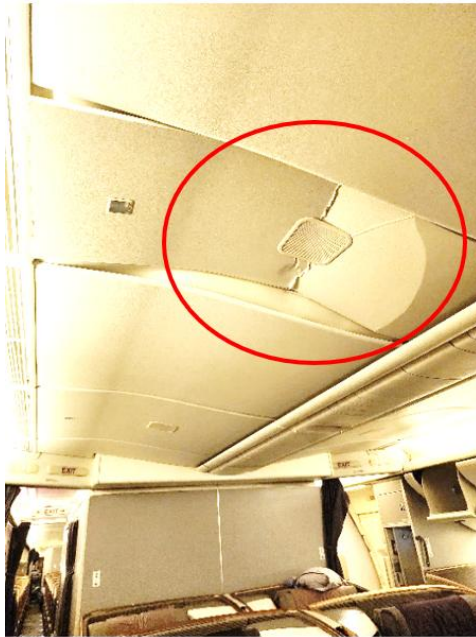
Figure 4: Broken ceiling panel

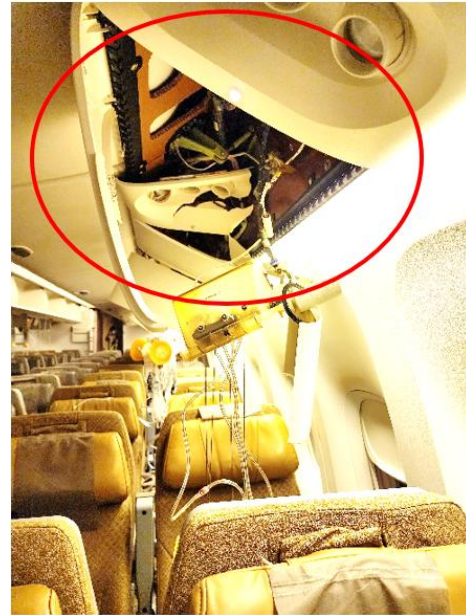
Figure 5: Broken PSUs with oxygen masks dislodged

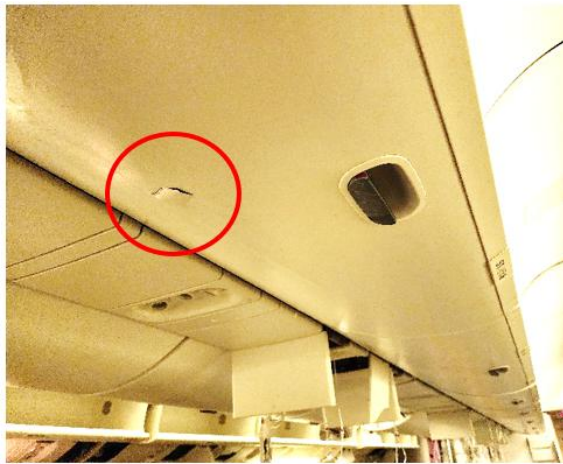
Figure 6: Punctured overhead bin

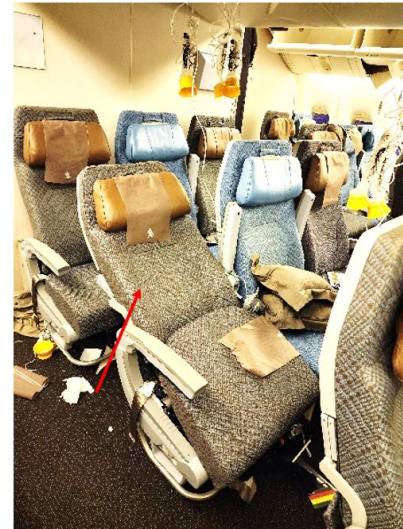
Figure 7: Damaged seat backrest reclining mechanism

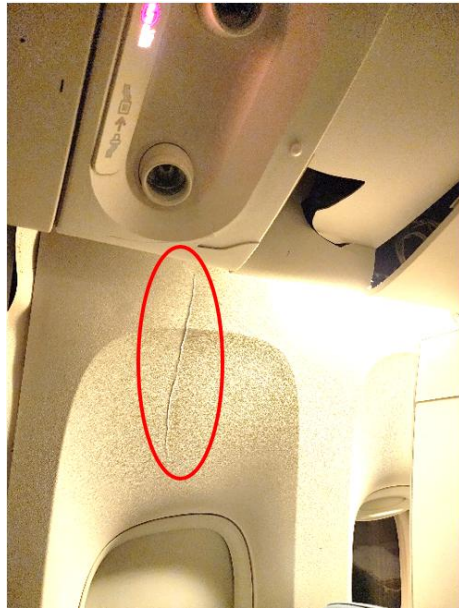
Figure 8: Cracked sidewall panel

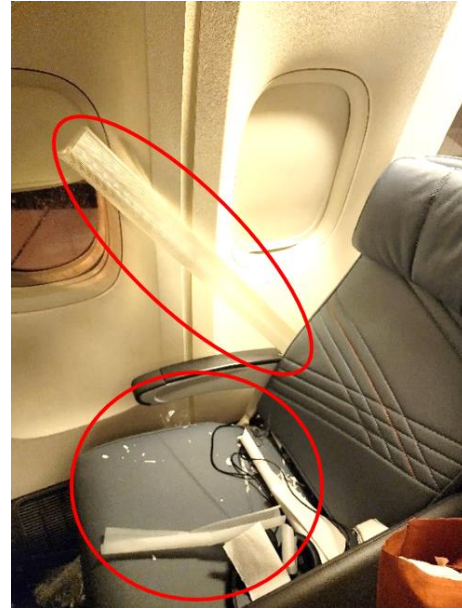
Figure 9: Broken sidewall light

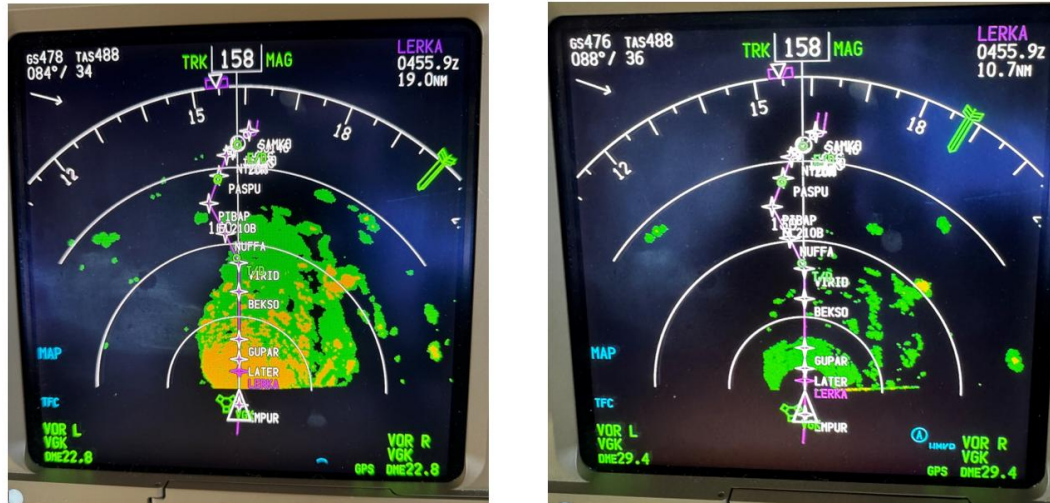
1.10.1.2 The photos taken by the flight crew indicated that the WXR-R was under-painting when compared with WXR-L (see **Figure 16**).

Figure 16: Comparison of WXR-L (left photo) and WXR-R (right photo) during in-flight WXR system check

2.4.1 The in-flight WXR system check carried out during the ferry flight from Bangkok to Singapore suggests that the WXR of the occurrence aircraft might have an under-painting issue, as observed by the flight crew operating the ferry flight.

2.4.2 The flight crew did not follow the WXR OEM's instruction to take a photo five minutes after switching from WXR-L to WXR-R to allow for a full scan cycle. The flight crew had taken a photo about one minute after switching WXR-L to WXR-R. They did not take another photo after five minutes as they noted that there was no difference in what was displayed on the ND five minutes after switching and therefore, they did not see the need to take another photo. The WXR OEM's view is that, since the ferry flight crew did not have photographic evidence taken in accordance with its instructions, the in-flight test result of the WXR systems was not valid and could not be used to infer on the performance of WXR-R versus WXR-L.

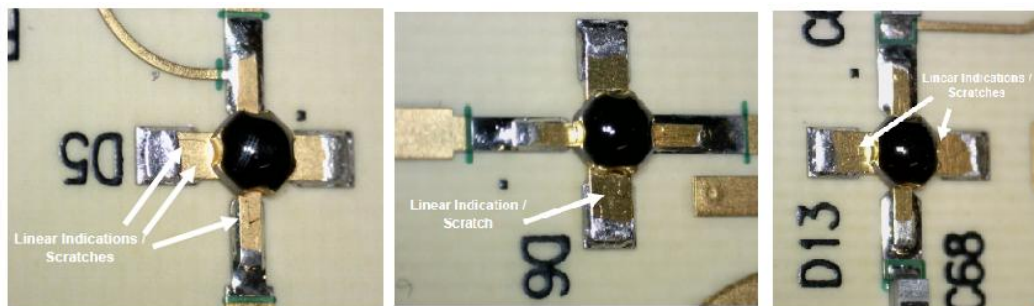
- (a) the solder joints on the diodes' leads were intact and appeared undamaged.
- (b) there were some fine linear scratches on the leads of the diodes.

Figure 18: Visual inspection of TR-R diodes

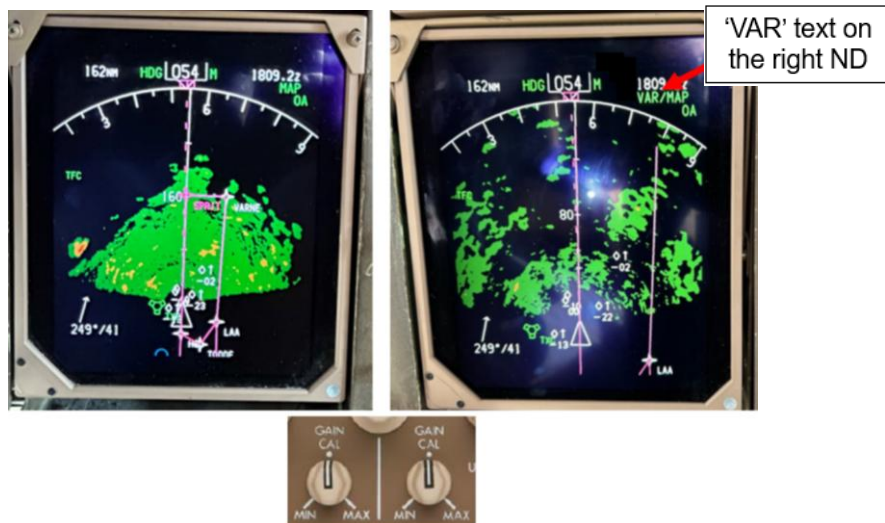
- 2.5.4 As regards ITP and flight test of CP, the VAR text appeared when the right GAIN knob was in CAL position. However, the CP OEM considered the unit to be within specification limits during the ATP and did not find any issues. The WXR OEM believes the occurrence CP right GAIN knob could have an intermittent issue but could not explain the cause of the CP intermittent issue.

Figure 19: Comparison of left and right NDs when GAIN knobs were set to CAL position (red arrow showing VAR text on the right ND)

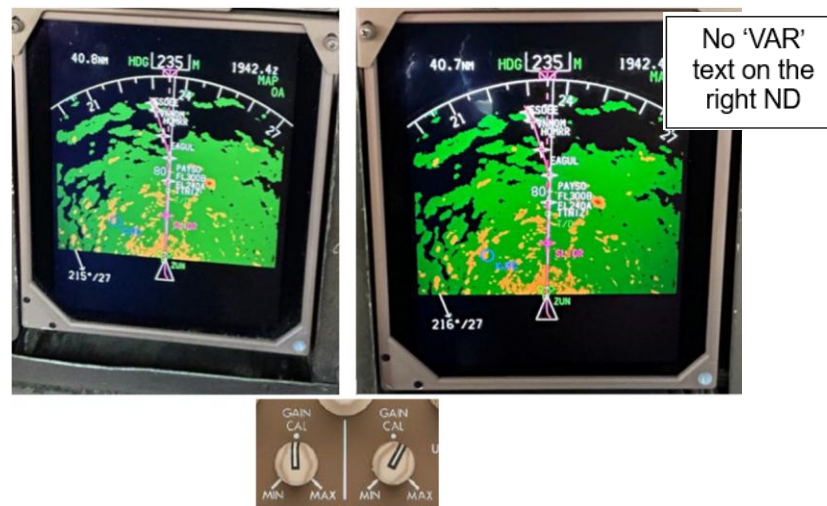
NDs appeared similar and the VAR text, which should appear on the right ND at this GAIN knob position, did not appear (see **Figure 20**).

Figure 20: Comparison of left and right NDs when left GAIN knob was set to CAL position and right GAIN knob set at 2 o'clock position

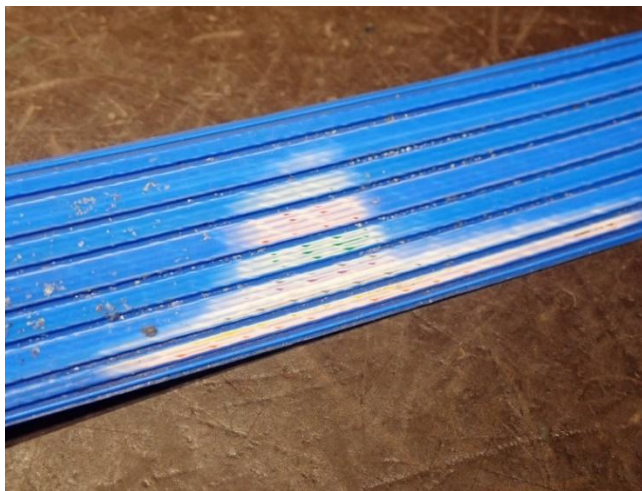
- A10.1 There are two ribbon cables (blue in colour), Ribbon 1 and Ribbon 2, in a DA that receive signals from the TRs to control the scanning pattern of the antenna. Ribbon 1 is associated with Side 1 of the DA and the left TR and left RP. Ribbon 2 is associated with Side 2 of the DA and the right TR and right RP.
- A10.2 The occurrence DA was disassembled to inspect Ribbon 1 and Ribbon 2. The inspection revealed scoring and debris. No exposed conductor was found on Ribbon 2, whereas about four inches (102mm) of exposed conductor was found on Ribbon 1 (see **Figure 21**).

Figure 21: Conductor found exposed on Ribbon 1
