# **FINAL REPORT**

**Runway Overrun Accident involving  
Arrow Air APWP5L  
McDonnell Douglas DC-8-62, N1804  
Singapore Changi Airport  
13 December 2002**

**AIB/AAI/CAS.002**

**Air Accident Investigation Bureau of Singapore  
Ministry of Transport  
Singapore**

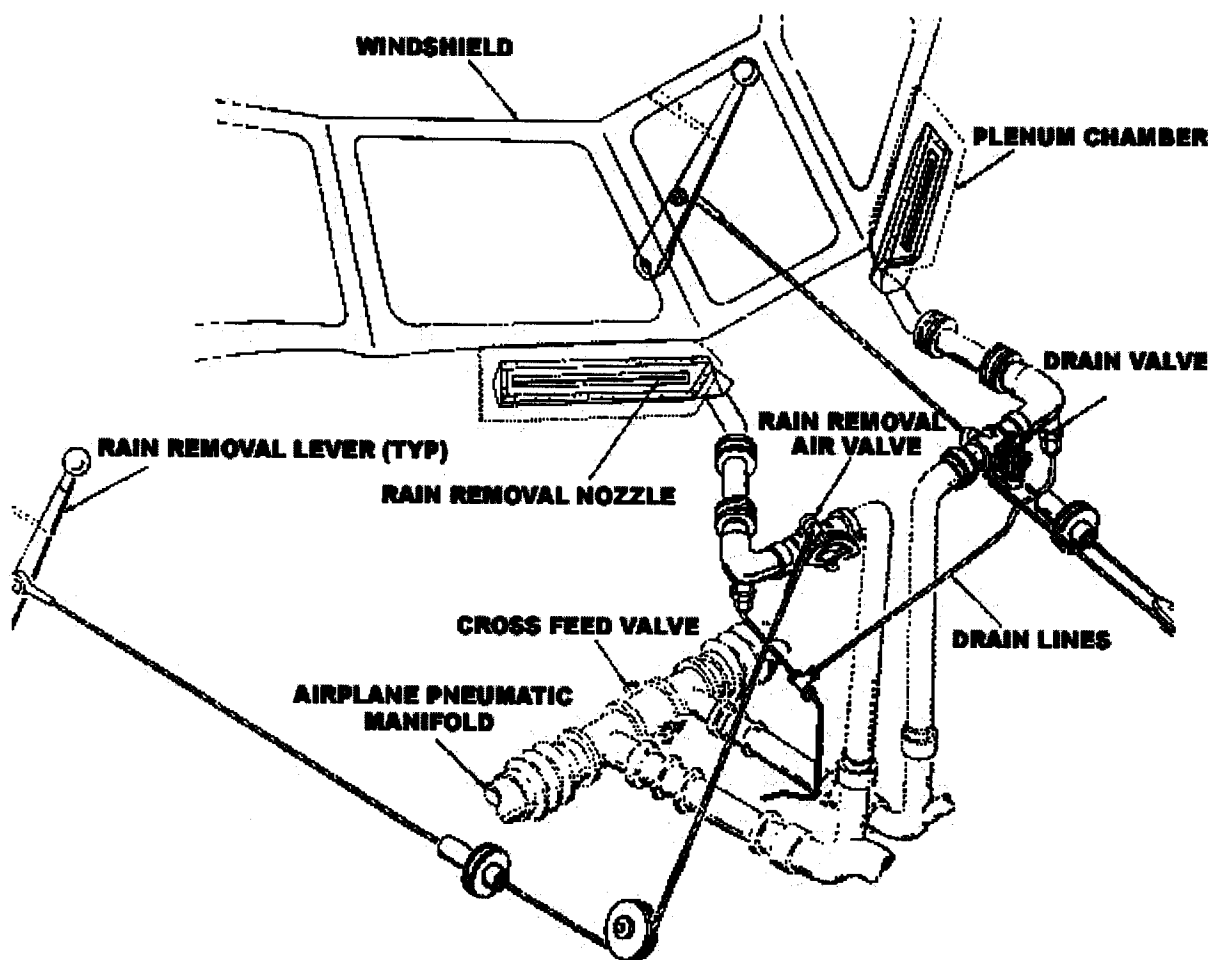
Figure 1. Windshield rain removal system

- 1.6.5.1 There were no windshield wipers used on the aircraft. The windshield rain removal system (see Figure 1) used hot air from the pneumatic system to blow away rain from the left and right windshields during flight.

1.6.5.5 The cabling of the windshield rain removal system was found to be intact after the accident. There was also no indication of any mechanical failure of the system or of the engine pneumatic system which supplied air to the rain removal system.

- 2.4.2 According to the PIC, the windshield rain removal system had not been used by the crew for several weeks and there were no reports of the system being inoperative. The cabling of the system was found to be intact after the accident and there was no indication of any mechanical failure of the system.

- 4.6 The FAA review the effectiveness of DC-8's windshield rain removal system in very heavy rain. [AAIB Recommendation R-2004-020]
- 4.7 The International Civil Aviation Organization encourage research that could lead to the production of equipment that can accurately measure the braking action of runways under all conditions of surface contamination. [AAIB Recommendation R-2004-021]
